# Maryland Historical Trust State Historic Sites Inventory Form

historic  Frame house

18850 Arthur Lane JK 12/1/45

Survey No. WA-III - 113

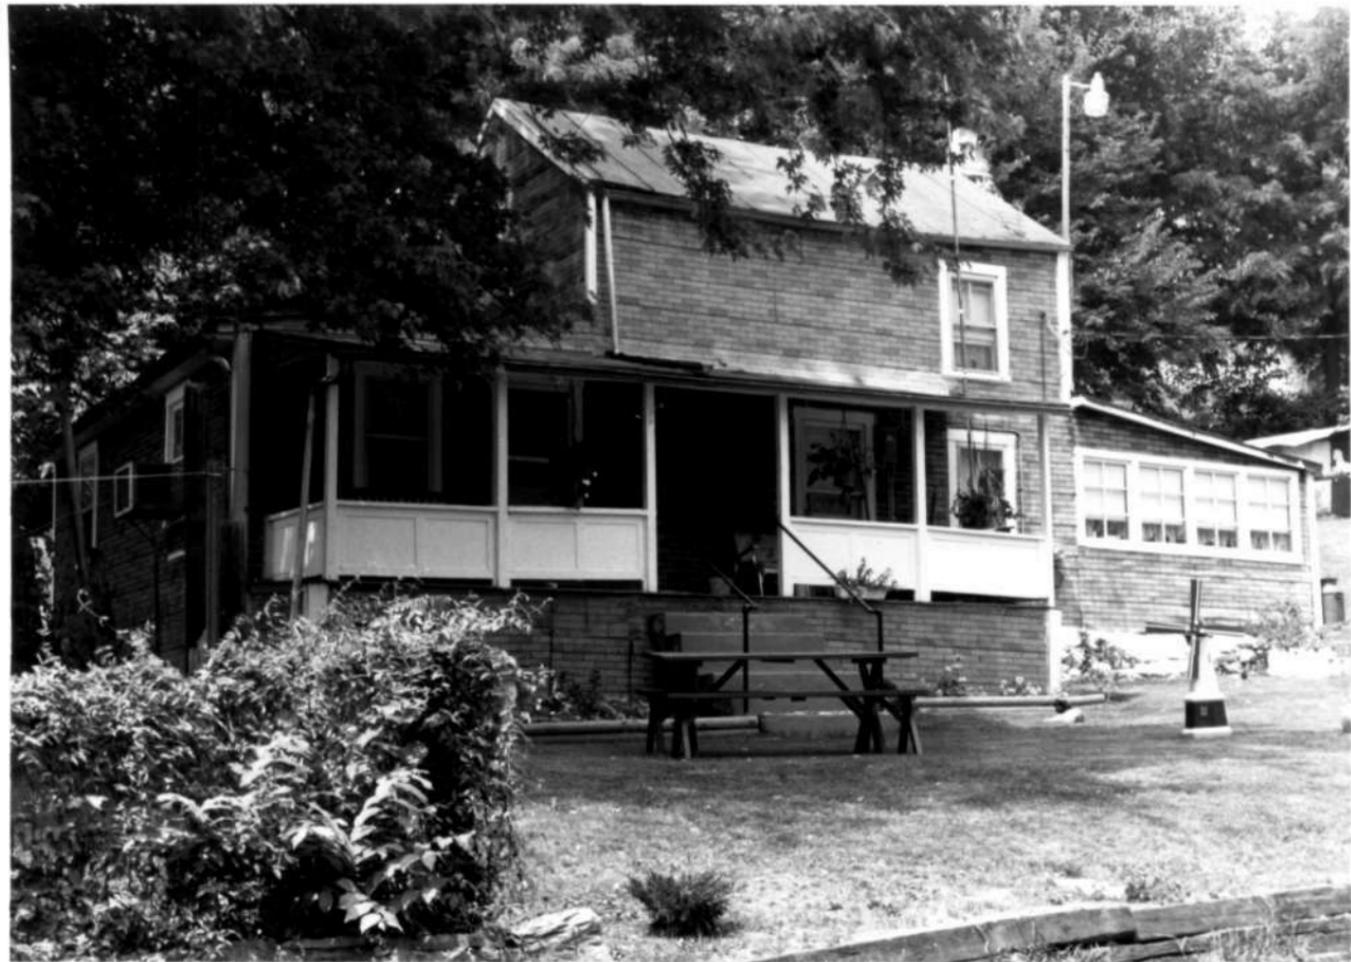
1. WA-III-113
2. Washington Co., Md.
3. Joe Getty
4. ~~April 1983~~ 7/82
5. Md. Hist. Trust, Annapolis, Md.
6. ~~South~~<sup>EAST</sup> elev. (camera facing ~~north~~  
west)
7. 1/1

The two-story structure is constructed of frame and covered in a asphalt shingle. The main facade is asymmetrically arranged. It has a one-story porch running along the two bays of the southern addition and one bay of the main section. The porch has a shed roof covered in sheet metal and is supported by square posts with panelled railing. The southern addition has a entrance and a one-over-one sash window. The main section has a entrance and a two-over-two sash window. There is a single two-over-two sash window on the second story. The northern addition has a shed roof and a row of four connected windows. On the north gable end is an interior-end brick chimney that rises from the exterior of the main section above the first story. The main section has a boxed cornice. The roof is covered in sheet metal.
