Survey # WA-III-138
Street Address 4401 Main Street
Town, State Rohrsersville, Maryland 21779
private X, public _____

Approximate date Ca. 1920

MARYLAND COMPREHENSIVE PRESERVATION PLAN DATA

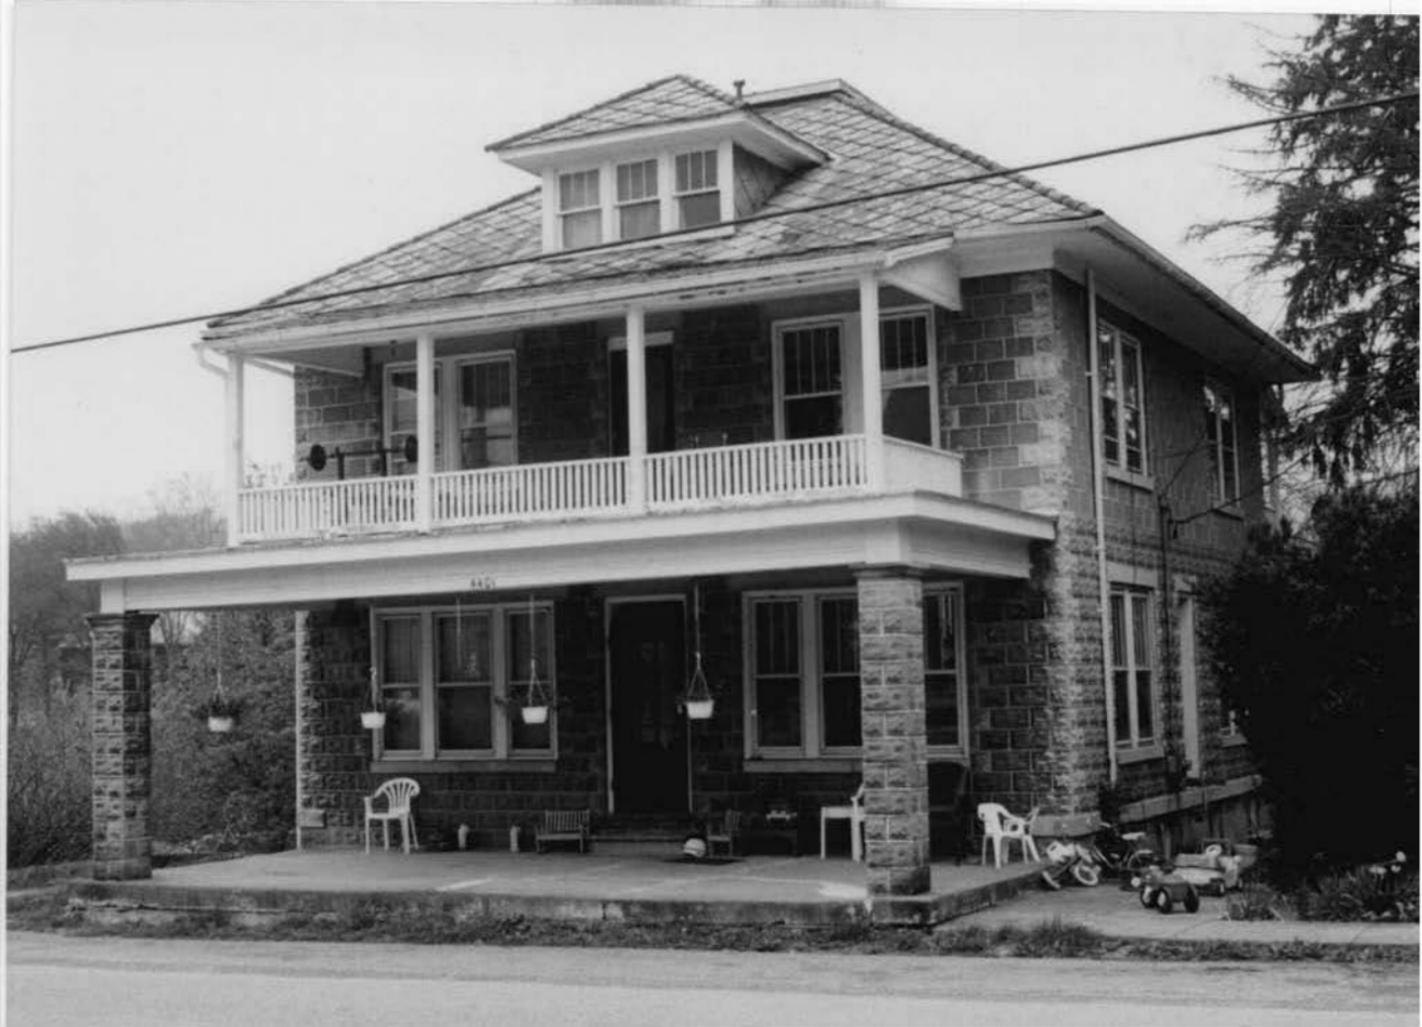
WA-III-138

Retaining a high level of integrity is this cast stone foursquare style house dating from approximately 1920. It is three bays wide with the typical foursquare hipped roof and dormer with overhanging roof and porch. A variety of types of cast stone are used, making this house distinctive. The foundation appears to be poured concrete, while a "watertable" of smooth cast stone forms a band around the base of the building. At the first story, construction is rock faced concrete block with lighter colored blocks defining the quoins and sides of the windows. Smooth cast stone is used for the lintels and sills of the windows. At the second story, regular concrete block forms the walls with rock faced block used for quoins and sides of the openings. Windows have three or four narrow vertical panes above single pane lower sash. The windows are doubled or tripled. The entrance is located in the center bay of the front elevation. A second entrance opened from the second floor onto an upper level porch. The first story porch extends across the front and is supported by two rock faced block piers. The second story porch is narrower covering only the openings and has a shed roof. It may be a later addition. The roof is covered with diamond shaped asbestos shingles. This house is an excellent example of the early use of concrete products. It is unusual to find such a variety of cast stone in a single building. The date attribution is based on the popularity of the foursquare style, the cast stone usage and the vertical paned upper sashes.

House. NE view
