## State Historic Sites Inventory Form

Survey No. WA-III-149

historic Miller House

street & number 4336 Main Street

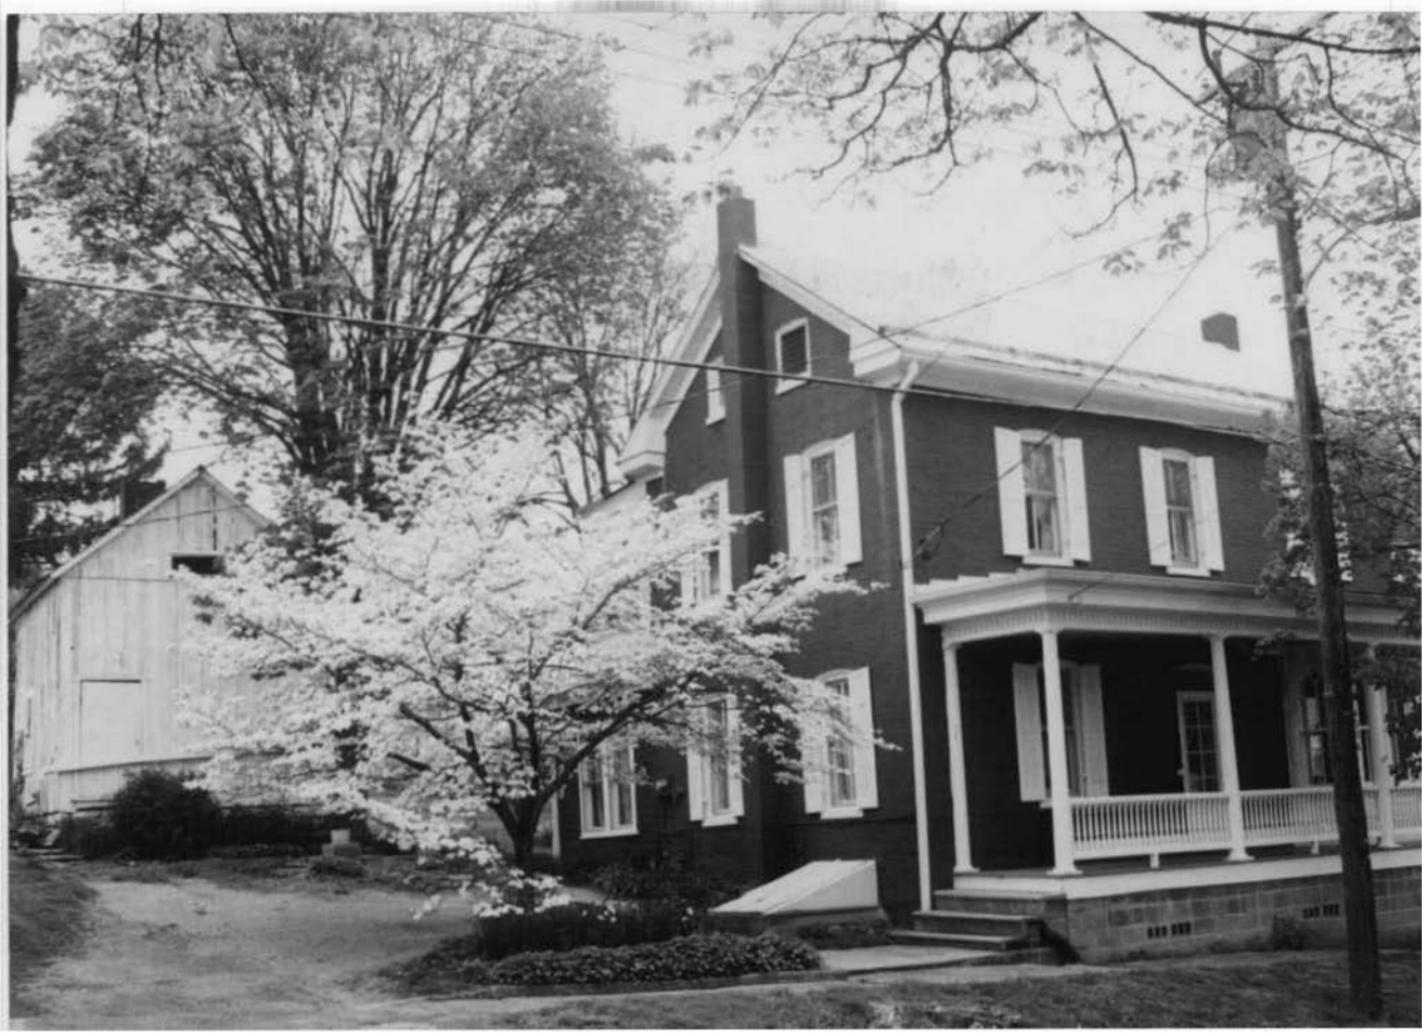
# 1 of 4 (ind)

VIEW NW TO MAIN HOUSE + OUTBUILDING

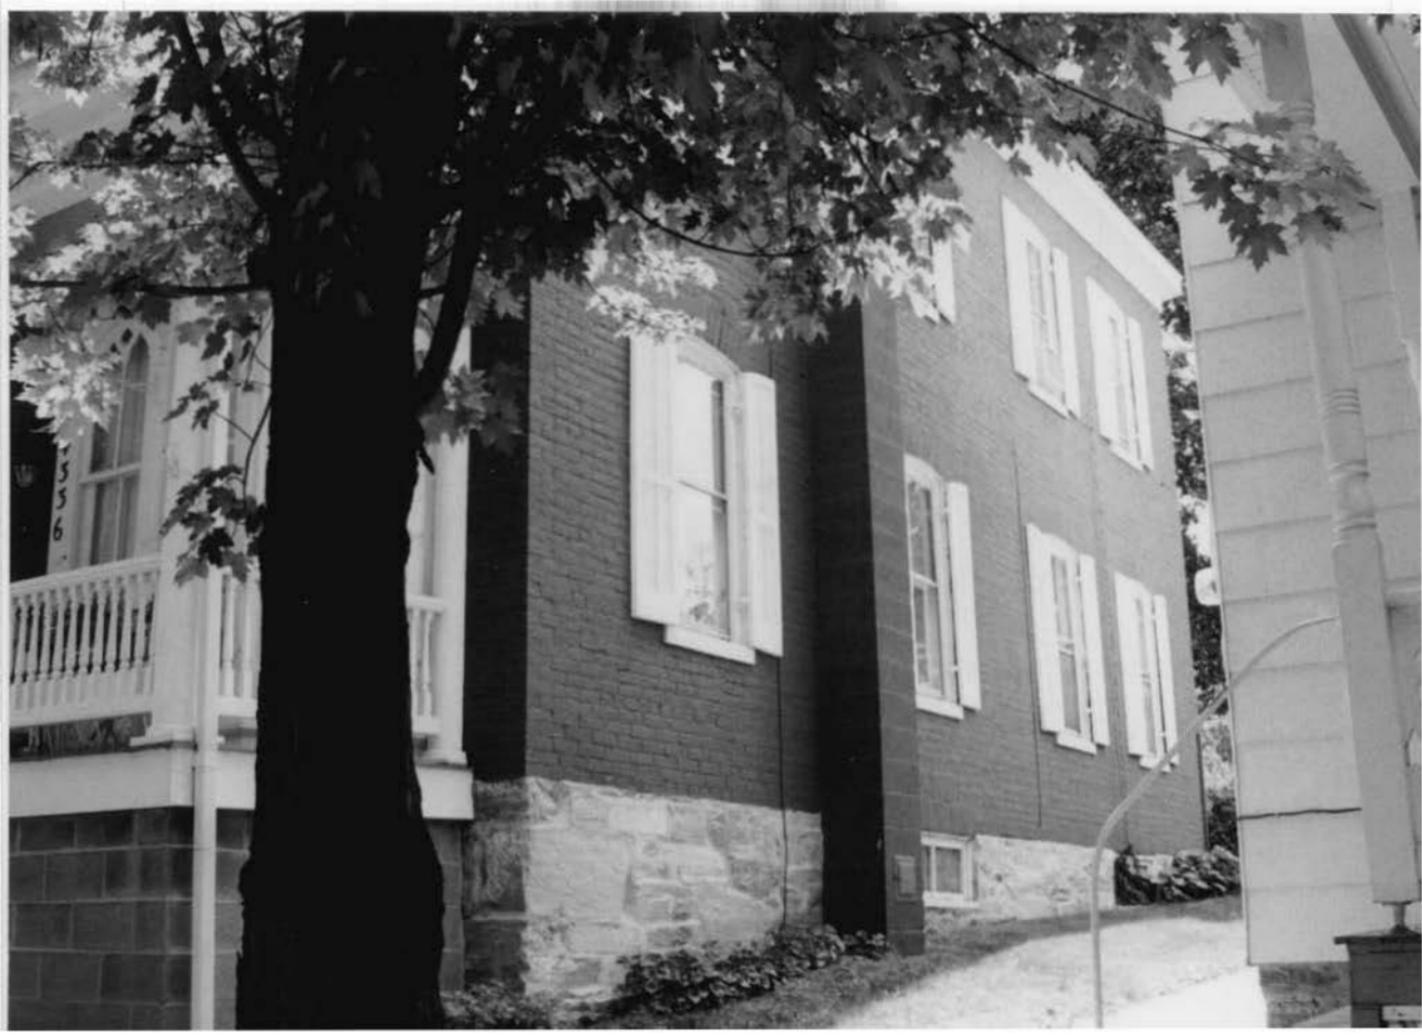
#2 of 4

The identical north and south sides of the main block contain two windows on the first and second floors flanking the chimney. These windows are identical to those found in the facade. Two small square windows flank the chimneys in the gable ends. A stone foundation is visible on the north side and contains two small flat arched windows. The ell extension on the south side has two evenly-spaced windows on each floor.

Miller House, view of N elevation

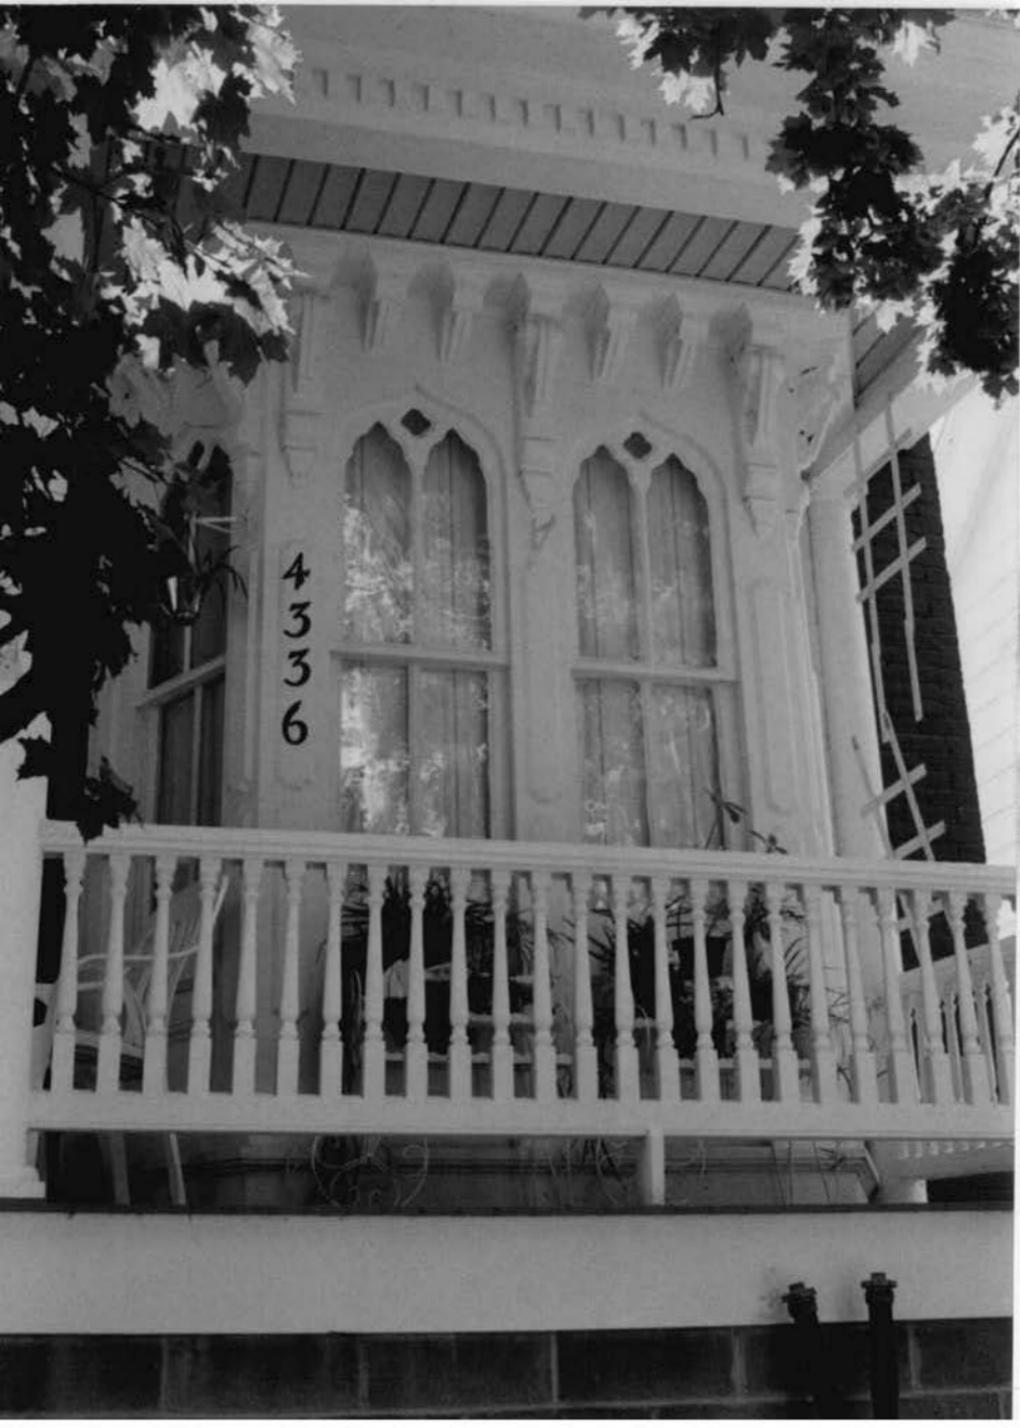
# 3 of 4

The three-bay facade features 2/2 double-hung sash windows, a central entry, a bay window, and a full-width front porch. Added in 1912, the porch rests on cement blocks and cement steps leading to the south end of the porch. Round porch columns extend from the wooden porch floor to an entablature containing dentils in the architrave. The balustrade has turned spindle posts. The central doorway has a curved transom and is flanked by a 2/2 window to its south and a Victorian Gothic projecting bay window to its west. The bay window contains lancet windows with a double arched pane pattern. The segmentally arched windows of the facade feature flat wood sills and louvered shutters. The second floor contains three evenly-spaced windows.

Miller House, view of bay window

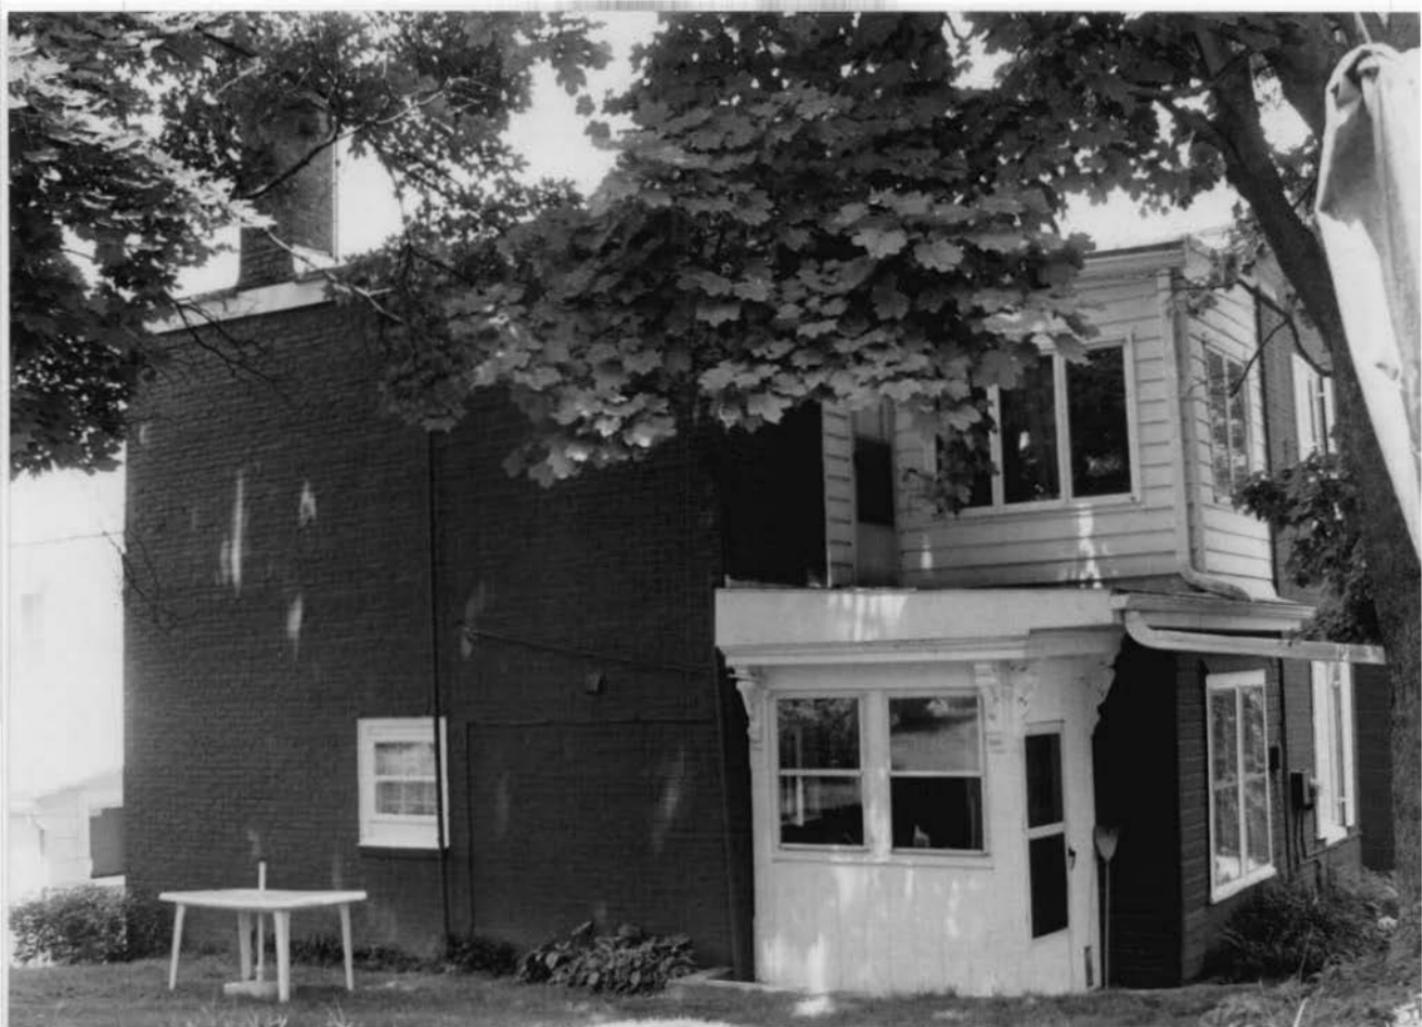
#4 of 4

Miller House, view NE
