Name: MILBROOK RD. OVER LITTLE ANTIETAM CRK.

Maryland Inventory of Historic Properties  
Historic Bridge Inventory  
Maryland State Highway Administration  
Maryland Historical Trust

SHA Bridge No. W-5981 Name: Millbrook Road over Little Antietam Creek

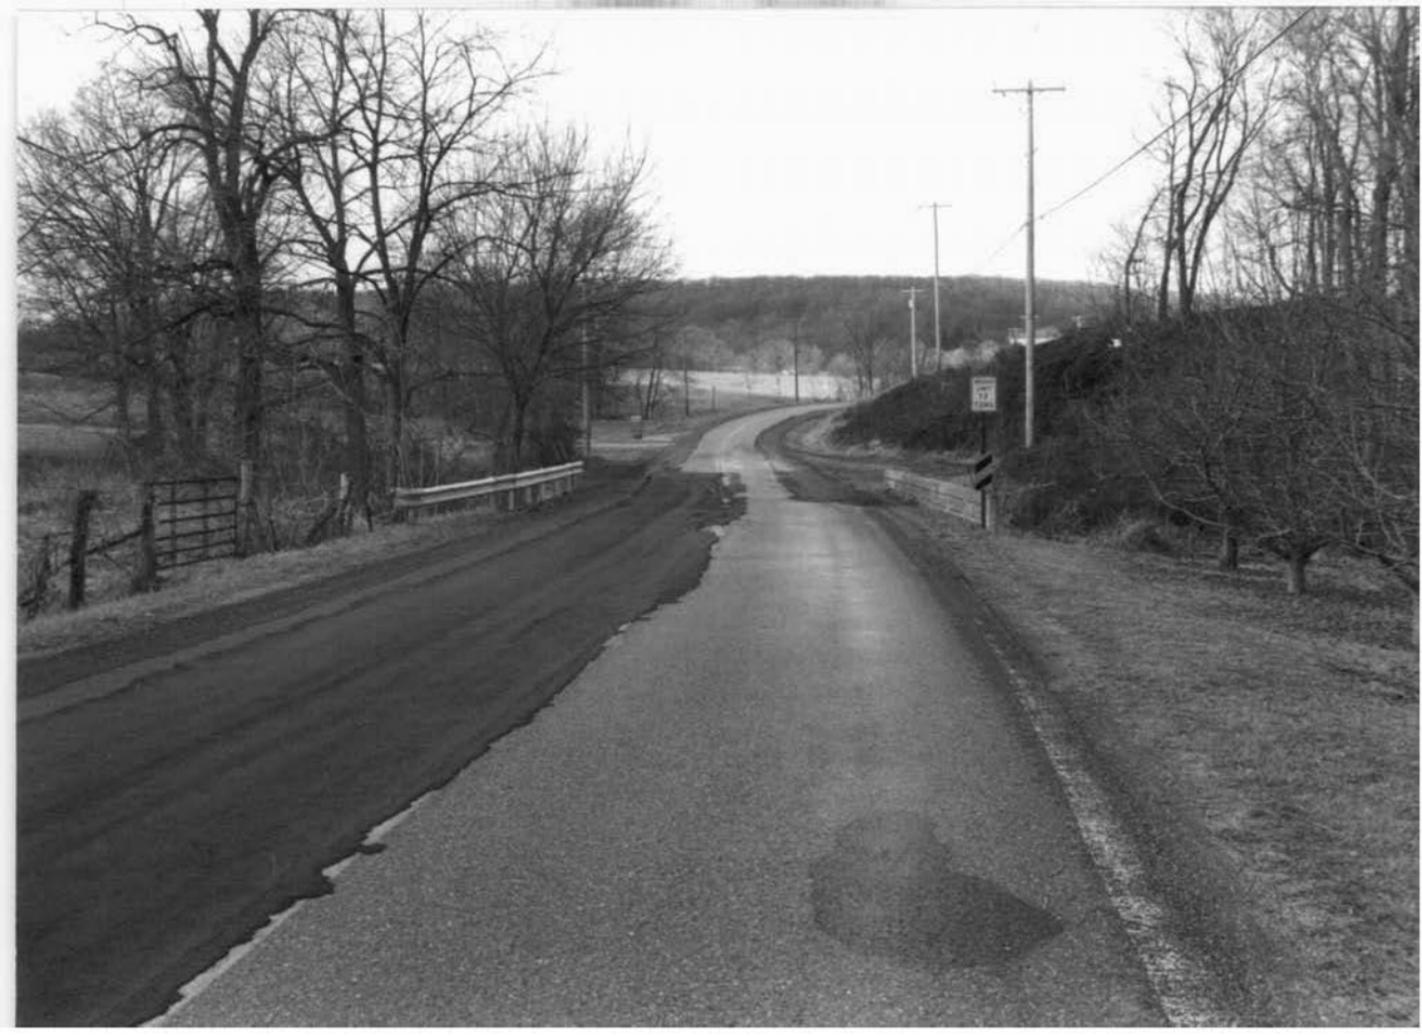
1 OF 4

SOUTHWEST APPROACH

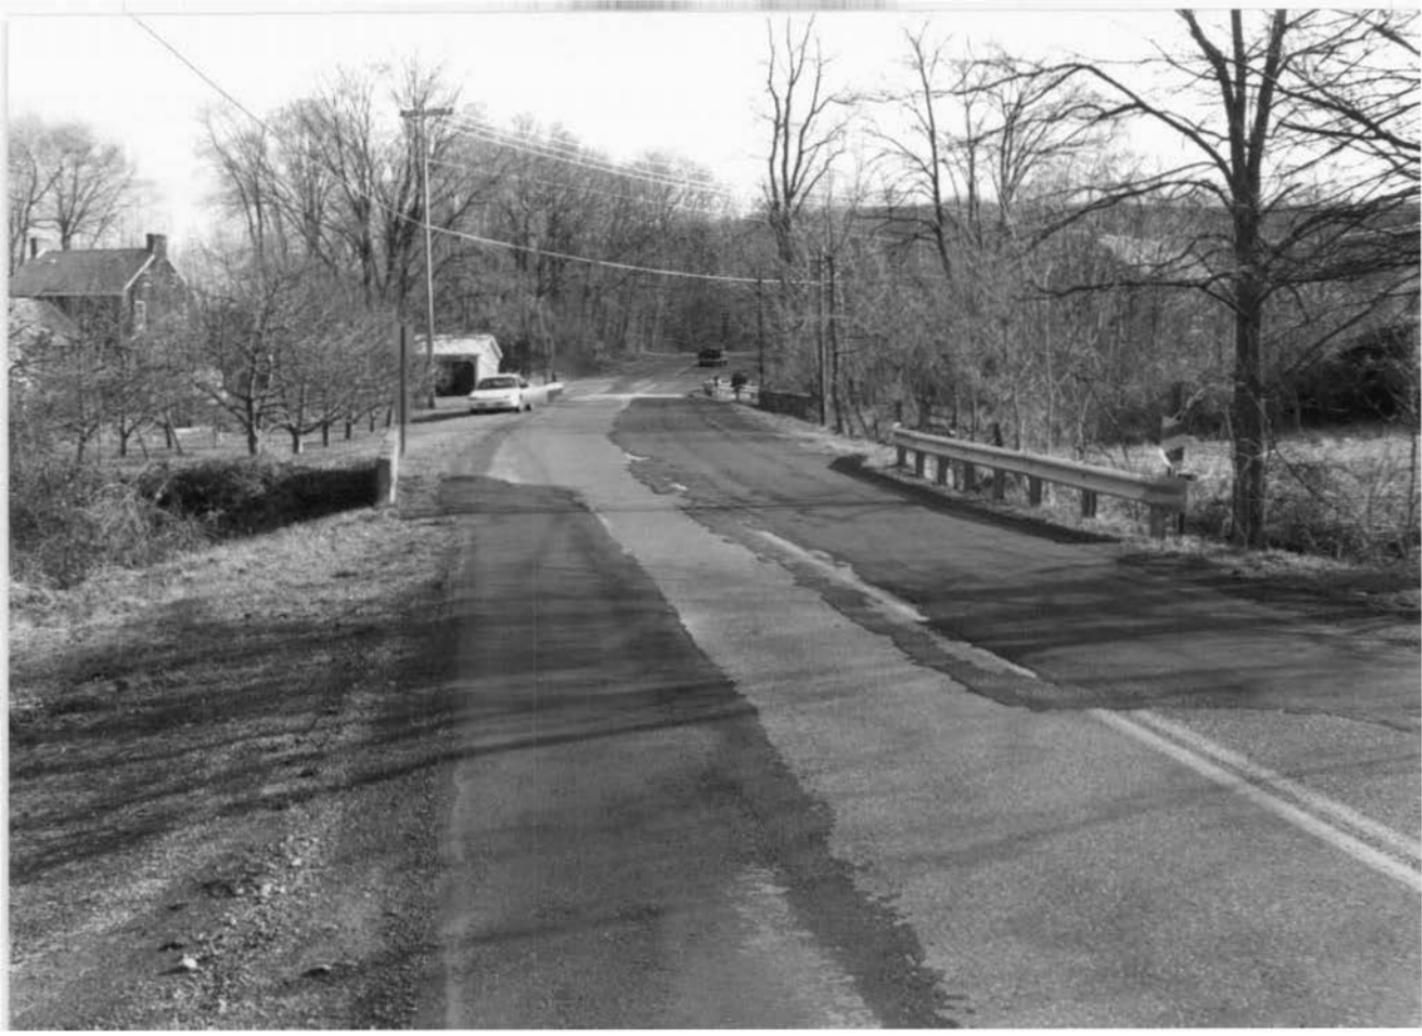
2 OF 4

NORTHEAST APPROACH

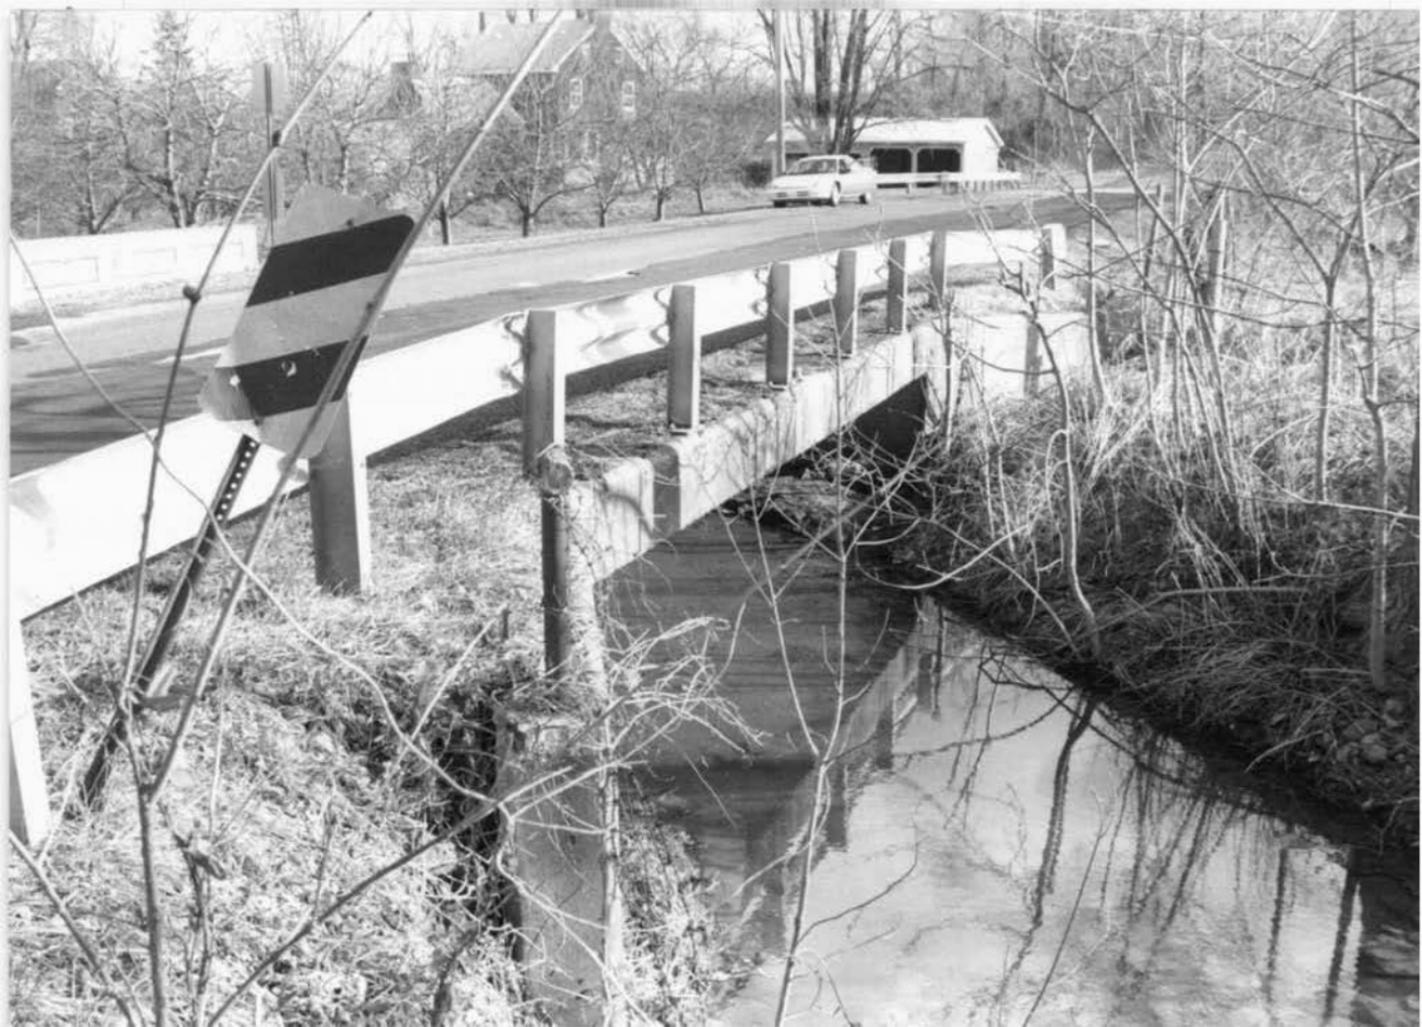
3 OF 4

The northwest side of the bridge is a concrete slab. The slab is approximately 28 feet long and 1 foot thick. The slab has a guardrail and post railing system. The 2-foot 6-inch posts are mounted to the deck of the slab with a steel plate. The slab has concrete wingwalls that are approximately 4 feet 6 inches wide and 3 feet high. The slab, railing, and wingwalls are in good condition with no visible cracks or spalling.

NORTHWEST ELEVATION

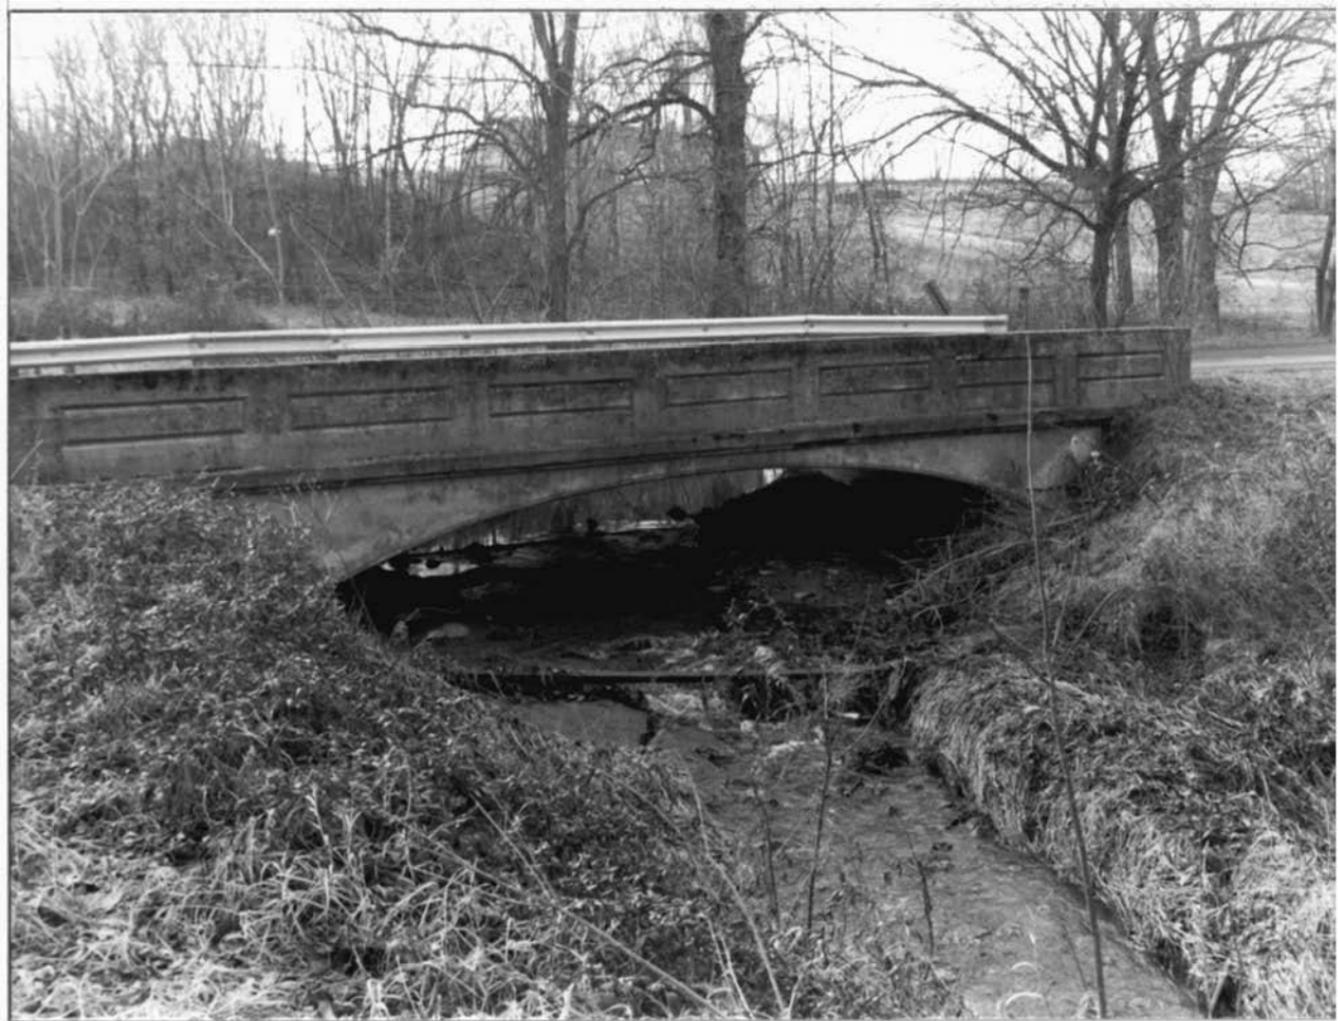
4 OF 4

Bridge W-5981 is a single span filled concrete arch and a concrete slab bridge. The southeastern side of the bridge is an arch. The length of the bridge is approximately 28 feet 4 inches with a clear span of approximately 27 feet 8 inches. There is a clear roadway width of 20 feet. The arch has a 4-foot rise from springline to the crown. The arch has a 1-inch incised molding along the intrados. The spandrel walls are approximately 4 feet high and 3 feet wide. The southeast side of the bridge has its original parapets. The parapet is approximately 28 feet in length. The parapet is a single solid panel with seven incised panels. Each incised panel measures 3 feet by 1 foot with a foot separating each panel. There is an exterior ledge separating the parapet base from the top of the arch. The ledge is 28 feet long, 5 inches high and 4 inches wide. The parapet is in fair condition with minor spalling and cracks. The spandrel walls and the arch ring have minor to moderate spalling and light efflorescence. No large cracks or holes are visible. According to a 1995 inspection report, the bridge is in fair condition with a sufficiency rating of 48.2.

SOUTHEAST ELEVATION
