Rocky Fountain Farm

WA-V-065

## MARYLAND HISTORICAL TRUST WORKSHEET

NOMINATION FORM  
for the  
NATIONAL REGISTER OF HISTORIC PLACES, NATIONAL PARKS SERVICE

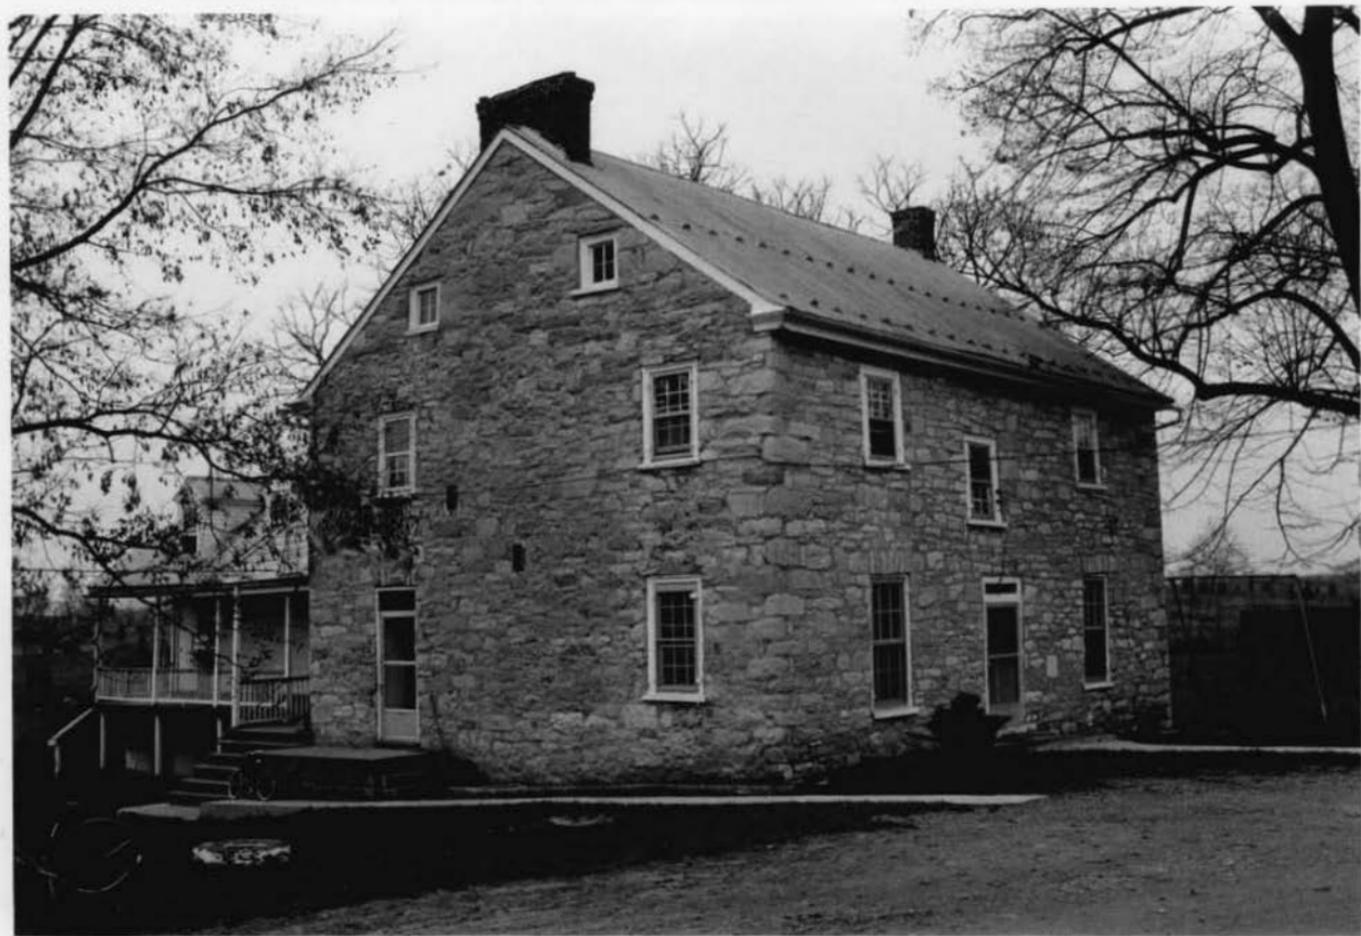
Dwelling #1 N.E.

The structure is a two story, three bay stone dwelling with a four bay, one and a half story addition extending to the south from a point just east of the west end of the main section, giving the overall structure a "T" shape. Along the east elevation of the addition is a deep porch included under the main roof span. Although the principal entrance is in the north elevation, it is readily apparent that the main section of the house originally faced south.

The walls are constructed of roughly coursed local fieldstone. Flat arches of stone are present over most first story windows of the main section. The east elevation of the addition has been sheathed with rough cast or stucco. A major portion of the original front elevation of the main section is concealed by the addition. It would appear, however, that openings there are spaced evenly. First story windows retain what appear to be original frames and possibly original sashes have nine over six lights held within wide wooden frames joined with pegs and displaying quarter round trim. Upper story windows have similar wide frames with six over six pane sashes. Replaced frames in the main section and those employed in the addition are quite narrow. Openings in the addition are topped with broad wooden lintels. On the east slope of the roof of the addition are three gable roofed dormers, each with a six over six light window.

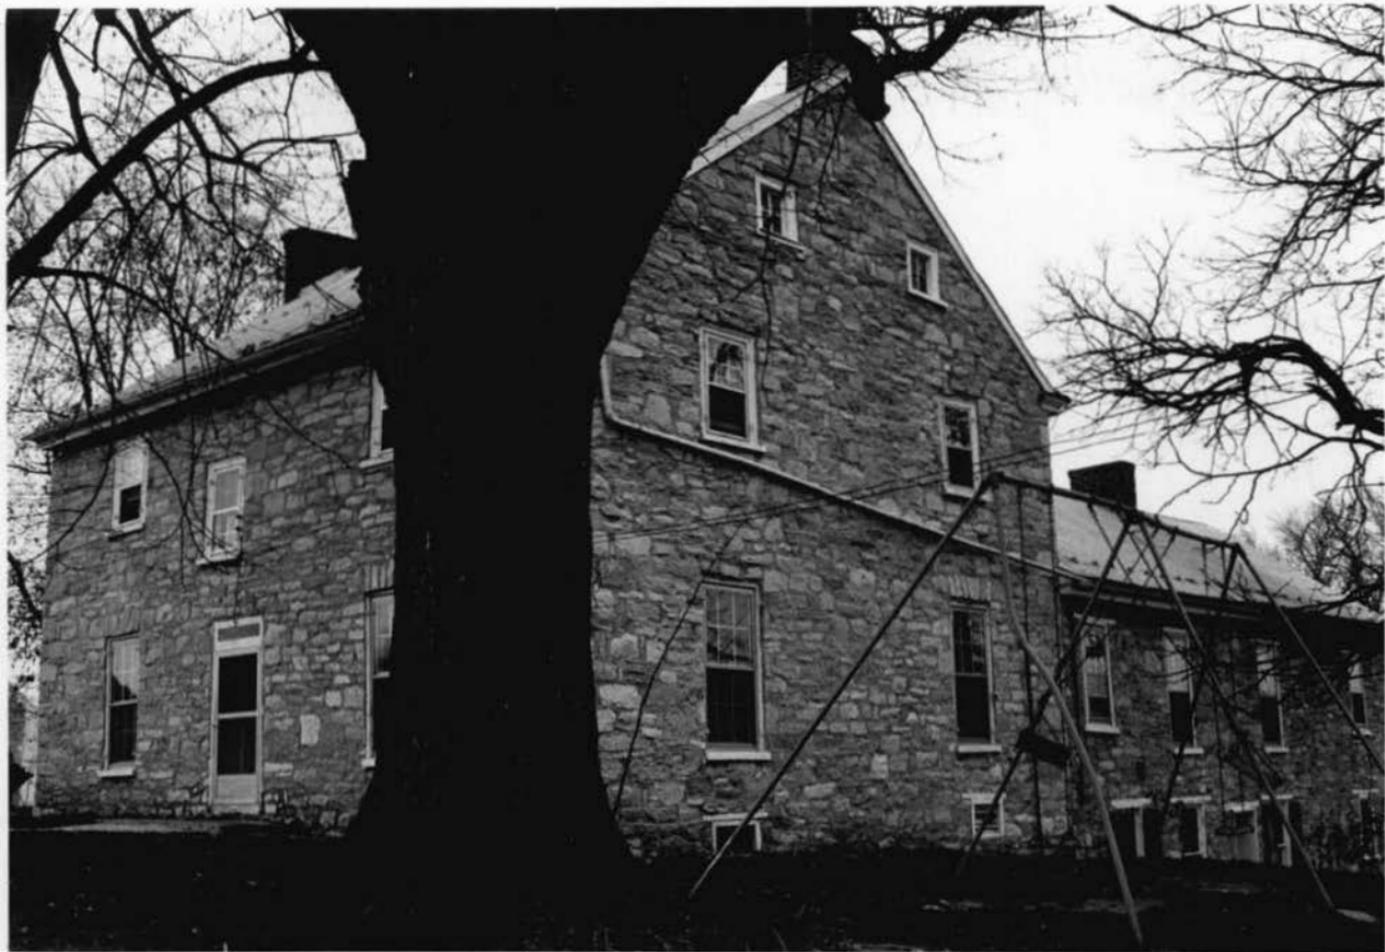
N.W. Dwelling #1

The present principal entrance is located in the center bay of the north elevation. The entranceway is treated simply with a narrow transom over the door. There is no decorative stone or woodwork associated with this opening. Another entrance is located in the east gable end of the main section. What appears originally to have been the main entrance in the south elevation is partially concealed by the addition. Other entrances are located at the ground and main floor levels of the addition.

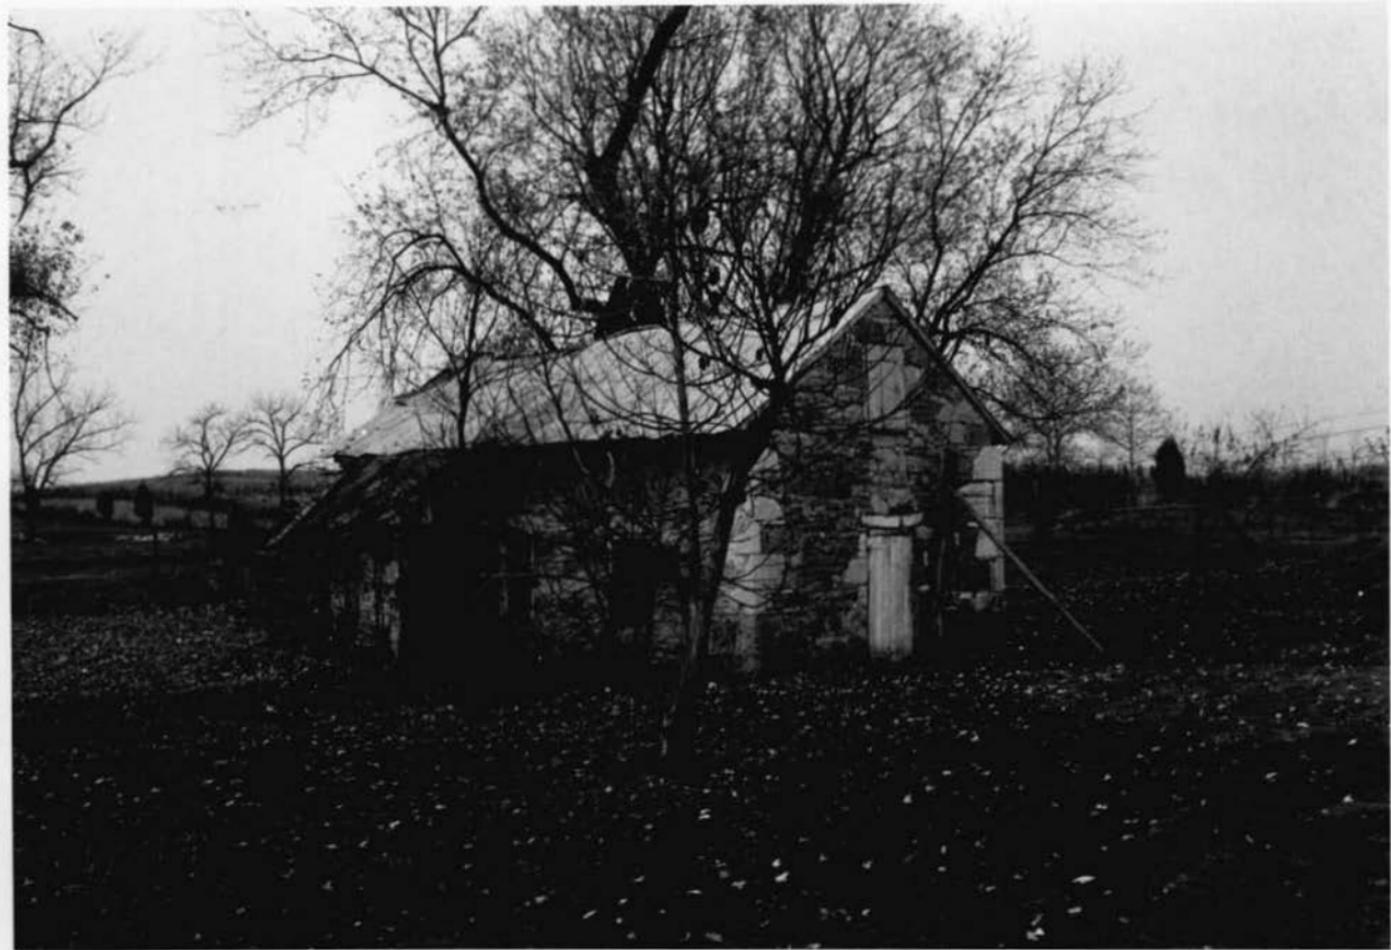
Spring house N.E.

The spring house and barn are also important as examples of such structures. Many early houses in Washington County are built directly over or near springs. This spring house with its finished interior may have been used as a dwelling. According to tradition, it was used to house slaves. The spring house does not appear to predate the original section of the main dwelling.

Just south of the stone dwelling is a three bay, one and a half story spring house, also constructed of roughly coursed stone. With an out-shot entrance on its east wall, the structure has a finished interior with a fireplace. Its windows display narrow framing with six over six pane double hung sashes. A rather large spring emerges from the east wall of the structure.
