Survey No. WI-135

MARYLAND COMPREHENSIVE HISTORIC PRESERVATION PLAN DATA - HISTORIC CONTEXT

INVENTORY FORM FOR STATE HISTORIC SITES SURVEY

HISTORIC HOLLOWAY HALL

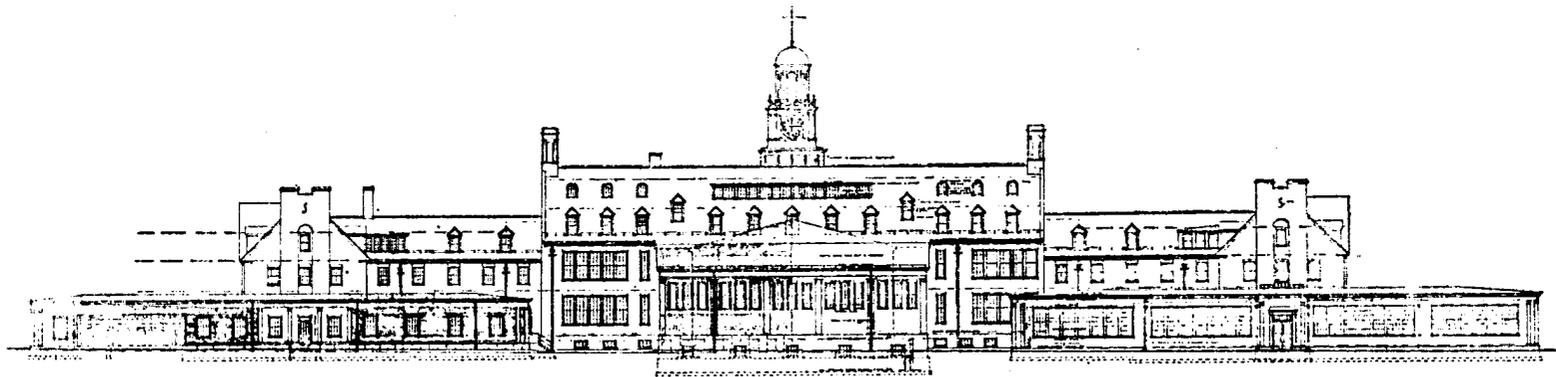
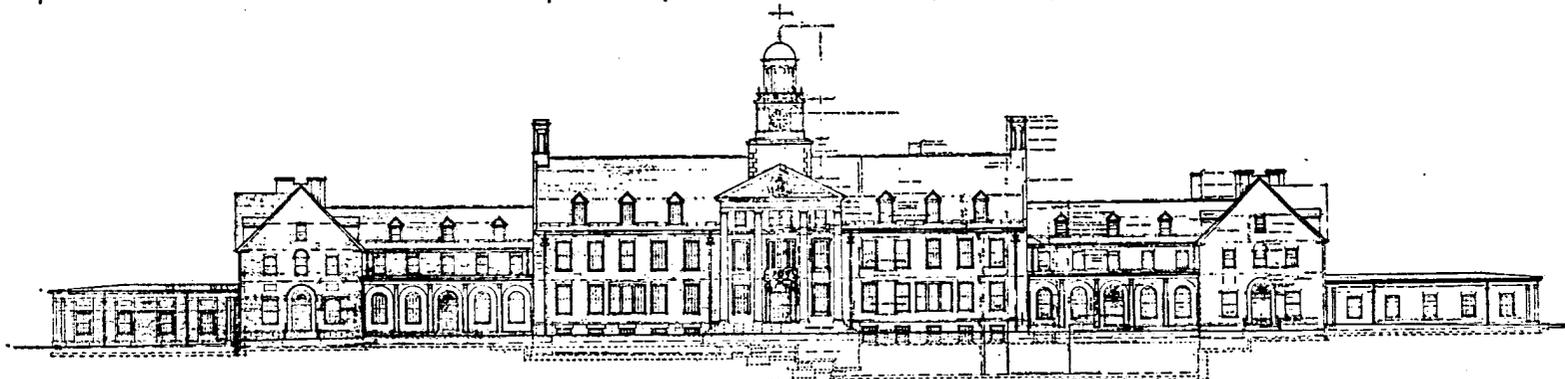
PLATE I.

REAR ELEVATION, FACING RAILROAD

FRONT ELEVATION, FACING STATE ROAD

Administration Building: Ten Classrooms, Administrative Offices, Auditorium, Gymnasium, 46 Beds on Third Floor, 18 Beds on Fourth Floor.  
North Wing: Library, One Classroom, 70 Beds.  
North Connecting Link: Eight Faculty Offices, 18 Beds.  
In Rear: Elementary School.

South Wing: Dining Room, Kitchen, Store Rooms, 54 Beds, Infirmary.  
South Connecting Link: Commons Room, 18 Beds.  
In Rear: Laundry, Bakery, Garage, Tool House, Stable, Store Rooms.

Smith & May, Architects, drawings of front  
and rear elevations  
Reproduced from the Report of the Commission  
to Study the Need for A Normal School on the  
Eastern Shore to the General Assembly, 1924

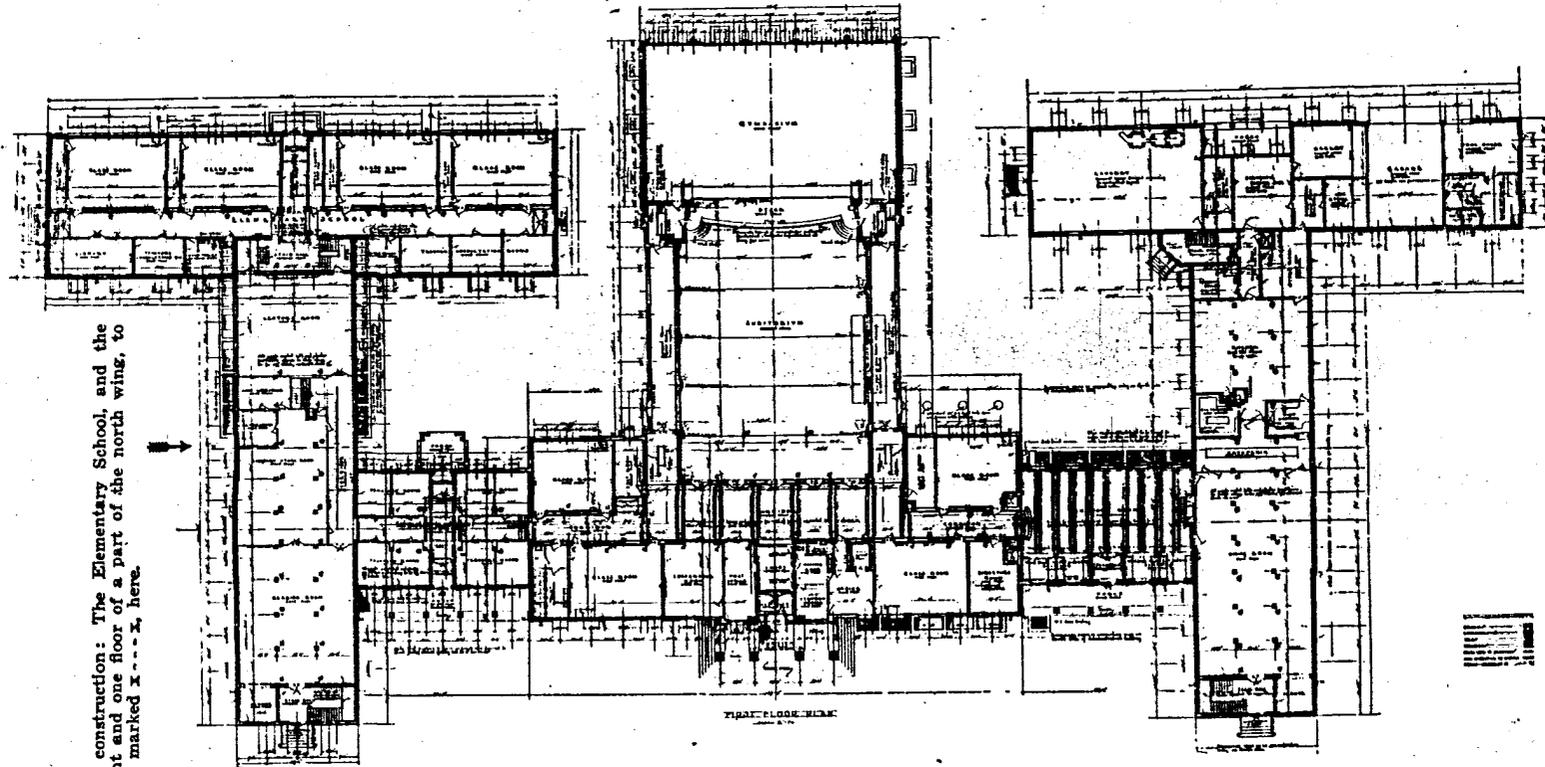
PLATE II,

Now under construction: The Elementary School, and the basement and one floor of a part of the north wing, to the line marked X---X, here.

FIRST FLOOR PLAN

North Wing and Connecting Link.		Administration Building	South Wing and Connecting Link.	
Library, Music and Lectura Room.	Teachers' Offices.	Principal's Office, Postoffice, Office of Dormitory Director, Four Classrooms, Conference Room, Auditorium, Gymnasium.	Commons Room.	Dining Hall, Kitchen, Store Rooms.
In Rear: Elementary School.			In Rear: Laundry, Bakery, Garage, Tool House, Stable, Store Rooms.

Holloway Hall  
 Salisbury State College  
 Wicomico County  
 Smith & May Architects, first floor plan  
 Reproduced from the Report of the Commission  
 to Study the Need for a Normal School on the  
 Eastern Shore to the General Assembly, 1924

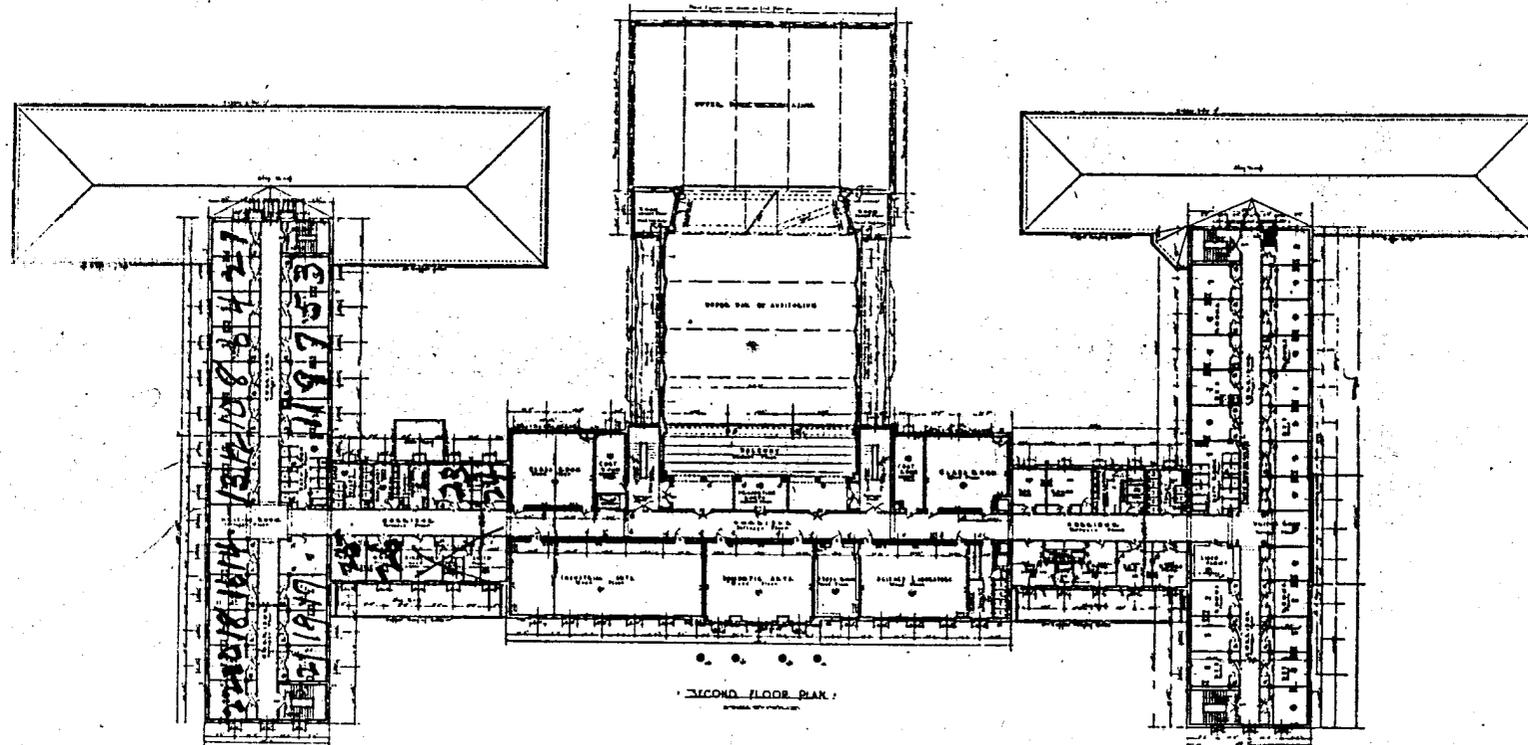
PLATE III.

Administration Building: Six Classrooms and Balcony of Auditorium.  
 North Wing: Forty-four Beds.  
 North Connecting Link: Eight Beds.  
 South Wing: Forty-four Beds.  
 South Connecting Link: Eight Beds.

Holloway Hall  
 Salisbury State College  
 Wicomico County  
 Smith & May Architects, second floor plan  
 Reproduced from the Report of the Commission  
 to Study the Need for a Normal School on  
 the Eastern Shore to the Gen Assembly, 1924

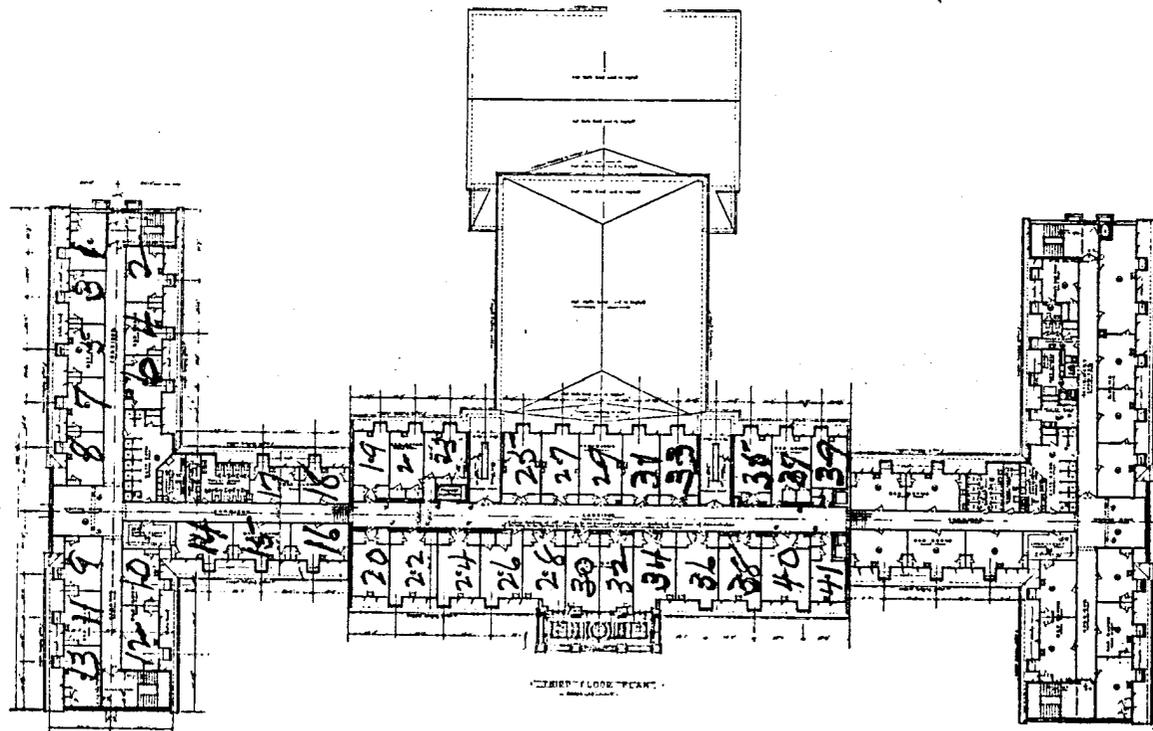
PLATE IV.

THIRD FLOOR PLAN

Administration Building: Forty-six Beds on Third Floor; Eighteen Beds can be provided on Fourth Floor.  
 North Wing: Twenty-six Beds.  
 North Connecting Link: Ten Beds.  
 South Wing: Ten Beds; also Infirmary with Ten Beds and Nurse's Quarters.  
 South Connecting Link: Ten Beds.

Holloway Hall  
 Salisbury State College  
 Wicomico County  
 Smith & May, Architects, third floor plan  
 Reproduced from the Report of the Commission  
 to study the need for a Normal School on  
 the Eastern Shore to the General Assembly,  
 1924

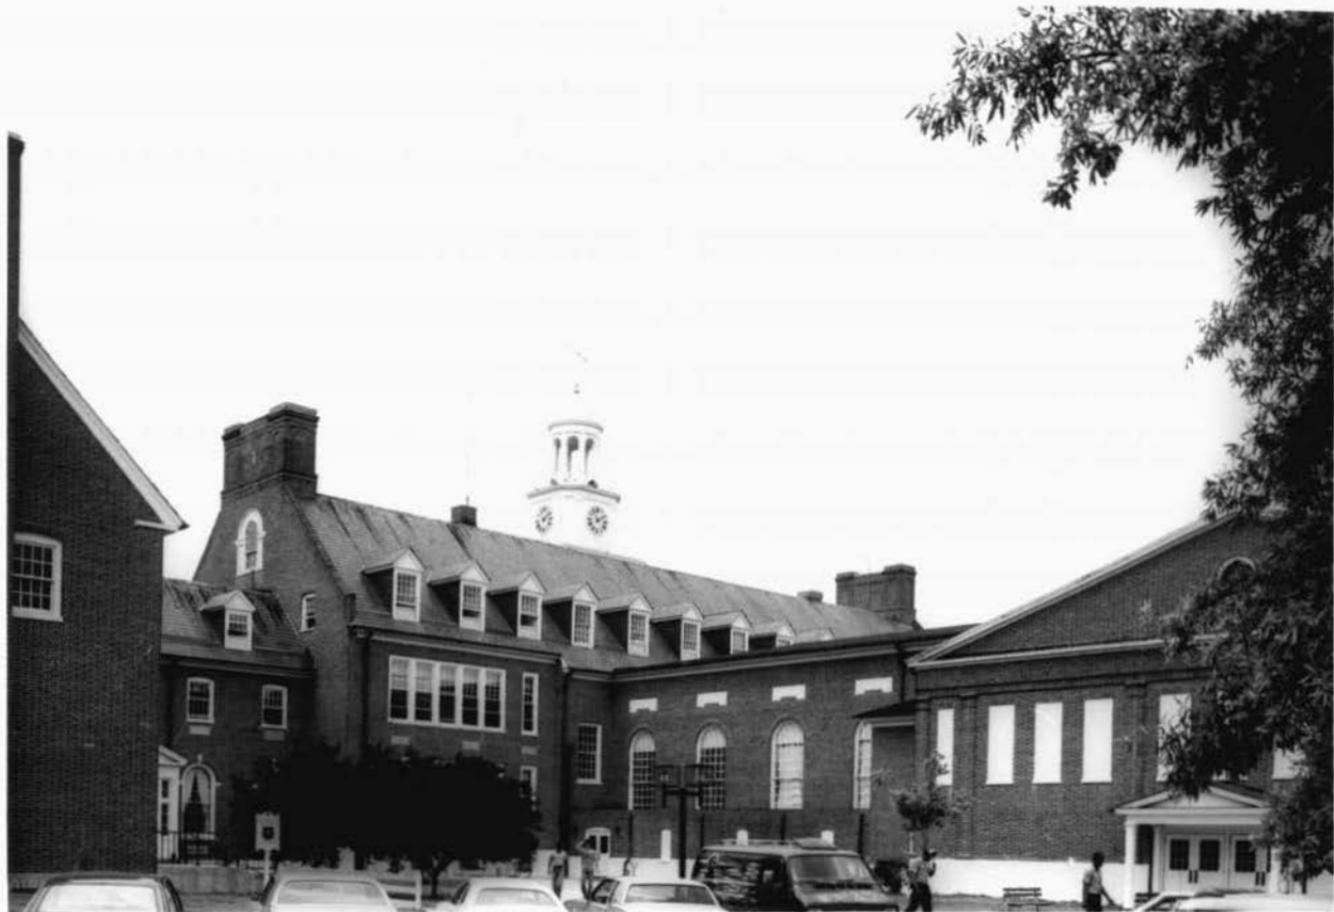
1/7

Md Historical Trust, Annapolis, Md  
East (rear) elevation

The rear (east) side of Holloway Hall is best viewed from a southeast vantage point into a three-sided courtyard formed by the easternmost (rear) end of the south wing, the rear facade of the main structure, and the south facade of the auditorium. The southernmost component of this visually complex view is the east facade of the south wing. This facade is dominated by a double chimney wall rising from basement to roof. In the center of

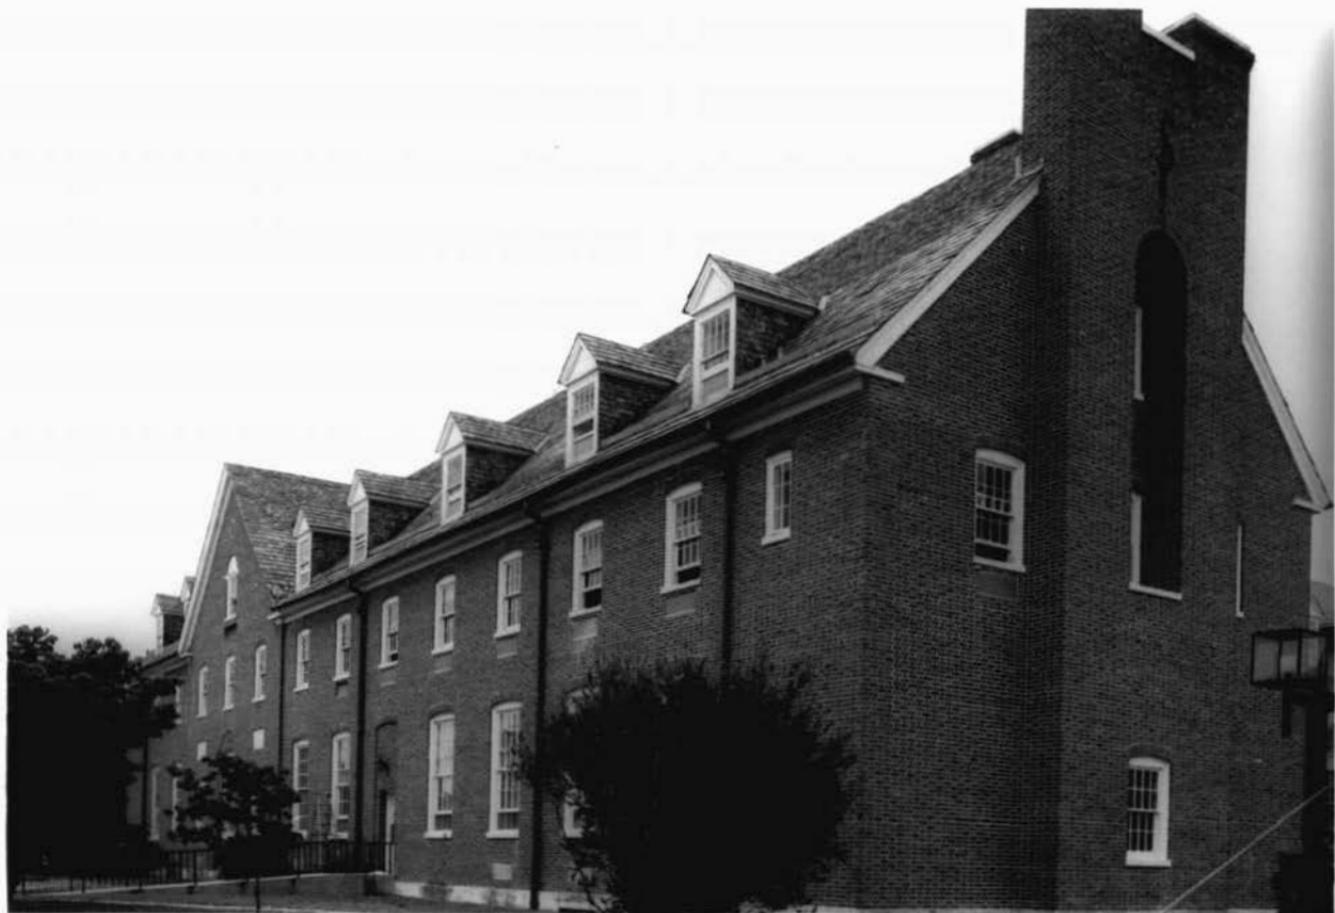
3 June 1981  
Md Historical Trust, Annapolis, Md  
Southeast corner, south wing  
2/7

The south facade of the south wing of Holloway Hall is composed of a central three bay section, flanked on the westernmost end by a second three bay section and an 8-bay section on the easternmost end. The entire facade rests on a marble trimmed basement wall. At first floor in the westernmost section are two 12/12 sash windows, at second floor a single casement window in the westernmost bay, and moving eastward, two 8/8 sash windows. At third floor are two dormer windows, 8/8 sash. All windows and dormers are trimmed in the same fashion as those corresponding on the front facade.

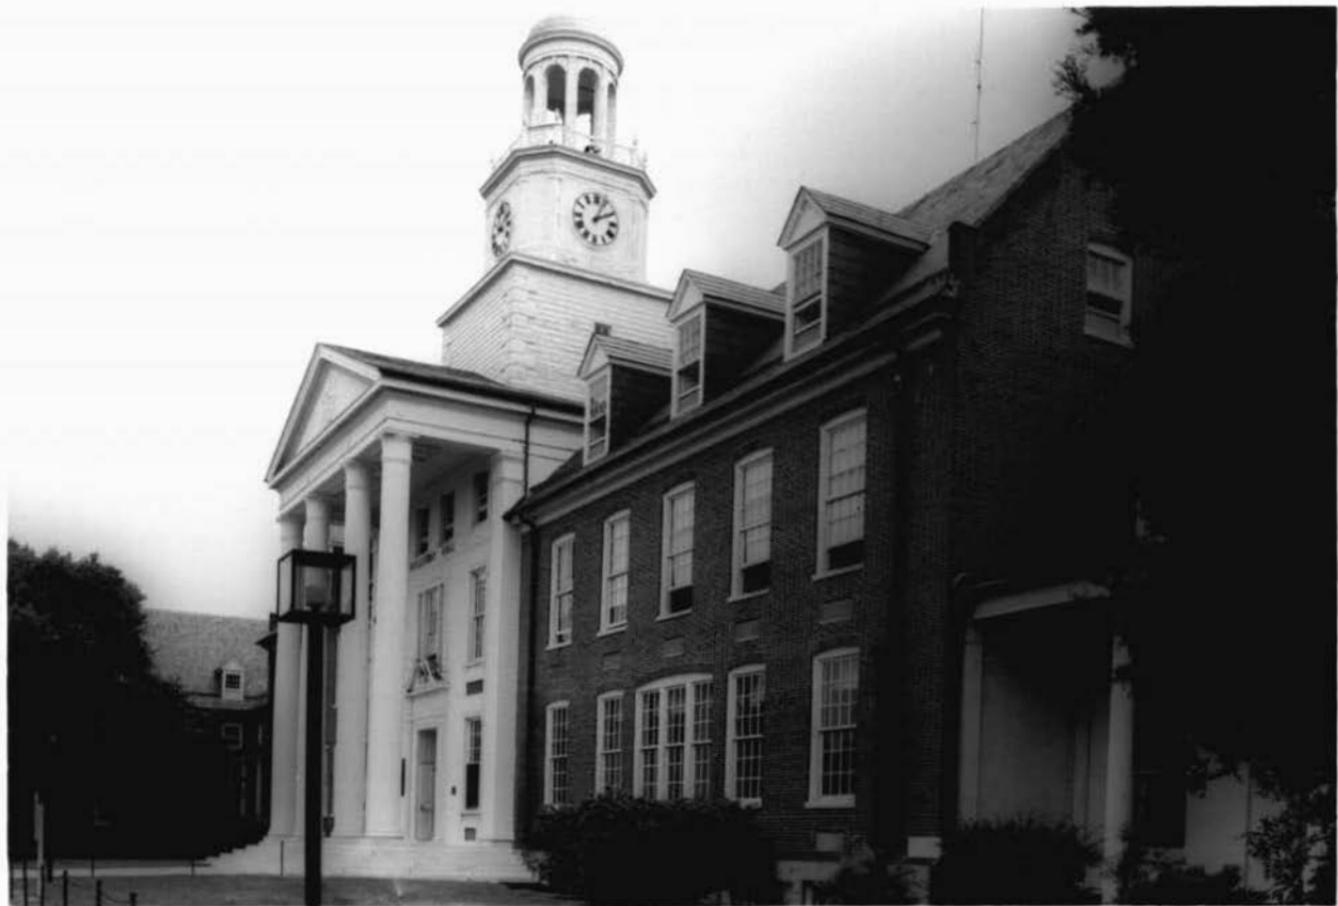
3/7

3 June 1981  
Md Historical Trust, Annapolis, Md  
Front (west) facade, camera facing  
northeast

The front (west) facade of Holloway Hall is symmetrical, and was constructed to replicate, albeit at a much larger scale, typical "Maryland Colonial" design of the 18th century. To this end, the main building stretches 13 bays in length, and is punctuated by a three bay wide central block with pedimented porch and clock tower. Appended to the gable ends of this structure are slightly recessed 5 bay long sections, which replicate "hyphens", and connect the main structure with north and south wings, which are placed perpendicular to the main building.

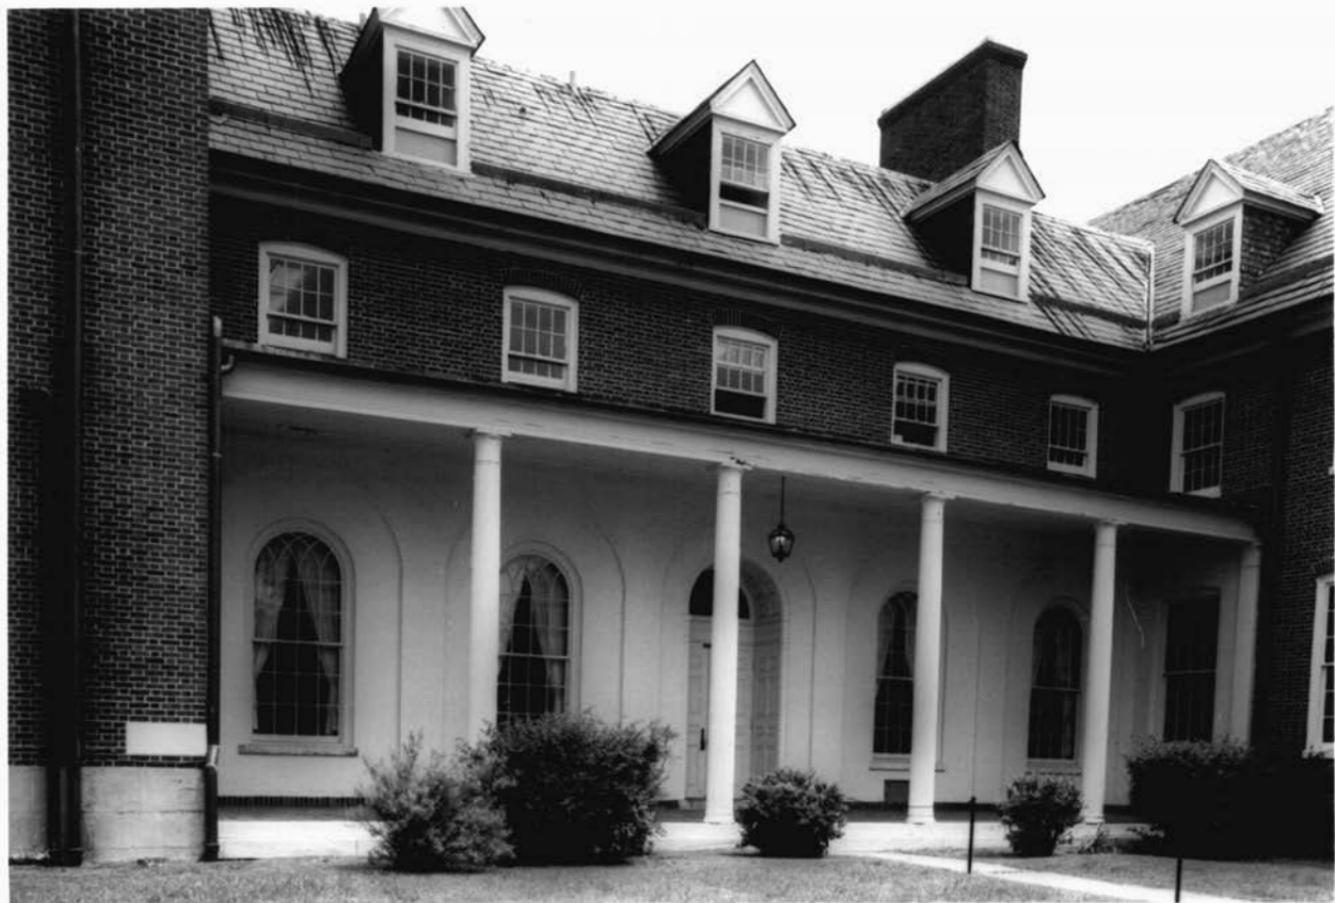
3 June 1981  
Front (west) facade, section connecting  
south wing to main structure  
4/7

Flanking the main section of the building are identical 3-story brick sections which connect north and south wings to the main structure. These sections are shorter than the central block of the building, and are recessed about 6 feet from the front wall plane. At first floor level, one story flat roofed porches rest on six wooden columns. Here, the end columns are engaged to the side walls of north and south wings. The columns

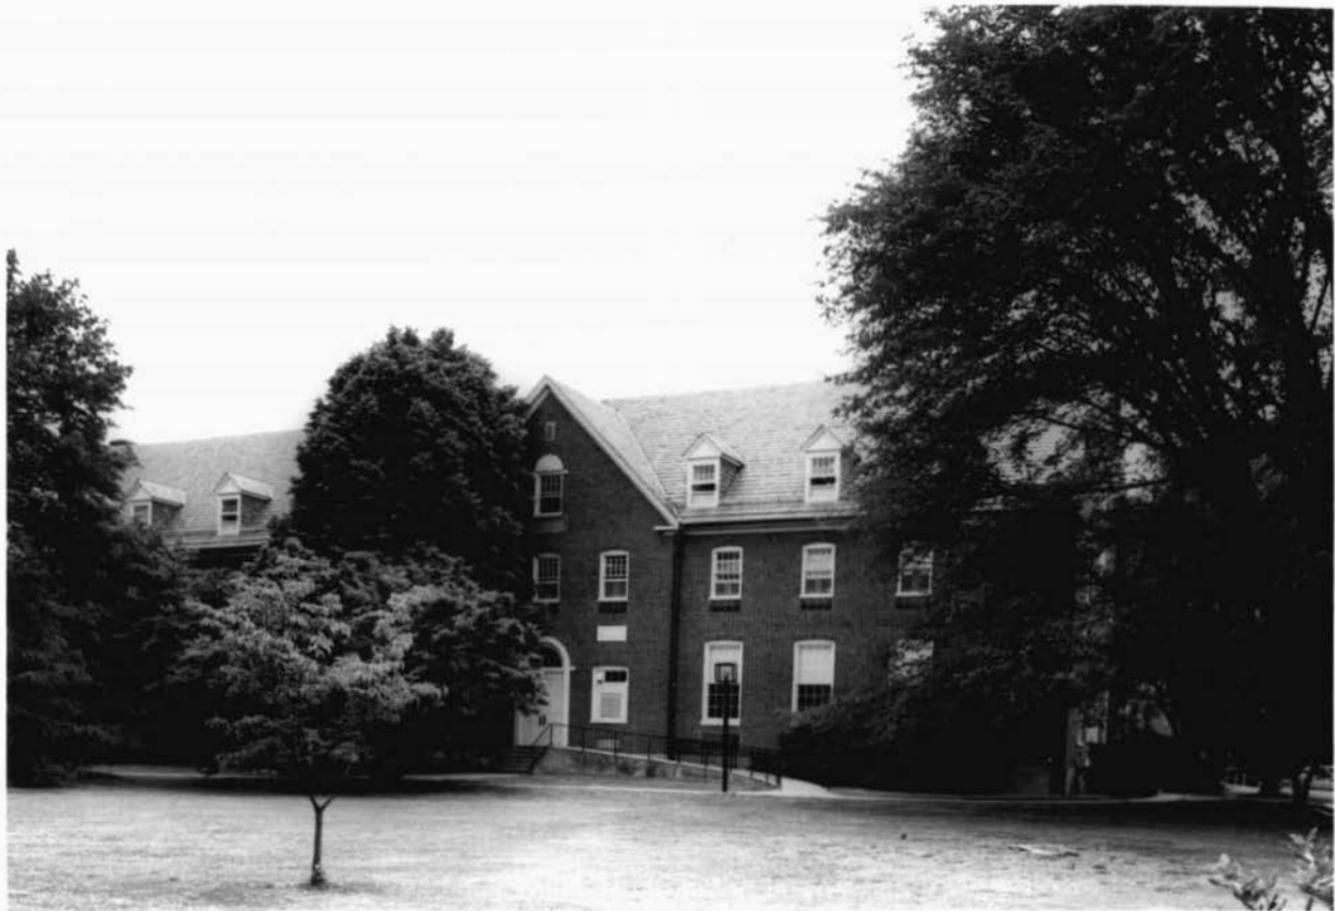
3 June 1981  
Northeast corner, north facade north  
wing  
5/7

Adjoining perpendicularly to the elementary school is the north facade of the north wing. The facade consists of a central three-bay section, flanked by a six-bay section on the easternmost end and a three-bay section on the westernmost end. The three-story central section contains a center double doorway at first floor, elevated from the ground by a flight of eight concrete steps with iron railings. The doorway is surmounted by a leaded glass fanlight which is topped by a rounded brick arch. Windows flank either side of the doorway, 8/8 sash, and stone tablets have been set into the wall above the windows. At second floor are three 8/8 sash windows, trimmed as those on the first floor. At third floor under the gable end of the roof is one 8/8 sash rounded arch window. The flanking side sections are

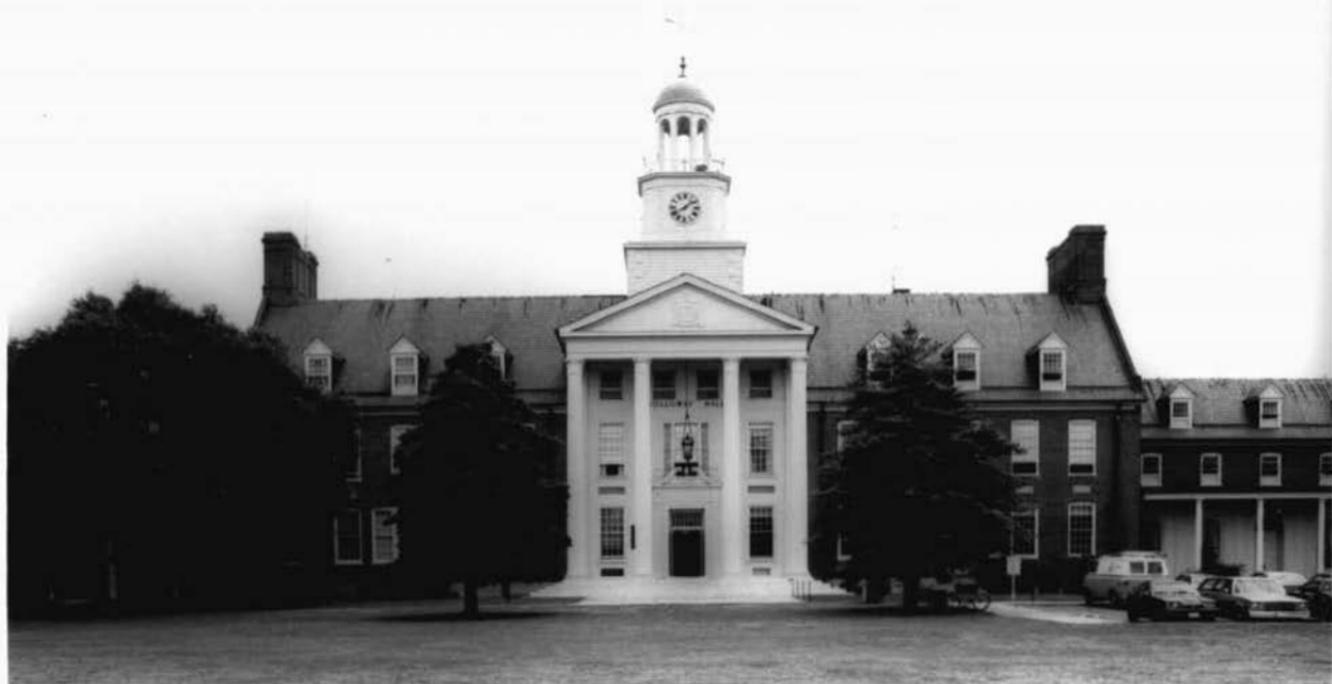
6/7

Front (west) facade, main entrance

At first floor center are double doors with an elaborate Federal style door surround featuring engaged fluted wooden columns on either side of the doors and milled scrollwork surmounting an overlight of two rows of 7 small panes each. The doorway rests on a single marble step, and is flanked by a pair of 12/12 sash windows with simple wooden trim and marble sills.

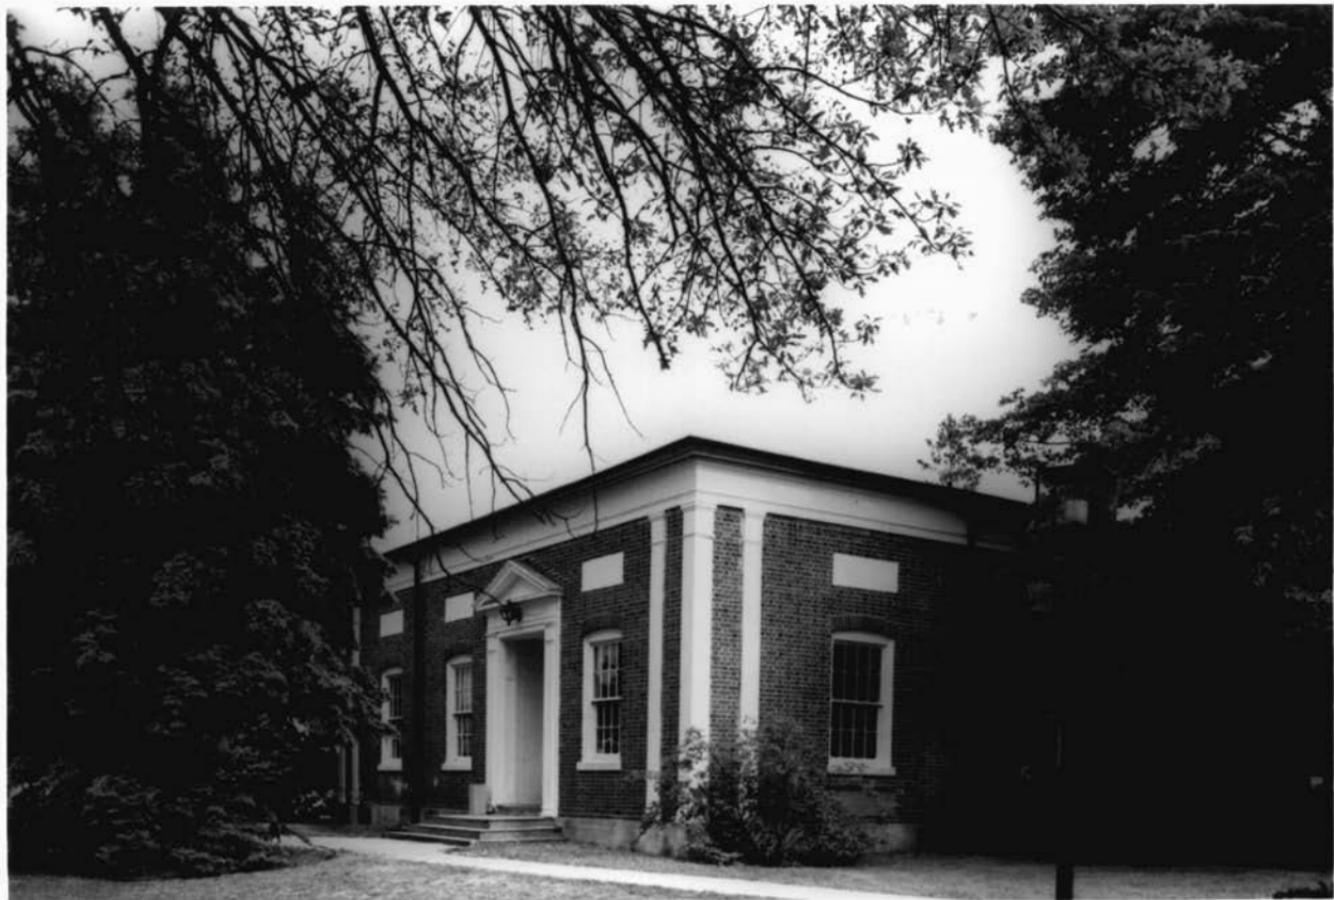
777

3 June 1981  
Former elementary school, projecting  
perpendiculary from NE corner of  
north wing

This view of Holloway Hall is dominated at the ground floor level by the one-story elementary school, an original component of the structure erected in 1924. The school originally contained four classrooms, library, offices, and conference rooms. The interior has now been altered to house administrative offices. The center of the east facade of the school has a double doorway with wooden door surround, now permanently sealed to accommodate interior room arrangements. Historic photographs (c. 1930) reveal this facade originally contained four groups of 7 windows each, all 12/12 sash. Window openings have been randomly filled with cement or replaced with modern sash windows to accommodate interior uses with no regard to exterior appearance.
