STATE Maryland
COUNTY Wicomico
TOWN Salisbury VICINITY
STREET NO. north of Salisbury Mall

HISTORIC AMERICAN BUILDINGS SURVEY
INVENTORY W1- 54

2. NAME Victorian Barn

DATE OR PERIOD c. 1860-80
STYLE
ARCHITECT
BUILDER

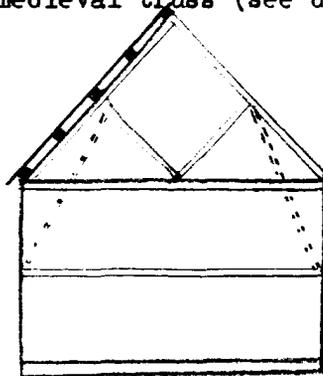
All interior structure was sawn by a radial saw; mortised and pegged. The roof was constructed in the manner of a medieval truss (see diagram).
