MARYLAND HISTORICAL TRUST
DETERMINATION OF ELIGIBILITY FORM

Property Name: Henry Merrill Farm Inventory Number: WO-563
Address: 1337 Cypress Road Historic district: ___ yes no
City: Pocomoke City Zip Code: 21851 County: Worcester
USGS Quadrangle(s): Pocomoke City
Property Owner: Maryland Stone, Incorporated Tax Account ID Number: 008943
Tax Map Parcel Number(s): 36 Tax Map Number: 91
Project: Proposed Mining Activities Pocomoke Sand and Gravel Pit Agency: United States Army Corps of Engineers
Agency Prepared By: A.D. Marble & Company
Preparer's Name: Emma Young Date Prepared: 5/23/2007

Henry Merrill Farm WO-563

1337 Cypress Road, Pocomoke City
Worcester County, Maryland

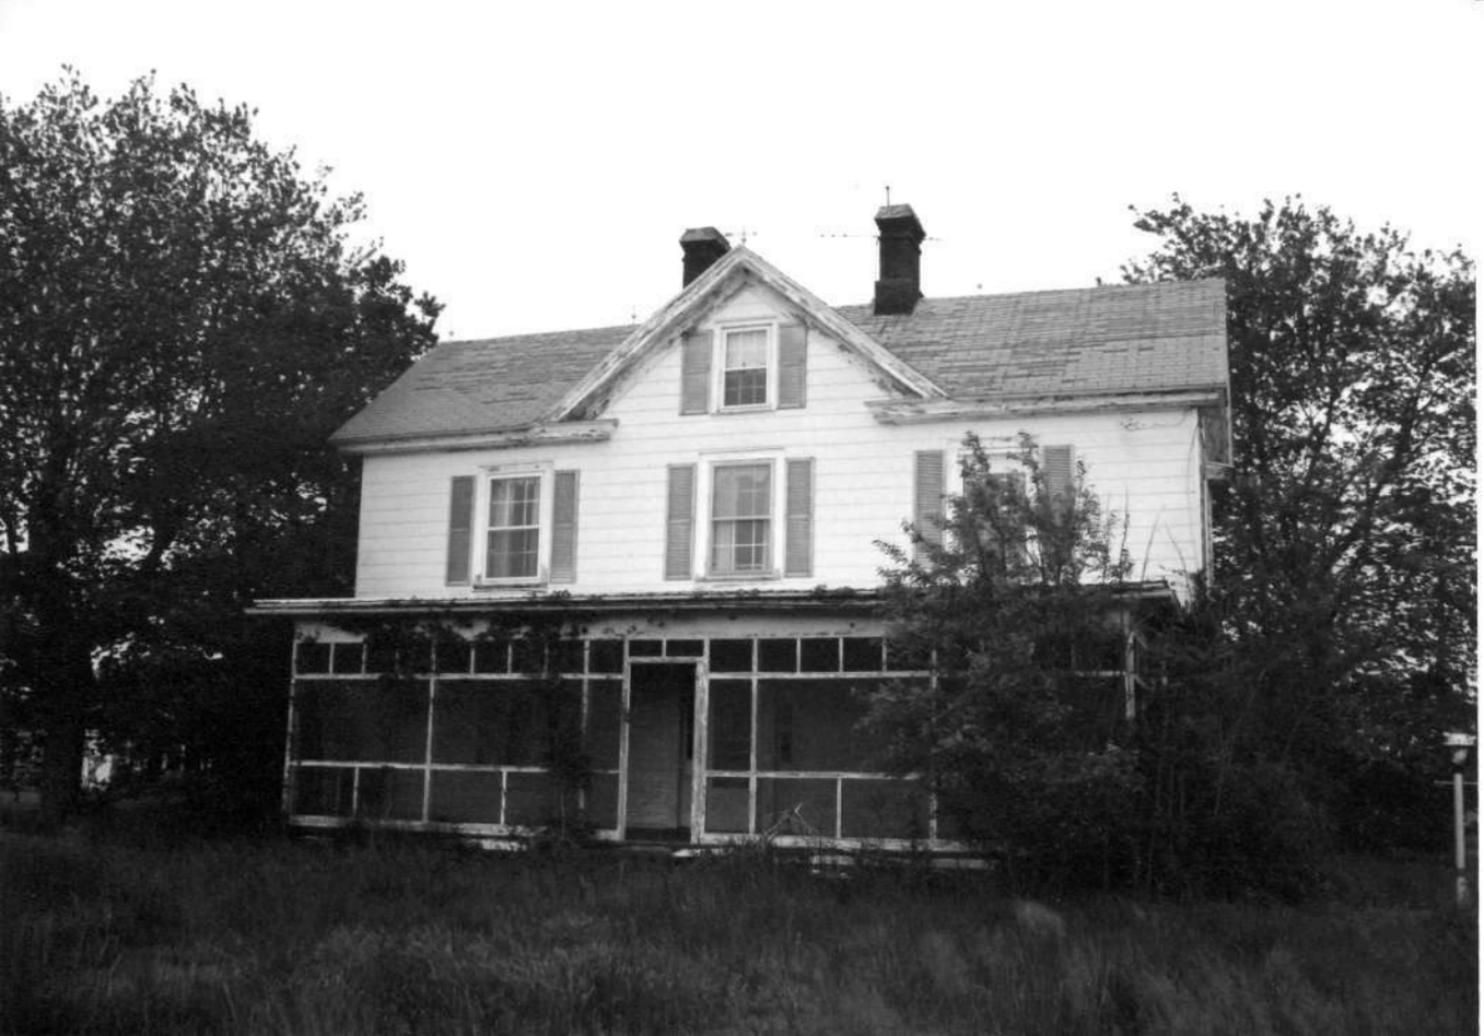
Photo # 3 of 21

The east (front) elevation measures three bays wide. A full-width, shed-roof, screened porch stretches across the first story of the elevation and shelters the main entry into the dwelling. The entry, situated in the center bay of the facade, consists of a single-leaf, wooden-paneled door capped by a four-light transom. The door is flanked by sidelight configurations that each contain two panes over a single panel. A two-light, aluminum storm door protects the entry. Single windows are located to the north and south of the entry. The second story contains three evenly spaced windows, and a single window is located in the cross gable. A set of inoperable, aluminum shutters flanks each window opening.

Dwelling, east elevation, view to southwest

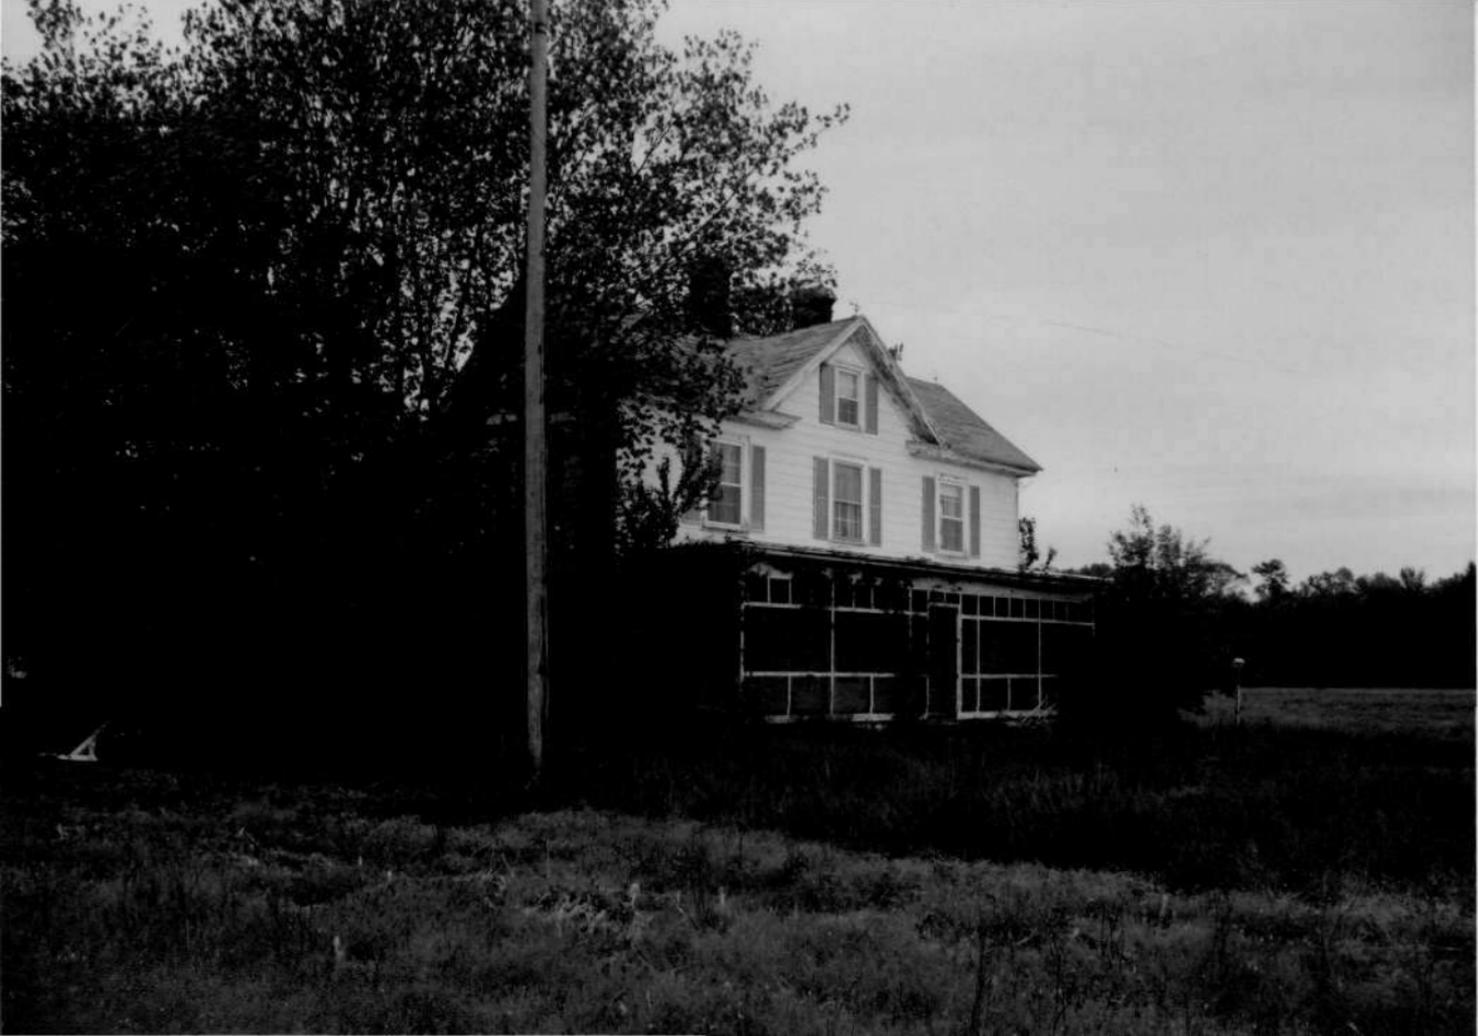
Photo # 4 of 21

Dense mature vegetation conceals the majority of details on the south elevation. The one-bay front block contains a single window on each story. Inoperable, aluminum shutters flank the windows on the front block. A one-story, shed-roof, screened porch extends the width of the first story of the rear ell. Dense overgrown vegetation obscures any additional details of the rear ell.

Dwelling, east & south elevations, view to northwest

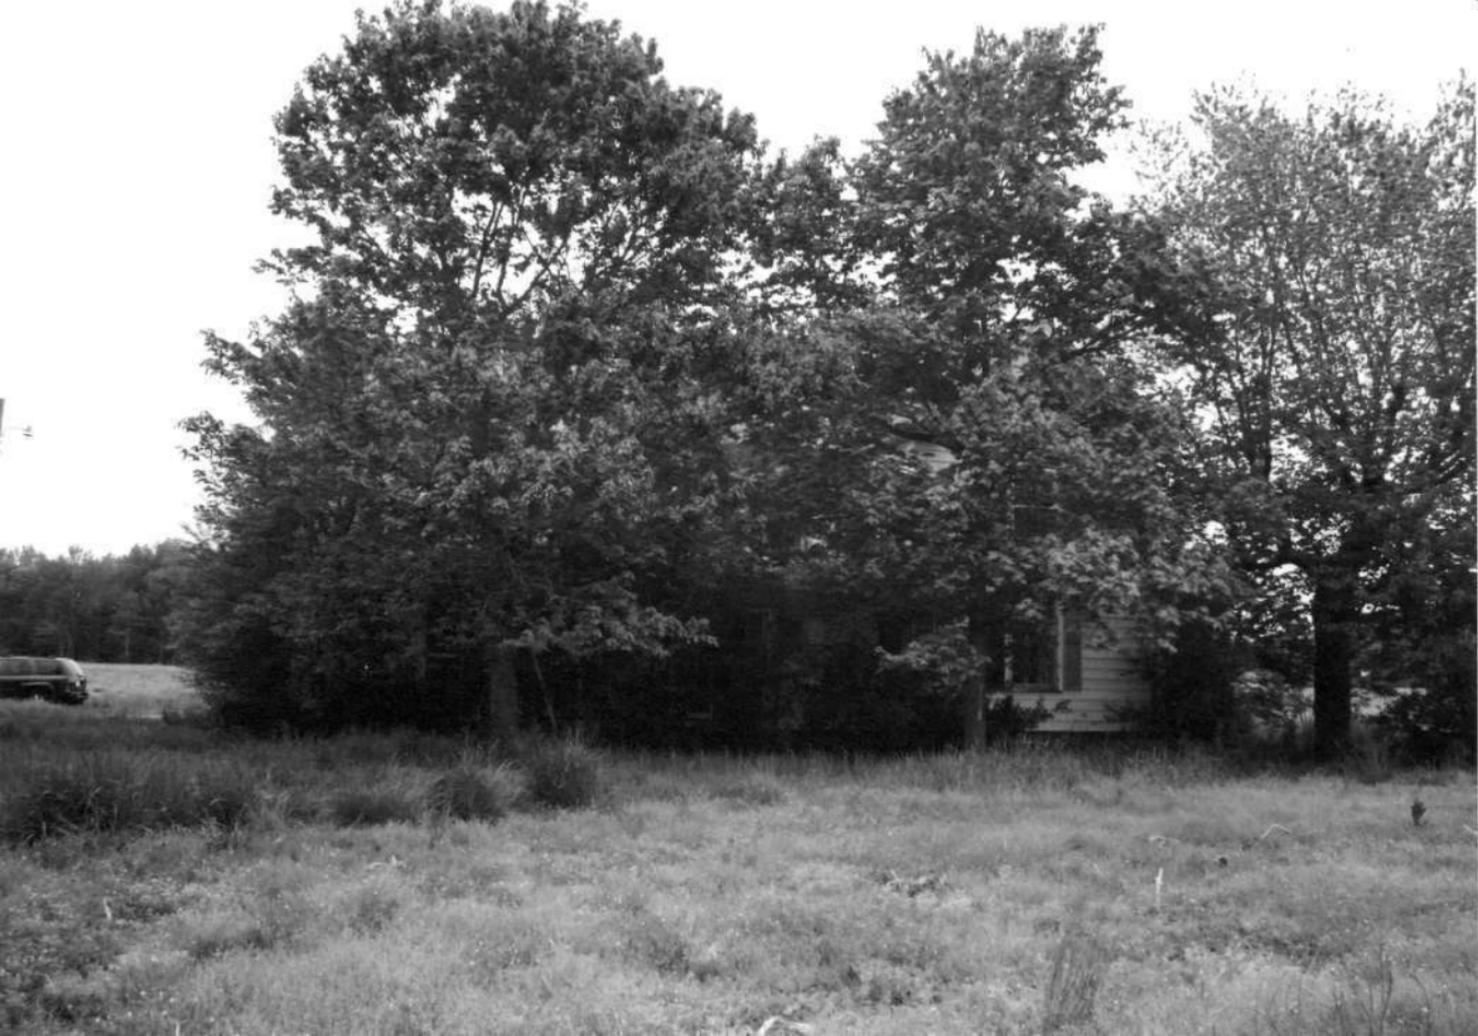
Photo # 5 of 21

Dwelling, south elevation; view to north east

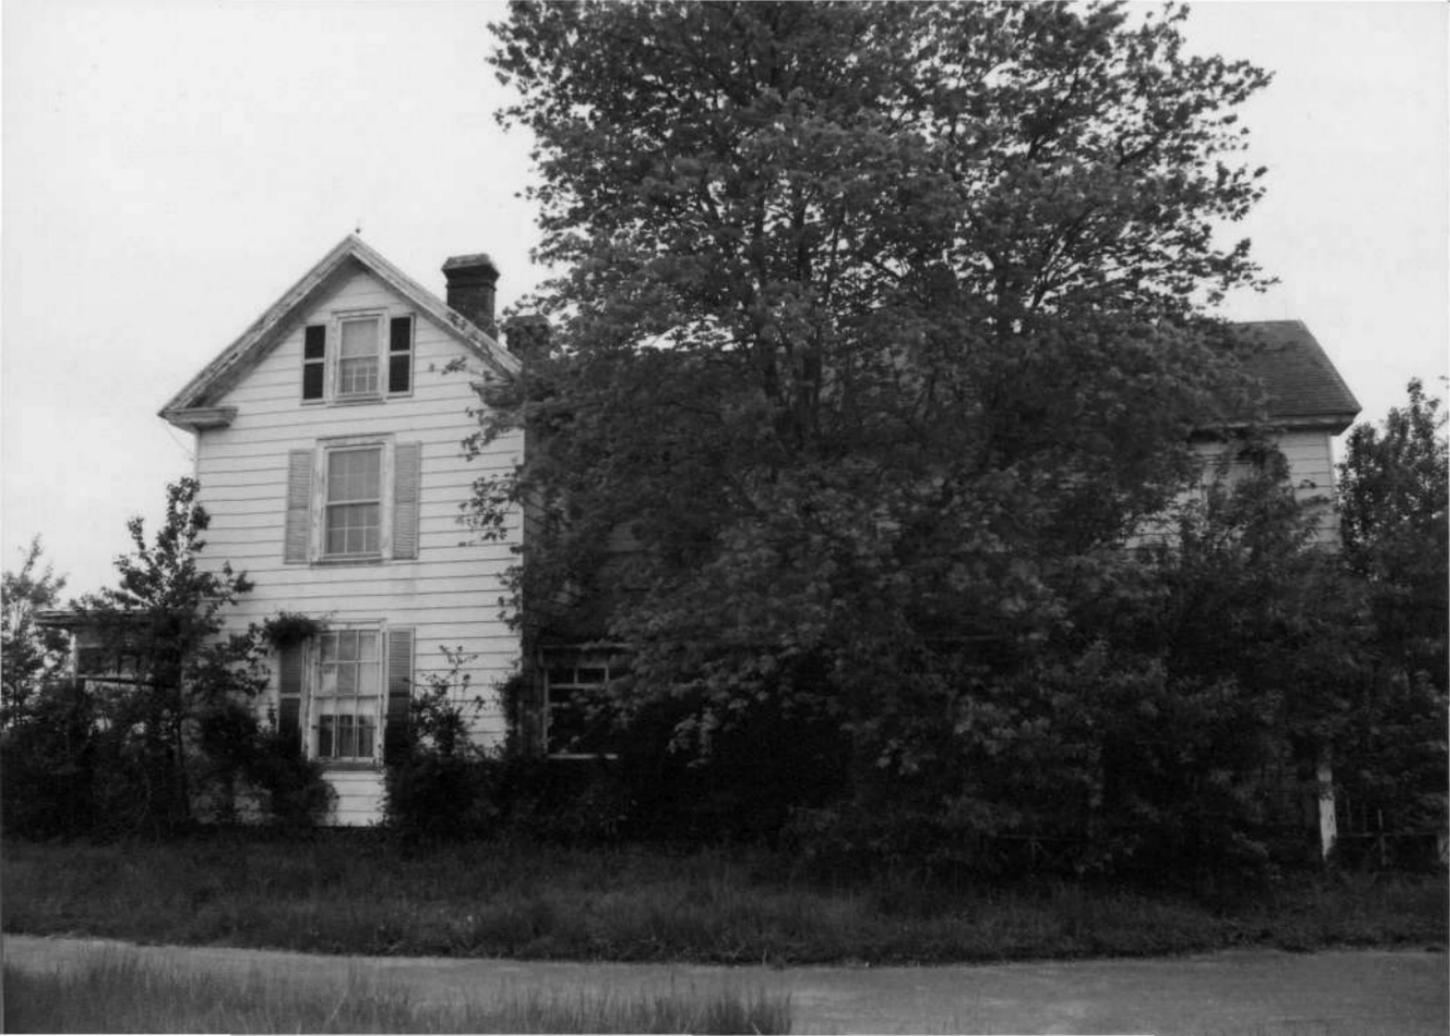
Photo # 6 of 21

The north elevation of the front block contains a single window featuring inoperable, aluminum shutters, in each story. A one-story, partially enclosed, shed-roof porch extends across the north elevation of the rear ell. The porch sits atop a full brick foundation. Dense vegetation conceals any additional details of the north elevation.

Dwelling, north elevation; view to southeast

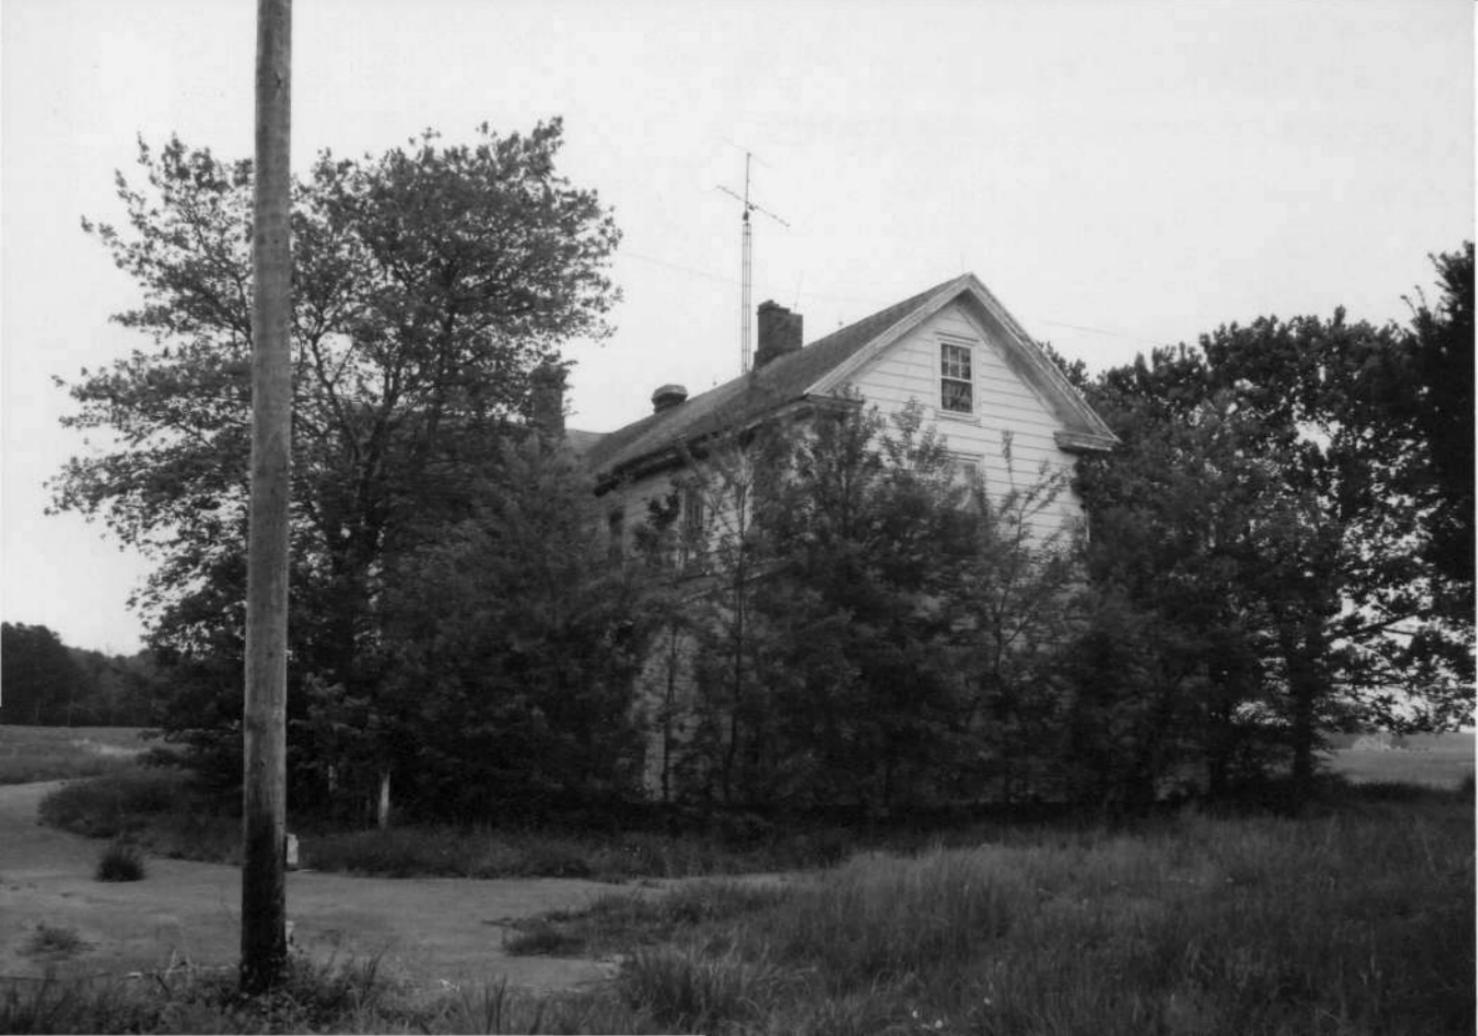
photo # 7 of 21

The rear ell extends westward from the center bay of the west (rear) elevation of the front block. The west elevation of the front block contains a single window in each visible story to the north and south of the rear ell. The rear ell contains a single window on each story.

Dwellings, north & west elevations, view to southeast

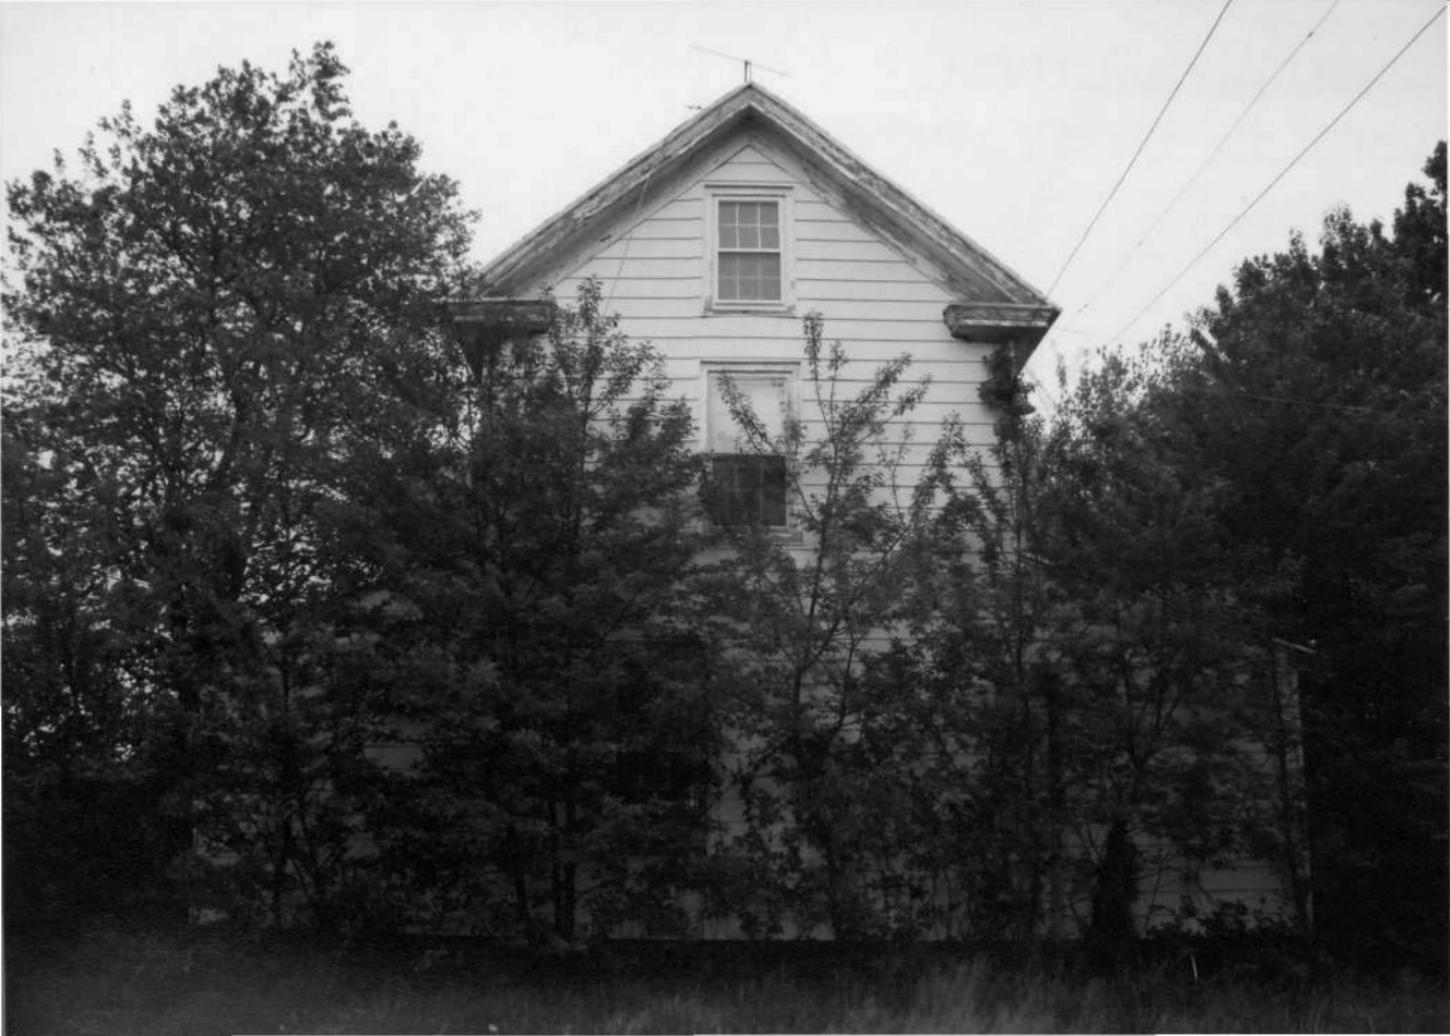
Photo # 8 of 21

DWELLING, west elevation, view to east

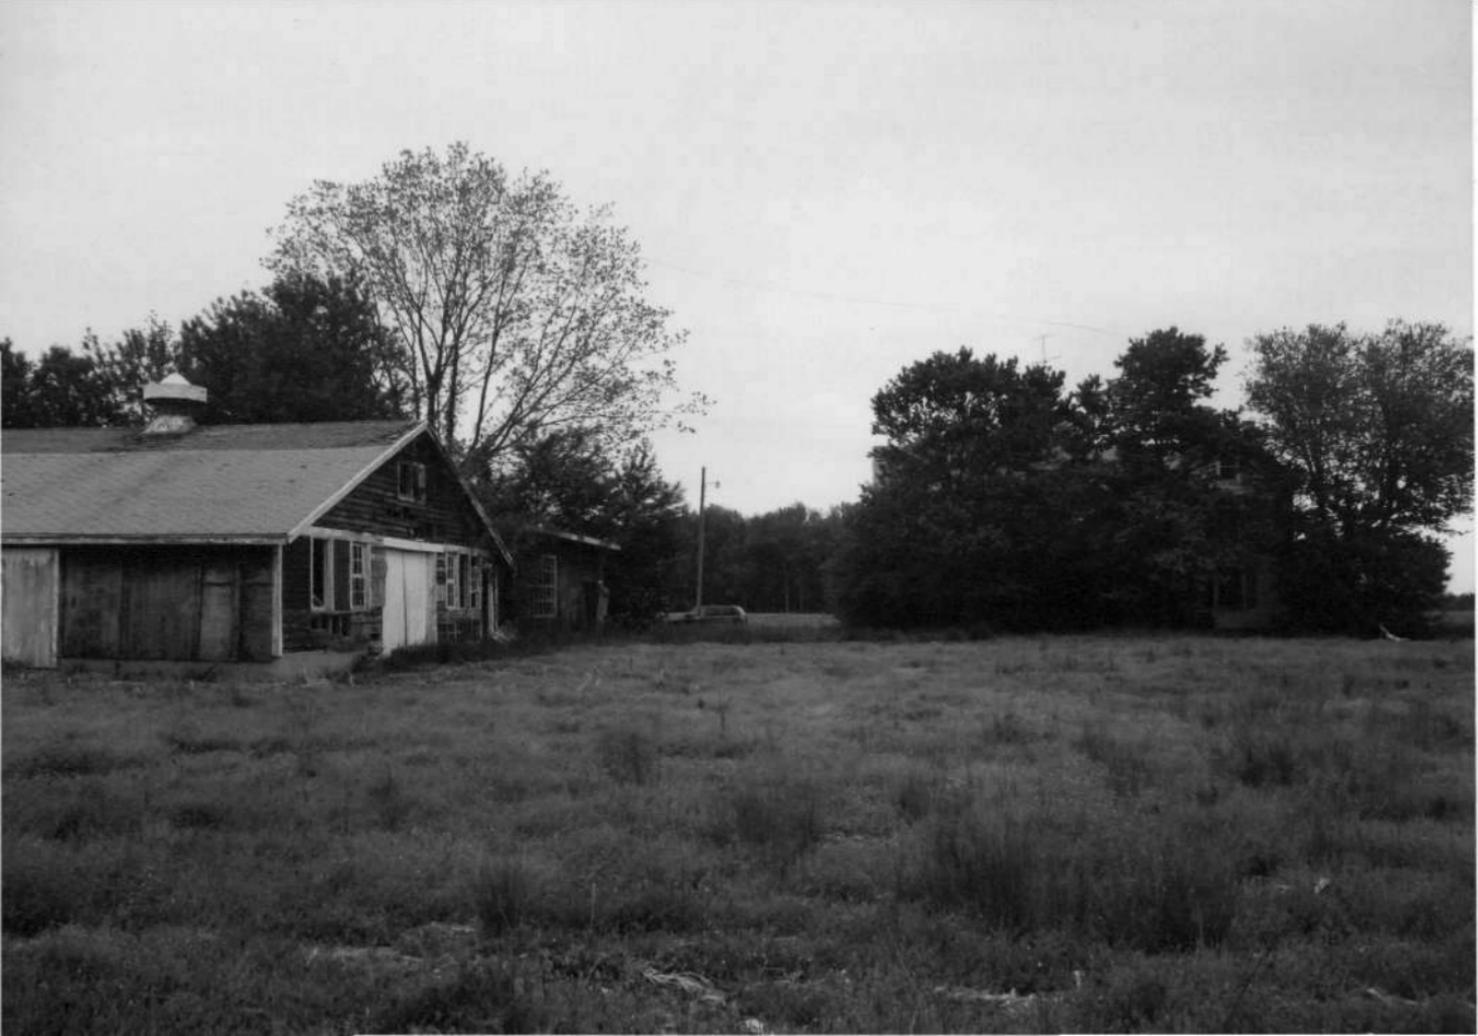
Photo # 9 of 21

view north to layer house, poultry house # 1 and dwellings

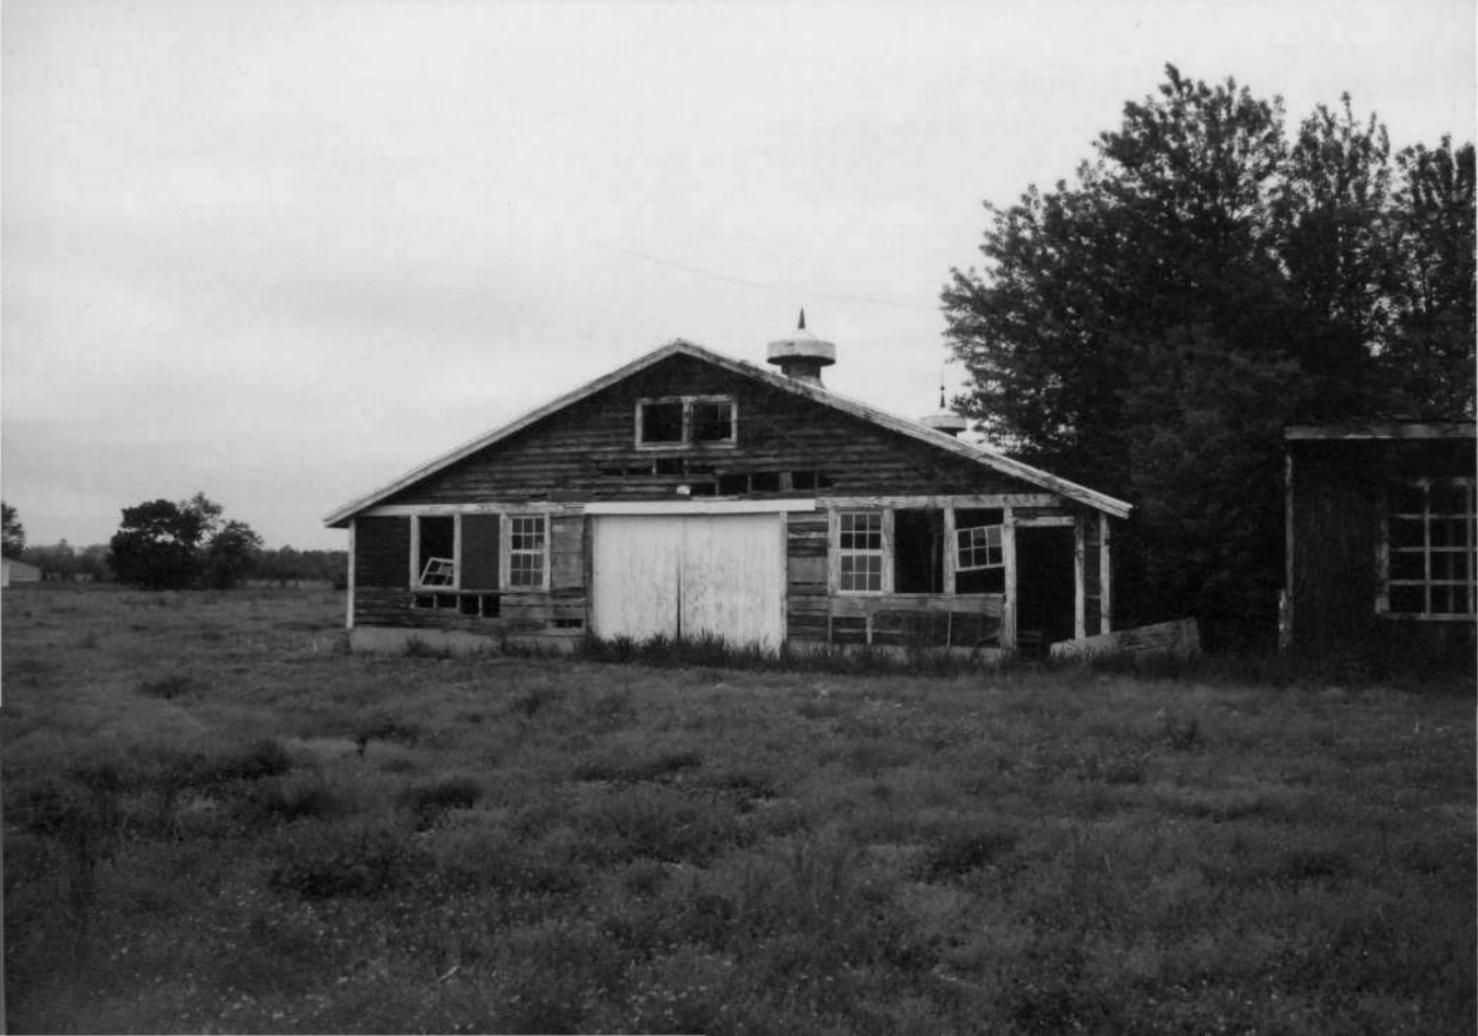
Photo # 10 of 21

A long, one-story, circa-1930, two-part layer house is located to the southwest of the dwelling. The building is currently vacant and is in poor condition. A shallow-pitched, front-gabled roof, clad in asphalt shingles, caps the eastern part of the building, which sits atop a concrete block foundation. A shorter, front-gabled section, the roof of which is clad in standing-seam metal, is appended directly to the west elevation of the building. The entire building is comprised of wooden lap siding that is painted red.

The east (front) elevation features a centrally located set of double-leaf, swinging, vertical-board doors. The remnants of two six-over-six light, double-hung sash, wooden windows, in poor condition, are located to the north and south of the entry. An entrance opening that does not retain a door occupies the northernmost bay of the east elevation.

layer House, east elevation; view to southwest

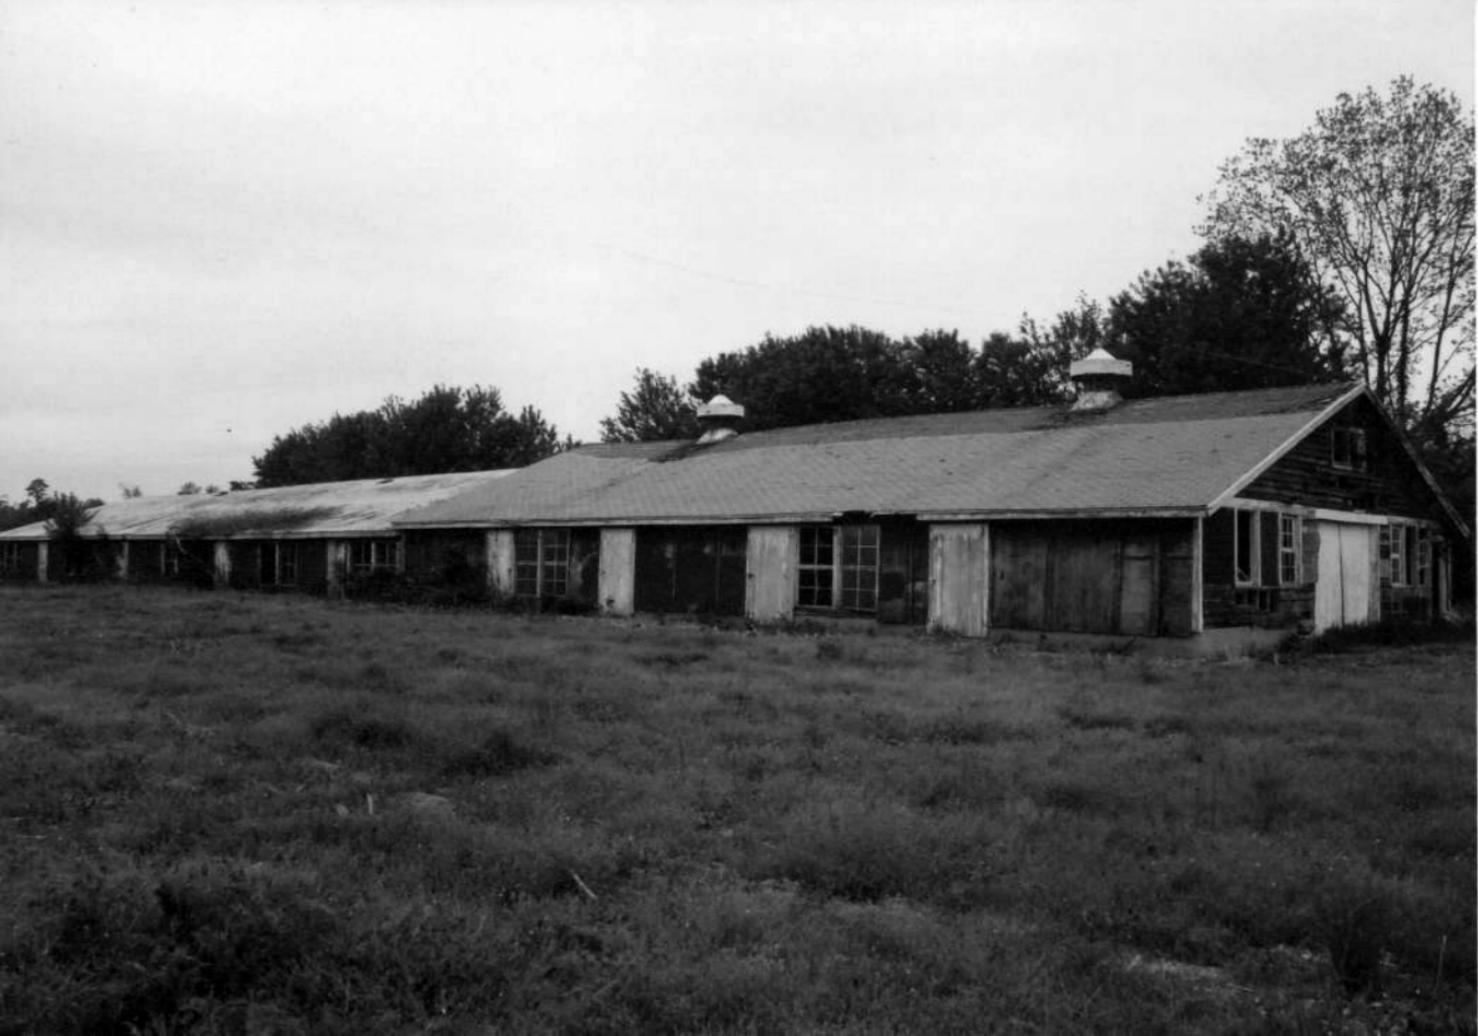
Photo # 11 of 21

The south elevation contains eight single-leaf, vertical-board doors, painted white and evenly spaced throughout the elevation. Seven sets of paired, four-over-four light, double-hung sash, wooden windows are also interspersed throughout the elevation.

Layer House, south elevation; view to northwest

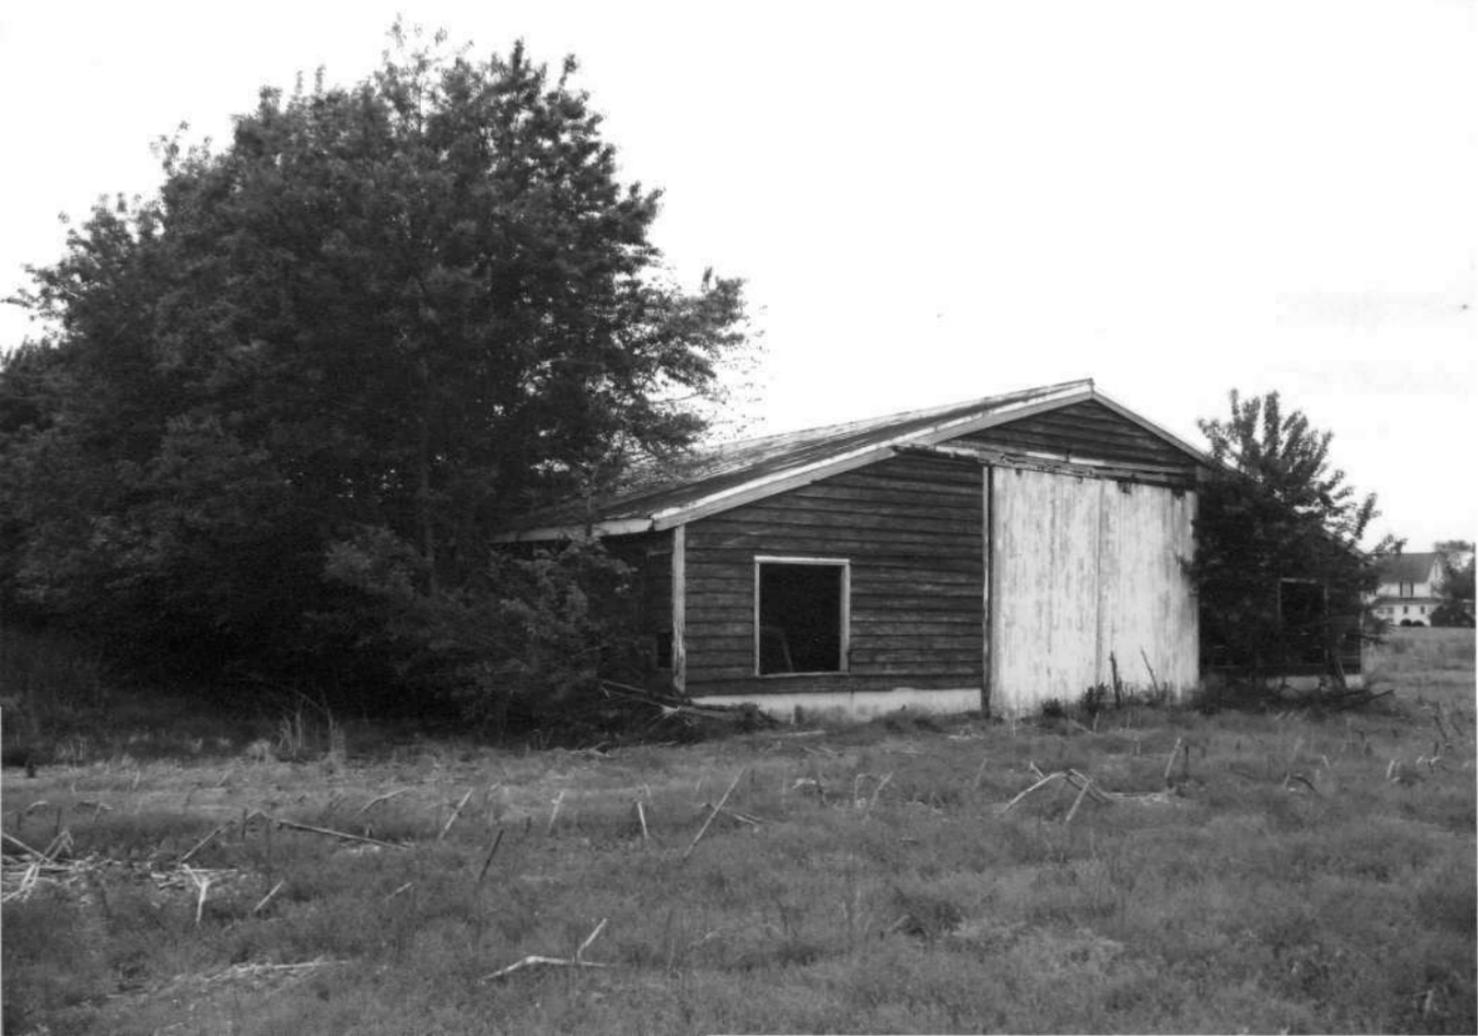
Photo # 12 of 21

The west (rear) elevation of the building contains three openings. A set of double-leaf, sliding, vertical-board doors attached to a metal track, occupy the center bay. A large square, window-like opening flanks each side of the entry.

Overgrown vegetation conceals the north elevation of the building.

Layer House, north & west elevations; view to southeast

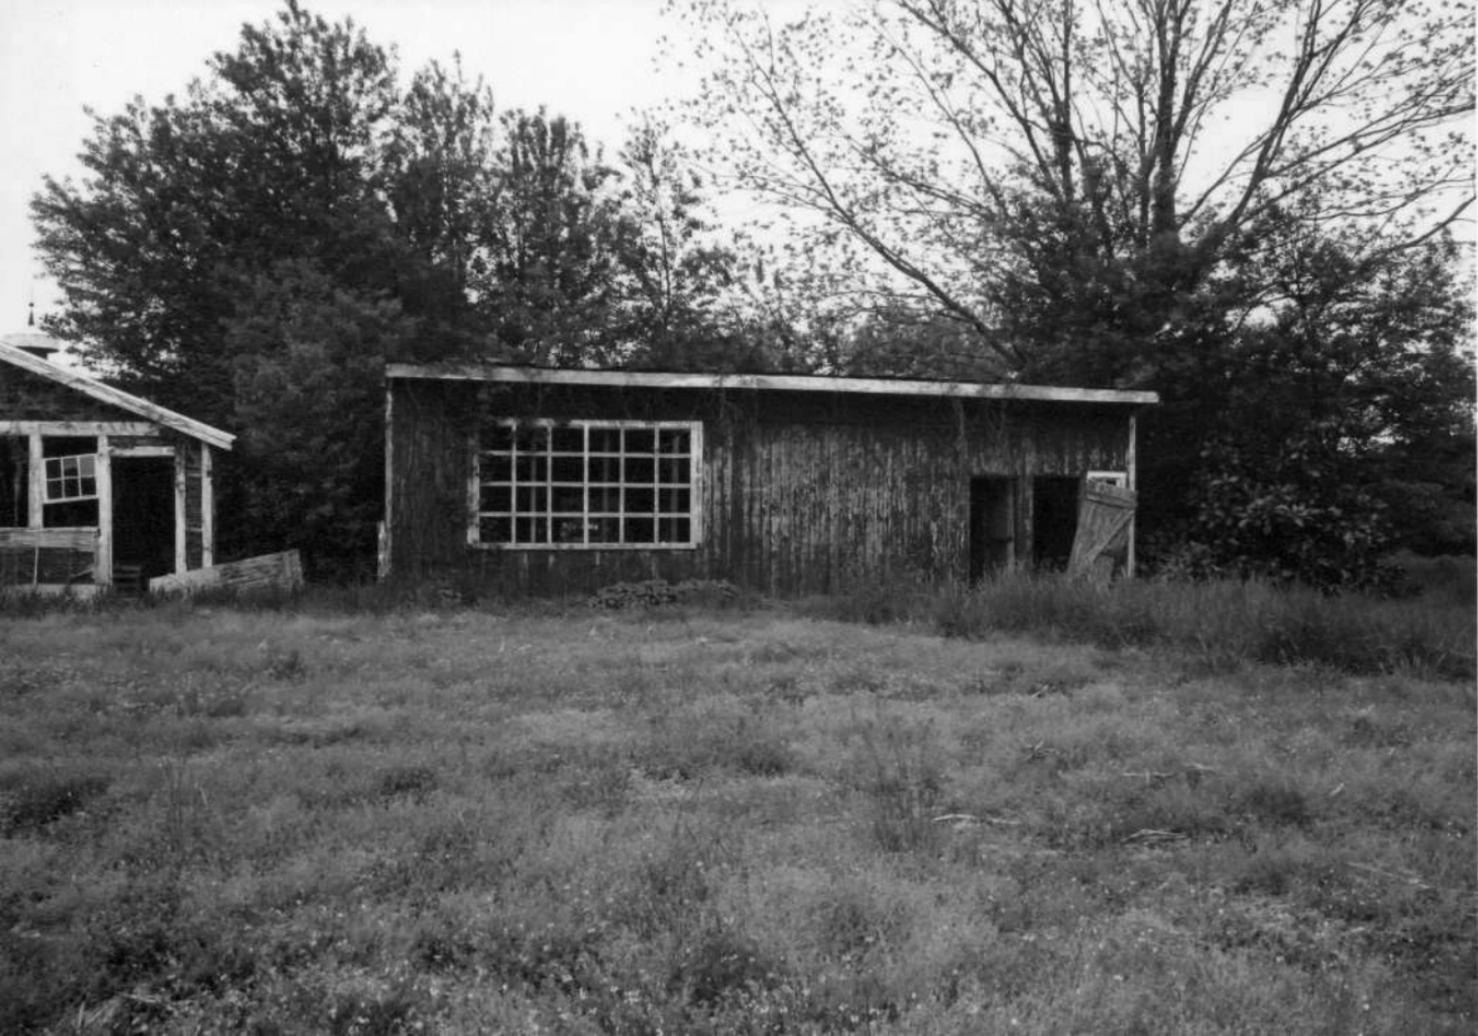
Photo # 13 of 21

To the north of the layer house sits a one-story, circa-1930, frame, poultry house (poultry house # 1) in fair condition and currently vacant. Vertical-board siding, painted red, comprises the exterior of the building. A shed roof, sheathed in asphalt shingles, caps the building. The east (front) elevation features four openings. A large 24-light window, devoid of panes or screens, occupies the southernmost bay. Two single-leaf, board-and-batten doors and a single four-light, casement window are located at the northern end of the elevation. A large rectangular opening is situated on the west elevation. The north and south elevations are devoid of openings.

Poultry House # 1, east elevation, view to west

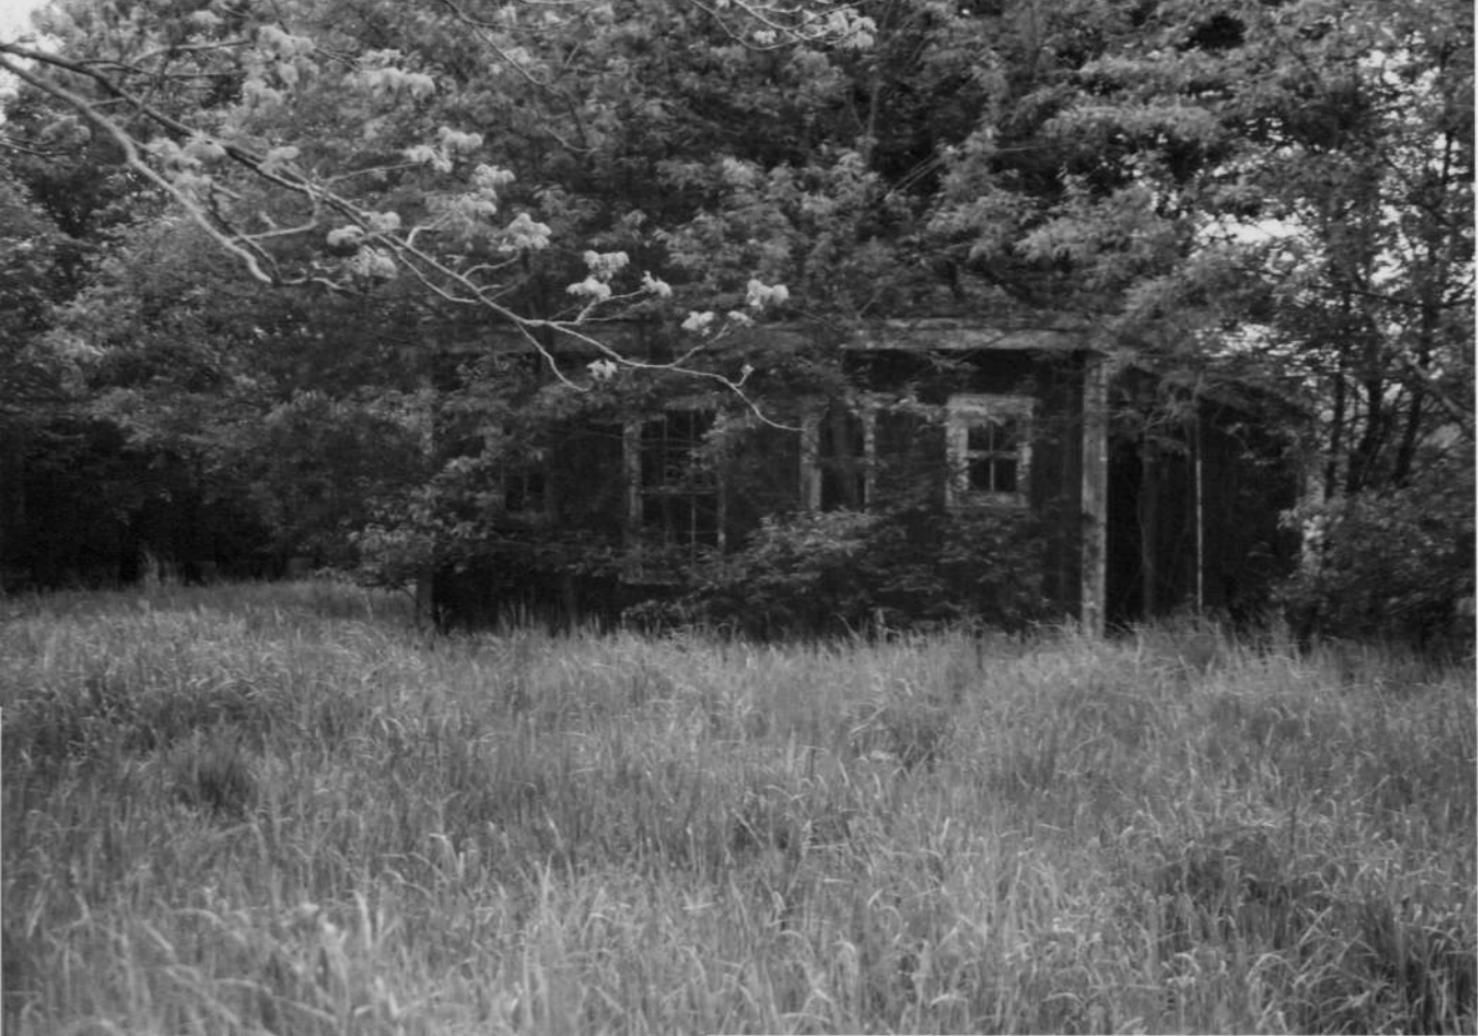
Photo # 14 of 21

A one-story, circa-1920, frame tool shed, currently vacant and in poor condition, is situated to the northwest of poultry house # 1. A shed-roof, clad in corrugated metal, caps the building and slopes downward from east to west. Vertical-board siding that is painted red covers the exterior. The north elevation features a one-bay entrance that does not retain a door. The east elevation features four openings. The northernmost and southernmost windows are two-over-two light, double-hung sash, wooden types. A square opening and a six-over-six light, double-hung sash, wooden window complete the elevation. The west and south elevations are devoid of openings.

TOOL SHED; north & east elevations; view to southwest

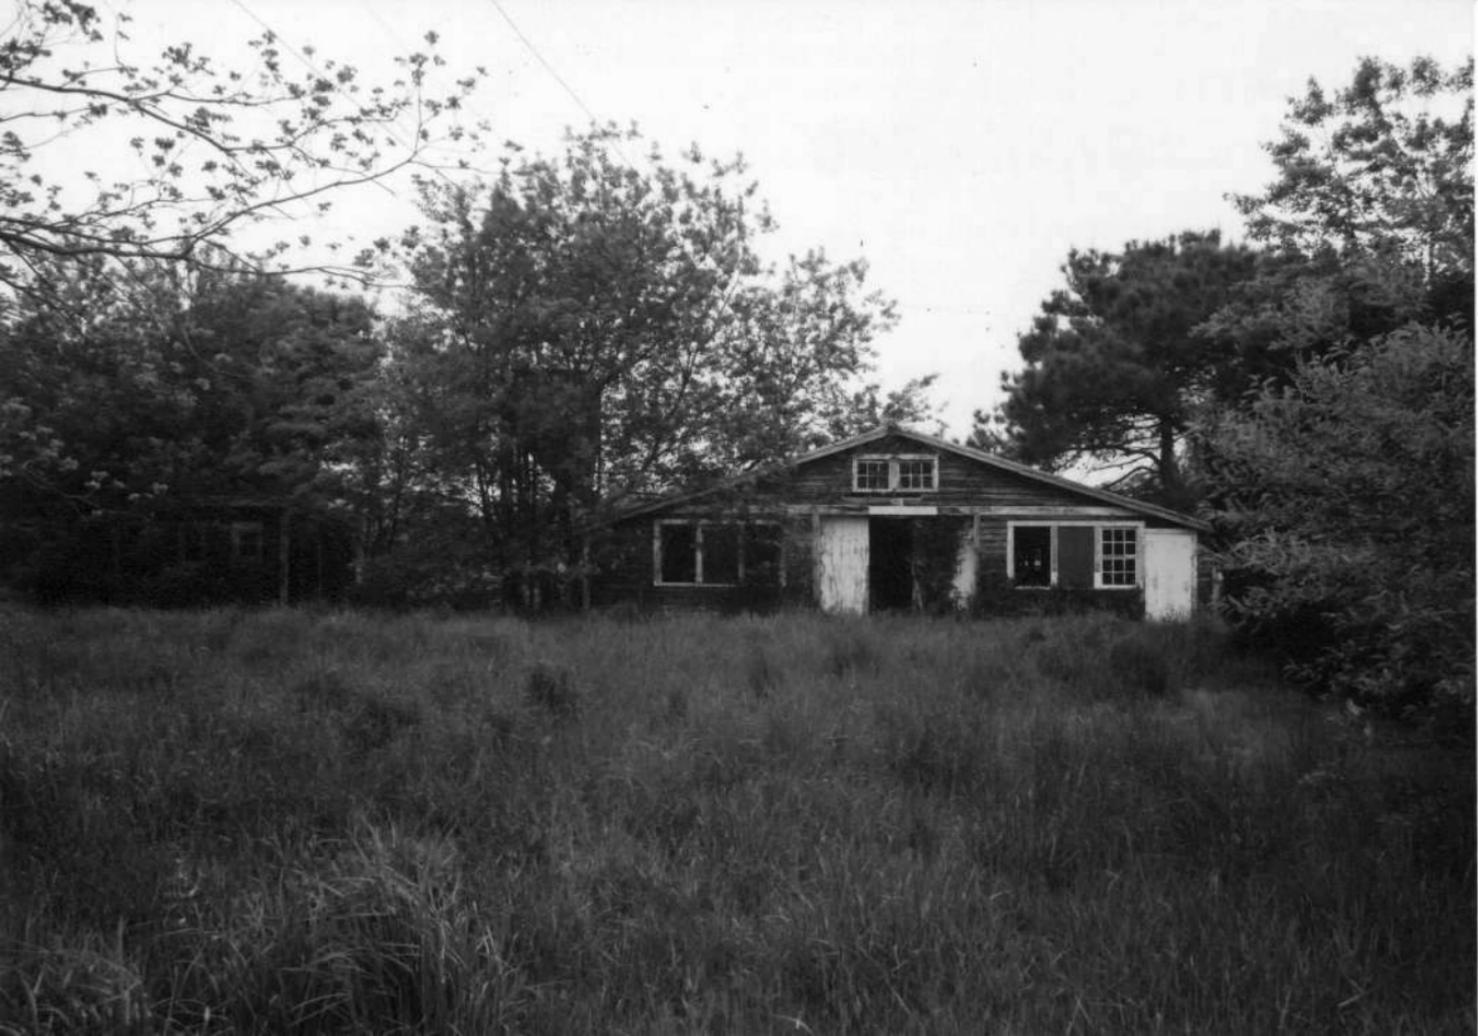
Photo # 15 of 21

TOOL SHED & POULTRY HOUSE # 2, east elevation; view to west
