MARYLAND HISTORICAL TRUST
DETERMINATION OF ELIGIBILITY FORM

Property Name: Henry Merrill Farm Inventory Number: WO-563
Address: 1337 Cypress Road Historic district: ___ yes no
City: Pocomoke City Zip Code: 21851 County: Worcester
USGS Quadrangle(s): Pocomoke City
Property Owner: Maryland Stone, Incorporated Tax Account ID Number: 008943
Tax Map Parcel Number(s): 36 Tax Map Number: 91
Project: Proposed Mining Activities Pocomoke Sand and Gravel Pit Agency: United States Army Corps of Engineers
Agency Prepared By: A.D. Marble & Company
Preparer's Name: Emma Young Date Prepared: 5/23/2007

Henry Merrill Farm WO-563

1337 Cypress Road, Pocomoke City
Worcester County, Maryland

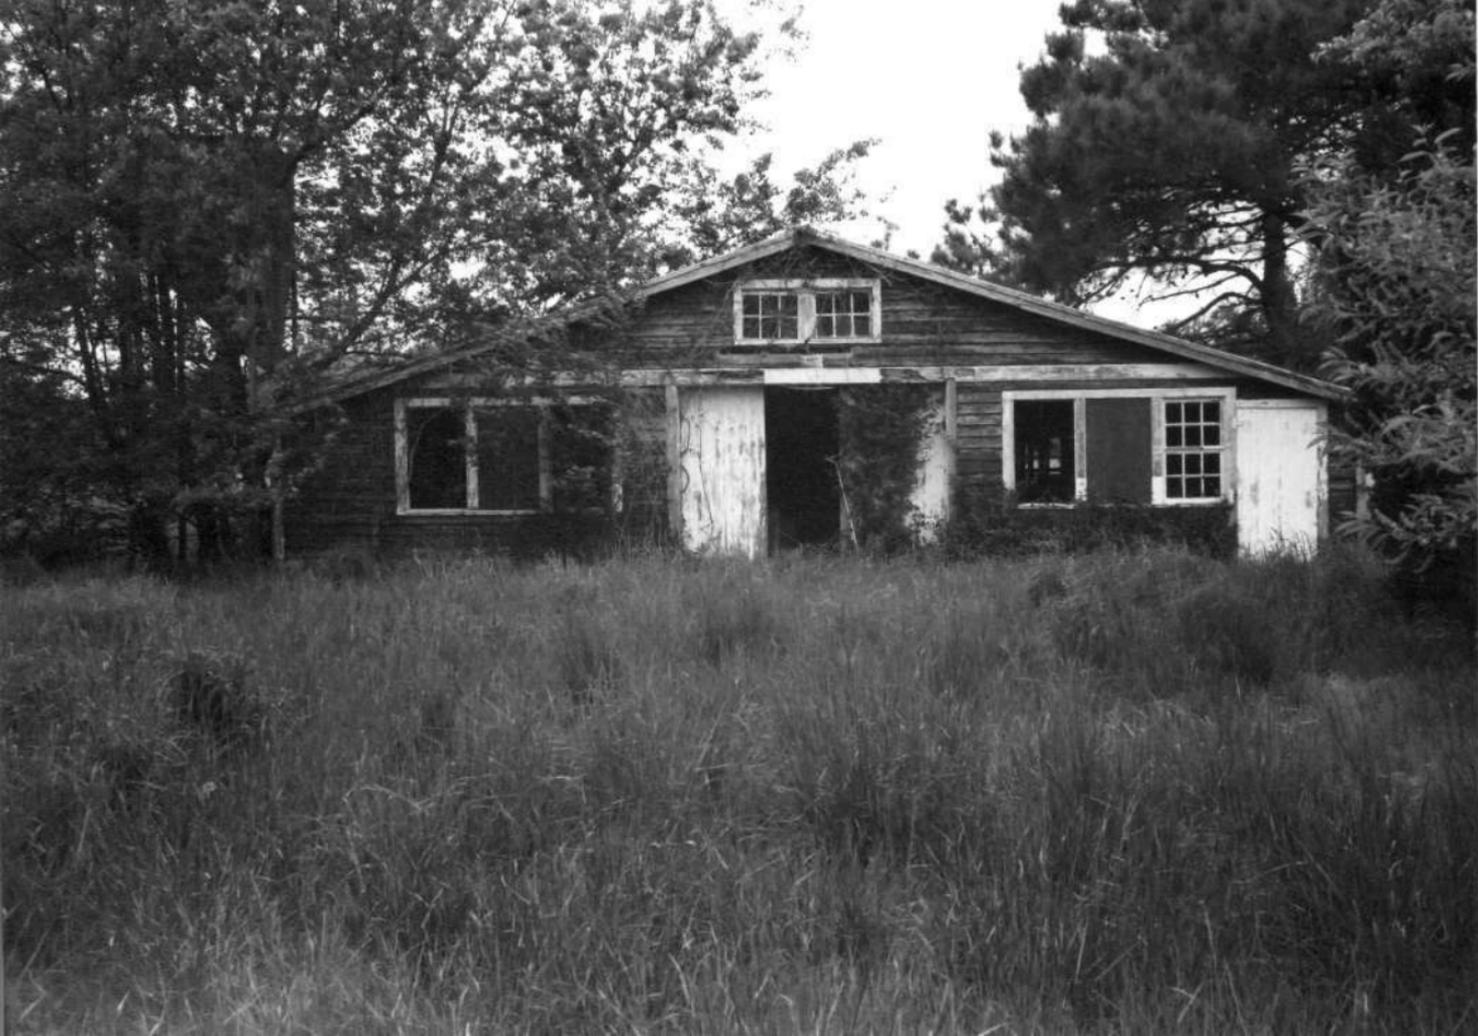
A one-story, circa-1930, frame, poultry house (poultry house # 2), currently in poor condition and vacant, is located to the northwest of the tool shed. A shallow-pitched, front-gabled roof, clad in standing-seam metal, caps the building, which sits atop a concrete block foundation. Wooden lap siding that is painted red covers the building.

The east (front) elevation contains a centrally located set of double-leaf, vertical-board doors, painted white. Three windows, the centers of which are concealed with a wooden panel, are situated to the north and south of the entry. Only one six-over-six light, double-hung sash, wooden window remains in the set. A single-leaf, vertical-board door that is painted white occupies the northernmost bay of the east elevation. A set of paired, six-light, hopper-sash windows is located in the gable.

POULTRY HOUSE # 2, east elevation, view to west
Photo # 16 of 21

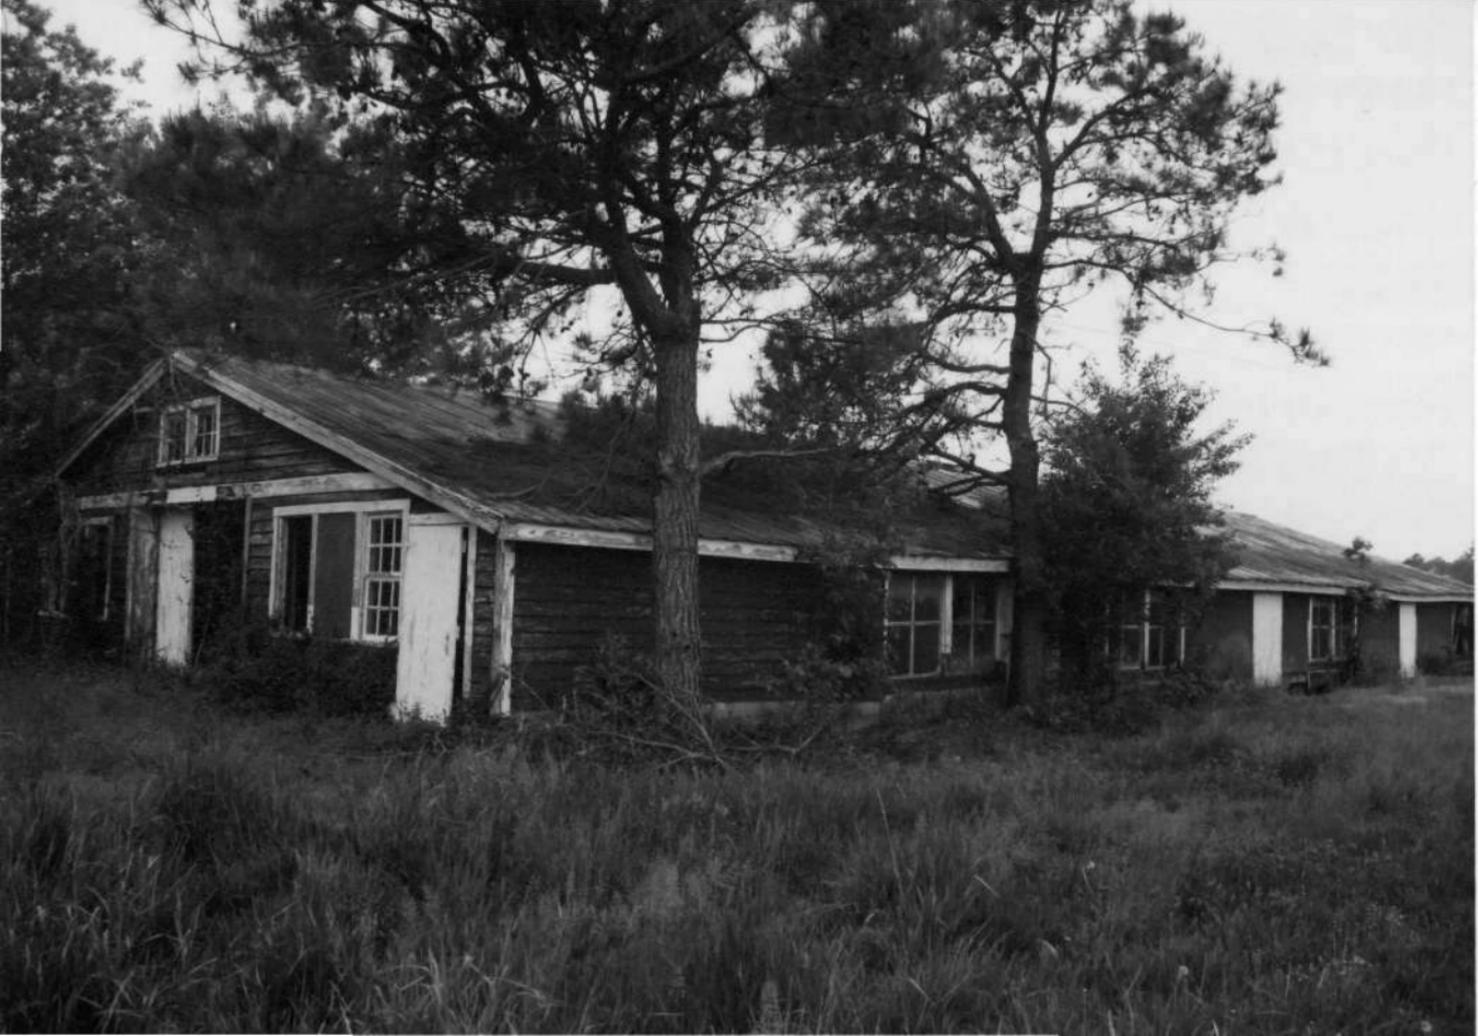
Photo # 17 of 21

The north and south elevations each contain four, evenly spaced, single-leaf, vertical-board doors that are painted white. Three sets of paired, four-light, hopper-sash windows, some devoid of panes, are interspersed throughout the elevations.

Poultry House # 2, north & east elevations; view to southwest

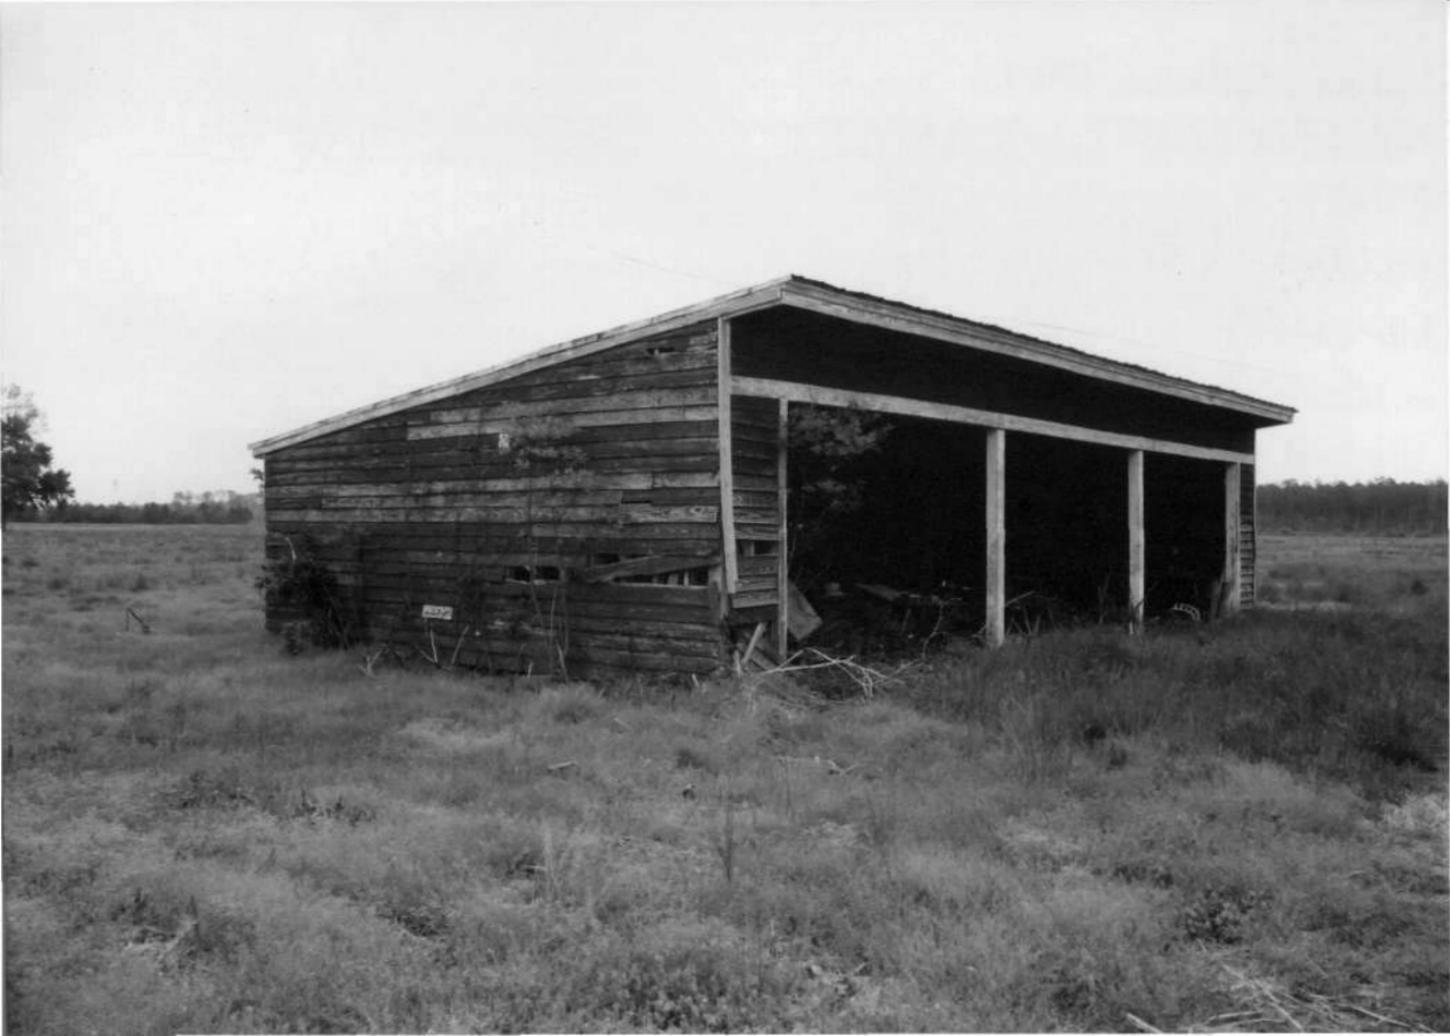
Photo # 20 of 21

A one-story, circa-1920, frame machine shed is located across the farm lane to the north of poultry house # 2. The building, currently vacant, is in fair condition. A shed roof, clad in corrugated metal, caps the building, which is covered in wooden lap siding, painted red. Three open bays, each divided by a simple wooden post, comprise the south (front) elevation. The north, east, and west elevations are devoid of openings.

Machine shed; south & west elevations; view to northeast

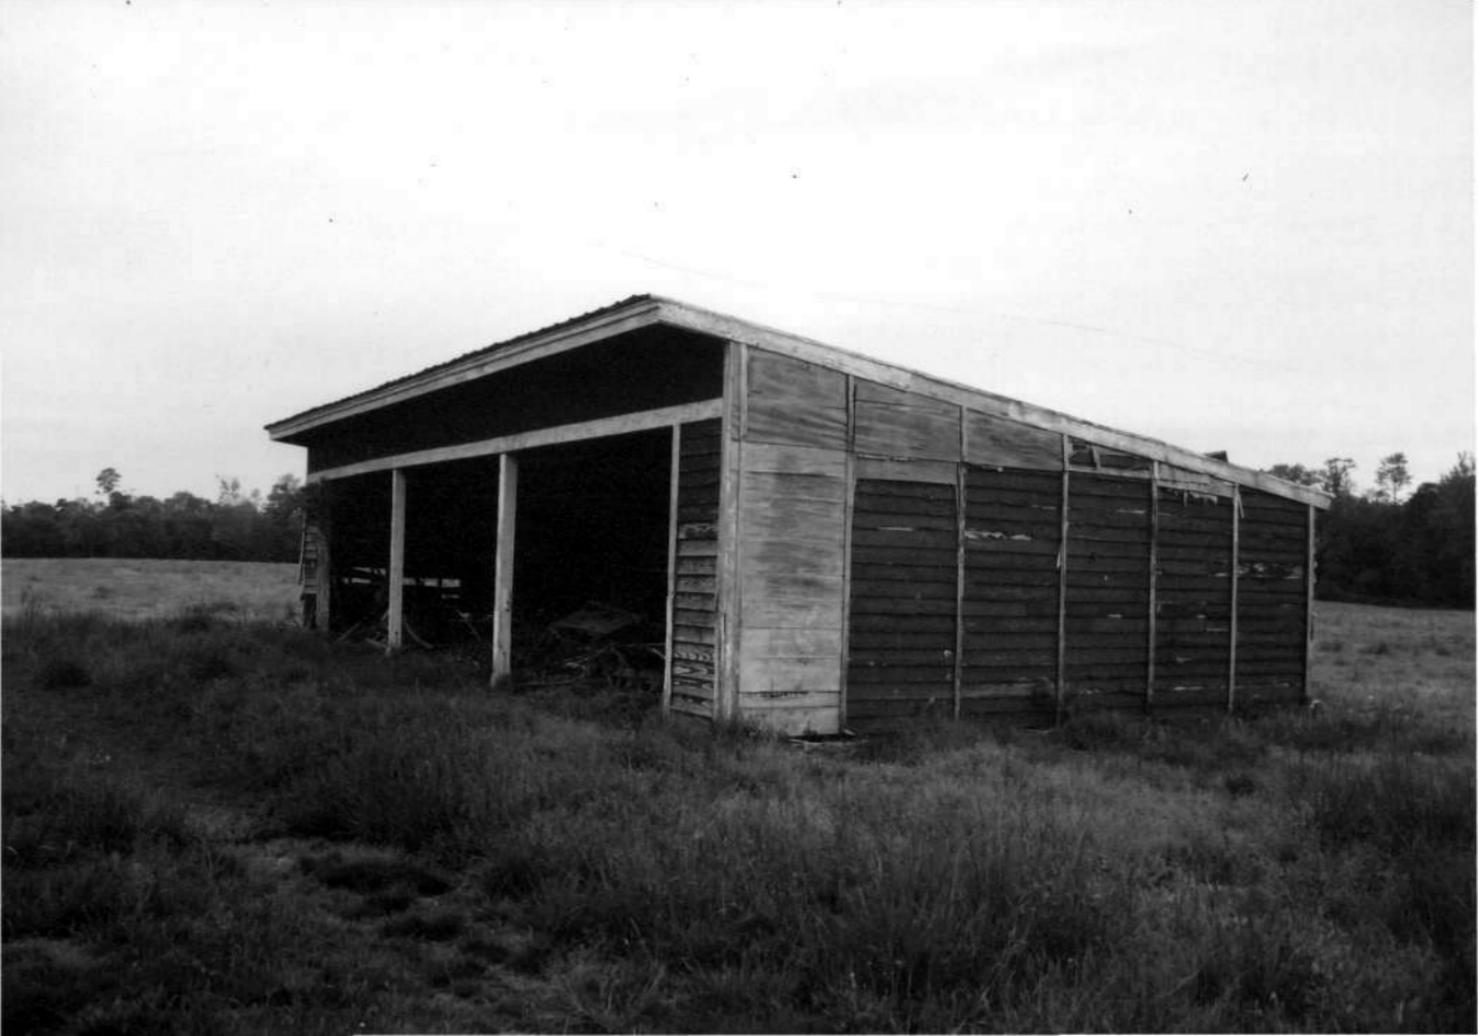
Photo # 21 of 21

MACHINE SHED; SOUTH & EAST ELEVATIONS; VIEW TO NORTHWEST
