B-831
1405 Eutaw Place
Block 0380 Lot 002
Baltimore City
Baltimore West Quad.

1405 Eutaw Place
Baltimore City, Md.

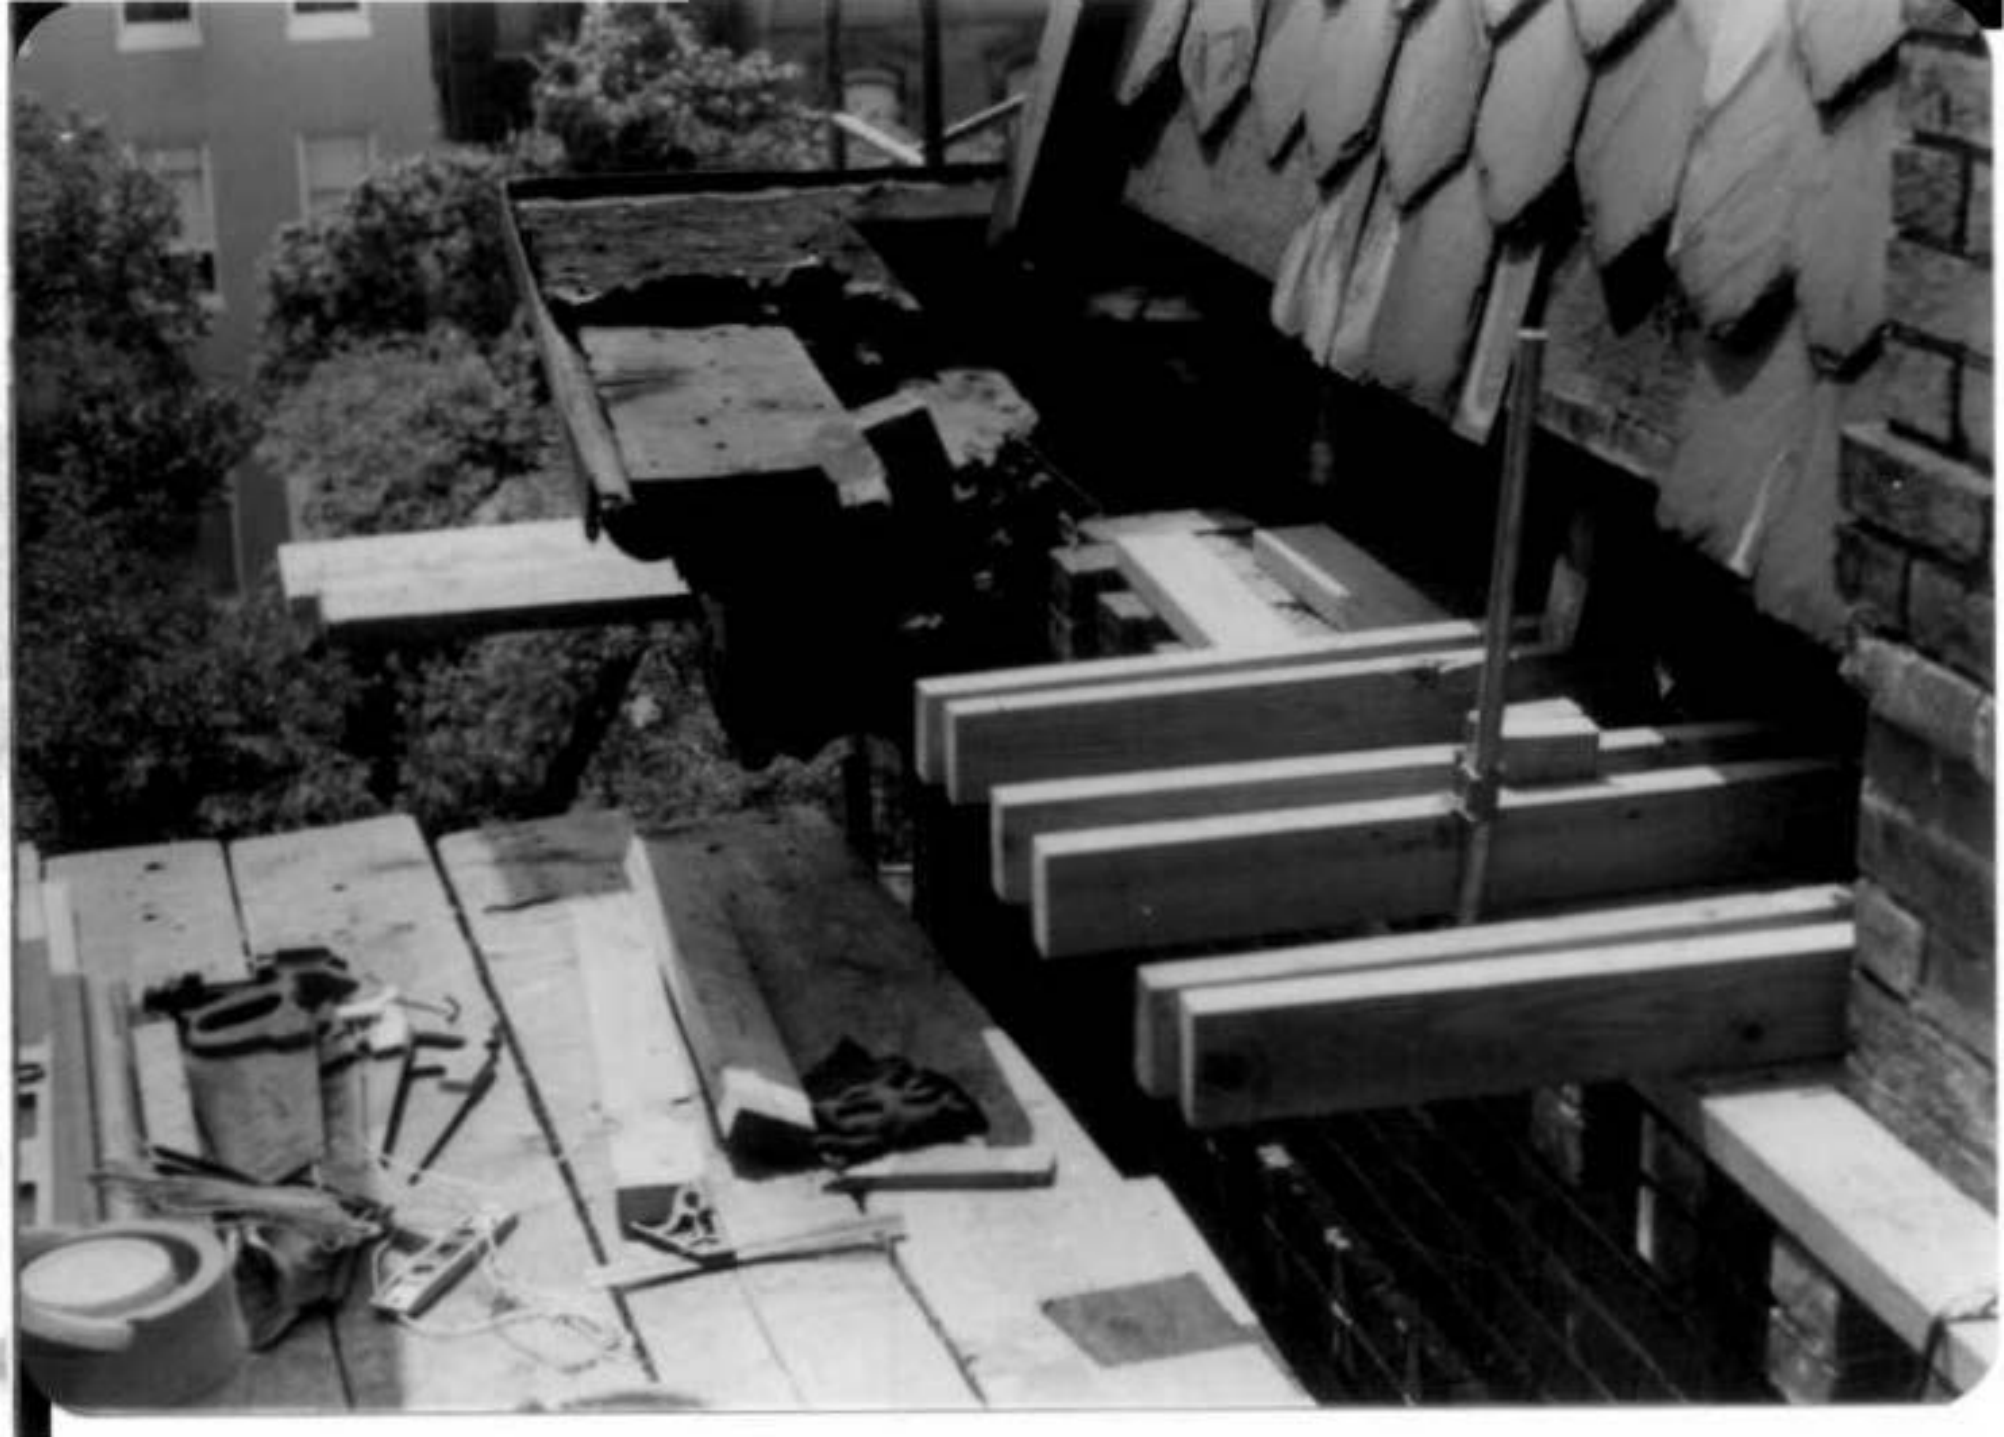
Side view from front toward bay showing replacement of supports for new built-in gutter
