SITE NUMBER: WA-II-951
ADDRESS: Across from 50 St. Paul Street, Boonsboro, Maryland
OWNER/LOT NUMBER/ACCESS: private
BUILDING DATE: mid 19th century? pre-1877

Prepared by Julianne Mueller, July 1992

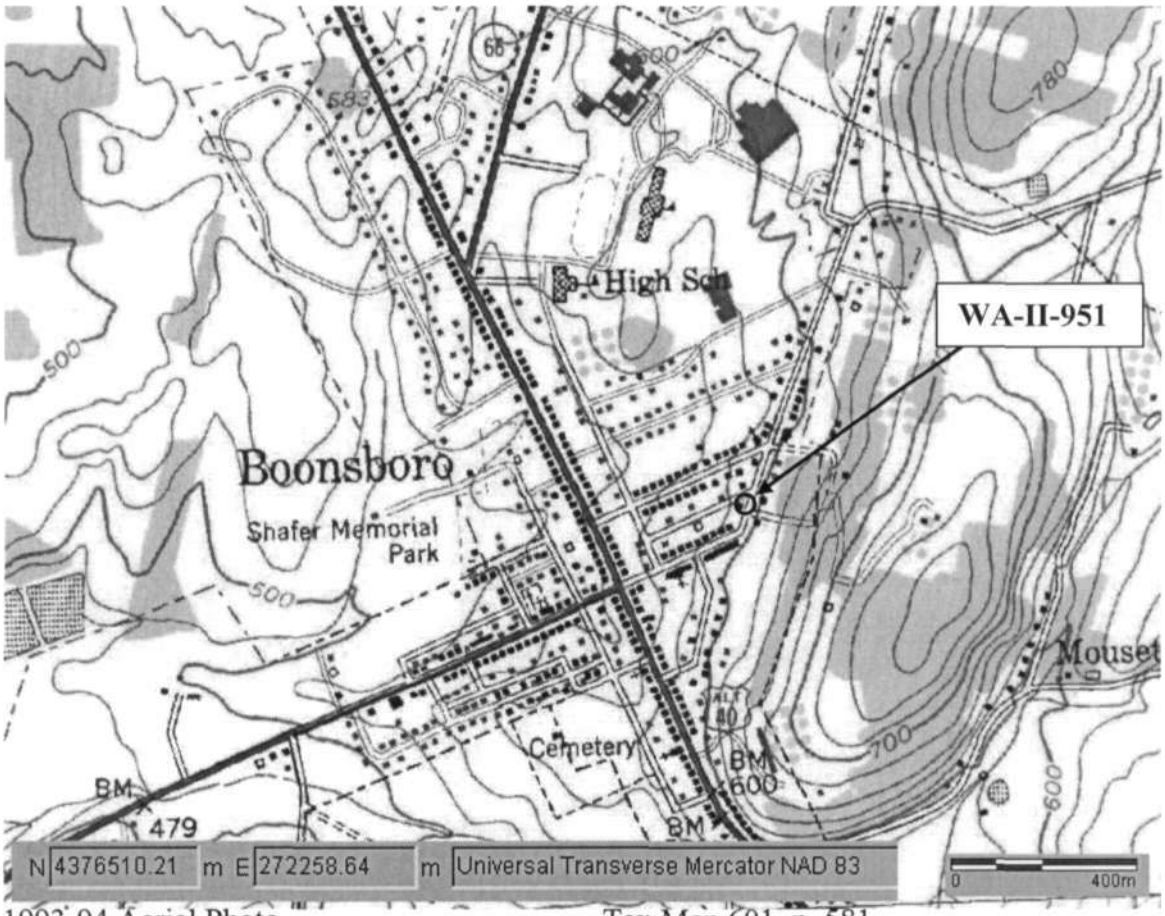
WA-II-951
ACROSS FROM 50 ST. PAUL ST, BOONSBORO, WASH. CO.
12.91
JULIE MUELLER.
LOOKING NW

This is an east-facing, horizontally massed, one-and-a-half-story, six-bay, frame, freestanding, double house that has been gutted by fire. The building is at the public-right-of-way and is covered with manufactured siding. The tin, side-gable roof has two chimneys and has been extensively damaged. All openings have been boarded up.
