### STAMP Tag Deploying Form

1. Tagged by: Susan Langley & Roger McGraw
2. Tag Number(s) (####): 0026
3. Date: Jan 29/24 Time: 11:30:12:30 am pm  
Tide level:  High  Medium  Low dropping but full moon.
4. Name of wreck (if known): N/A
5. Description: How did the wreckage reach its present position?  
 Float  Uncovered  Other \_\_\_\_\_

3" thick - 13 1/2" max wid  
± 19' long hull plank -  
treenails - even in places (end)  
slightly staggered.

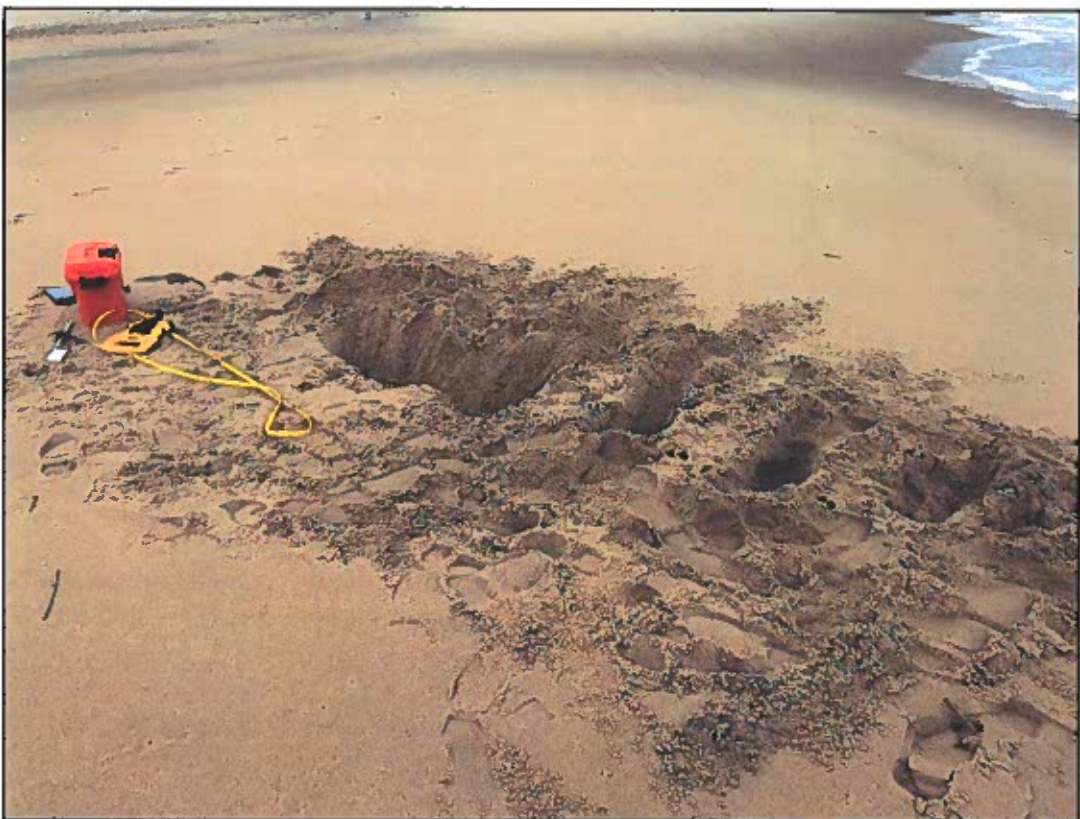
-This is a hull plank & likely below the water line since it appears to have small tack holes that usually indicate hull sheathing. There is no evidence of staining that often accompanies sheathing.

**Seeking the length of the timber; in 2 days 13 feet of the 19 foot length buried to a depth of over a foot. (S. Langley Jan. 29, 2024).**
