### STAMP Tag Deploying Form

1. Tagged by: Pamela Burgess
2. Tag Number(s) (####): MD 0024
3. Date: 8-14-2024 Time: 2:00 am ☒ pm  
Tide level: ☒ High ☐ Medium ☐ Low
4. Name of wreck (if known): \_\_\_\_\_
5. Description: How did the wreckage reach its present position?  
☒ Float ☐ Uncovered ☐ Other \_\_\_\_\_

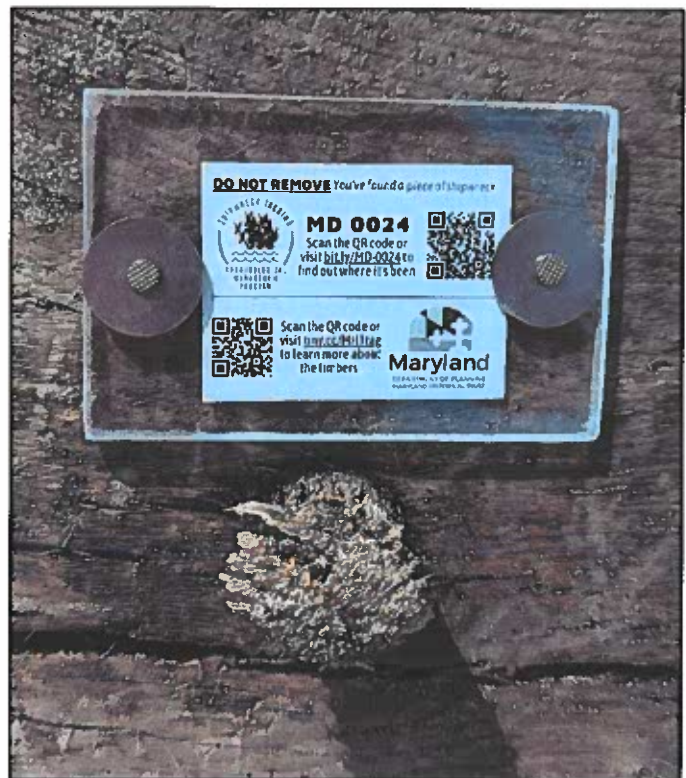
Damage by wood boring/devouring worms. These are probably by shipworm (*Teredo navalis*) although they seem small so may be made by another wood-eater the gribble (*Limnoria lignorum*).

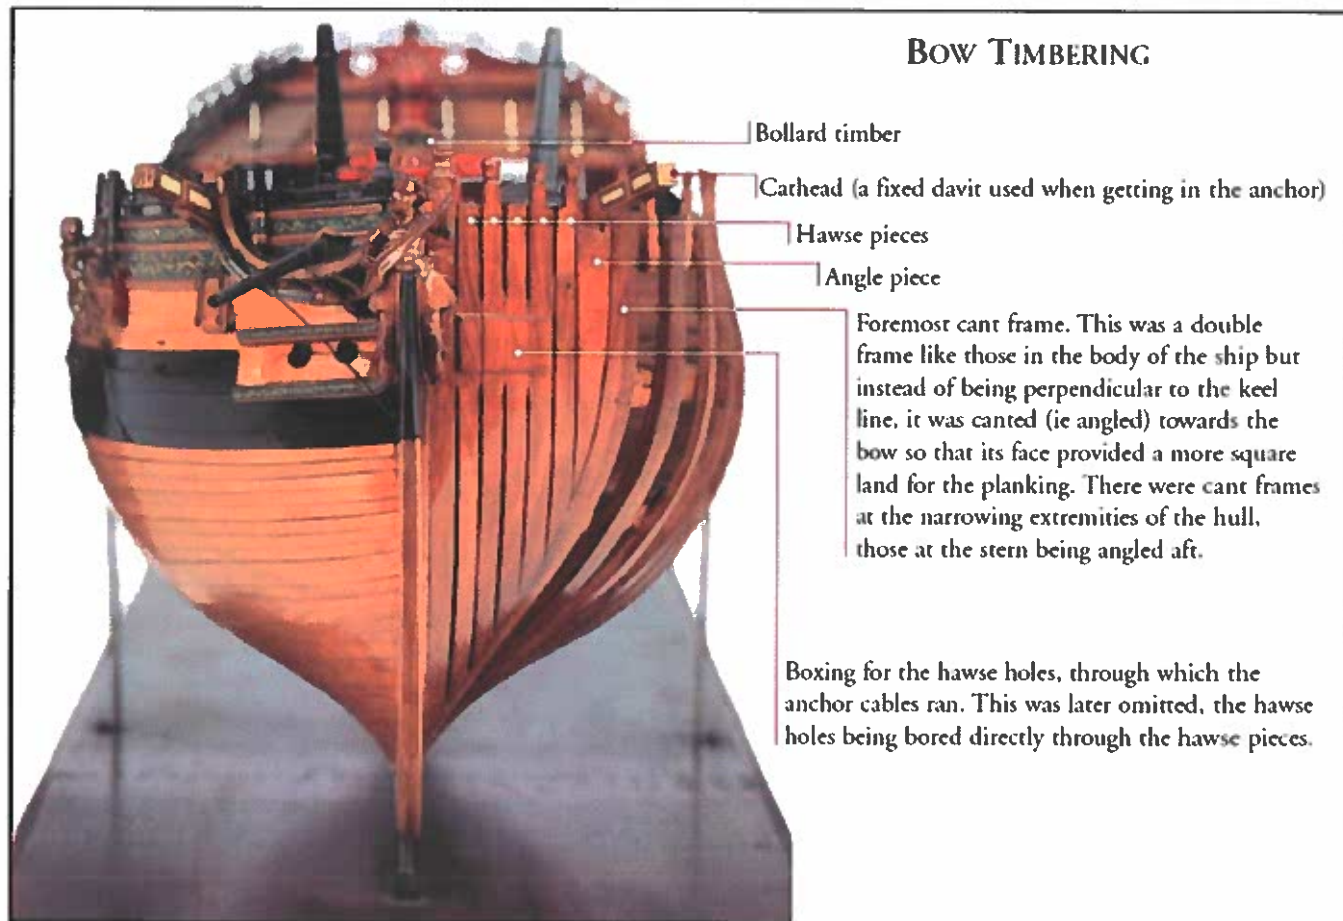
The half frames in the bow are called “cant” frames and are spaced very closely together to act as something of a shock-absorber as the vessel ploughs through waves.
