### STAMP Tag Deploying Form

1. Tagged by: Will Stegman
2. Tag Number(s) (####): MD0016, MD0015 MD0018 MD0017 <sup>4</sup> TAGS
3. Date: 12/22/23 Time: 10:50 am pm  
 Tide level:  High  Medium  Low
4. Name of wreck (if known): Not known; likely dates between mid and late 19th C 1850-1899 approx
5. Description: How did the wreckage reach its present position?  
 Float  Uncovered  Other Storm Action.

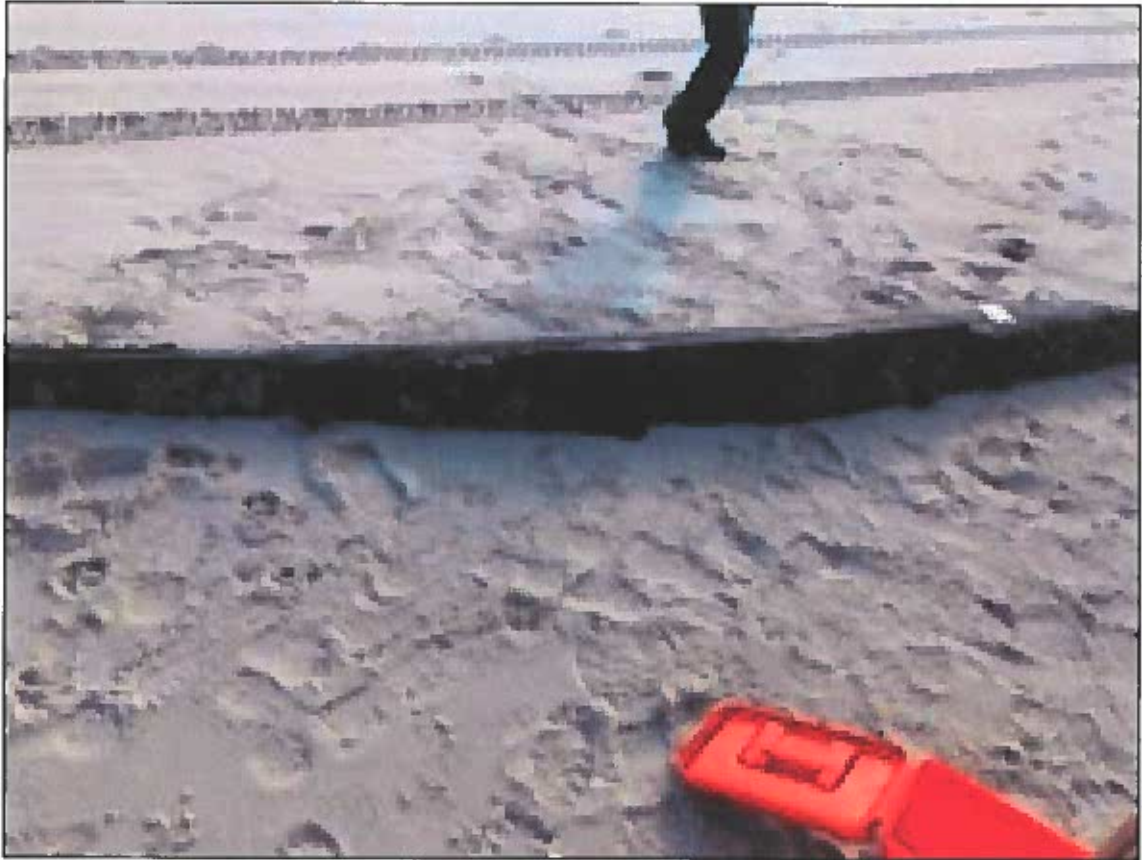
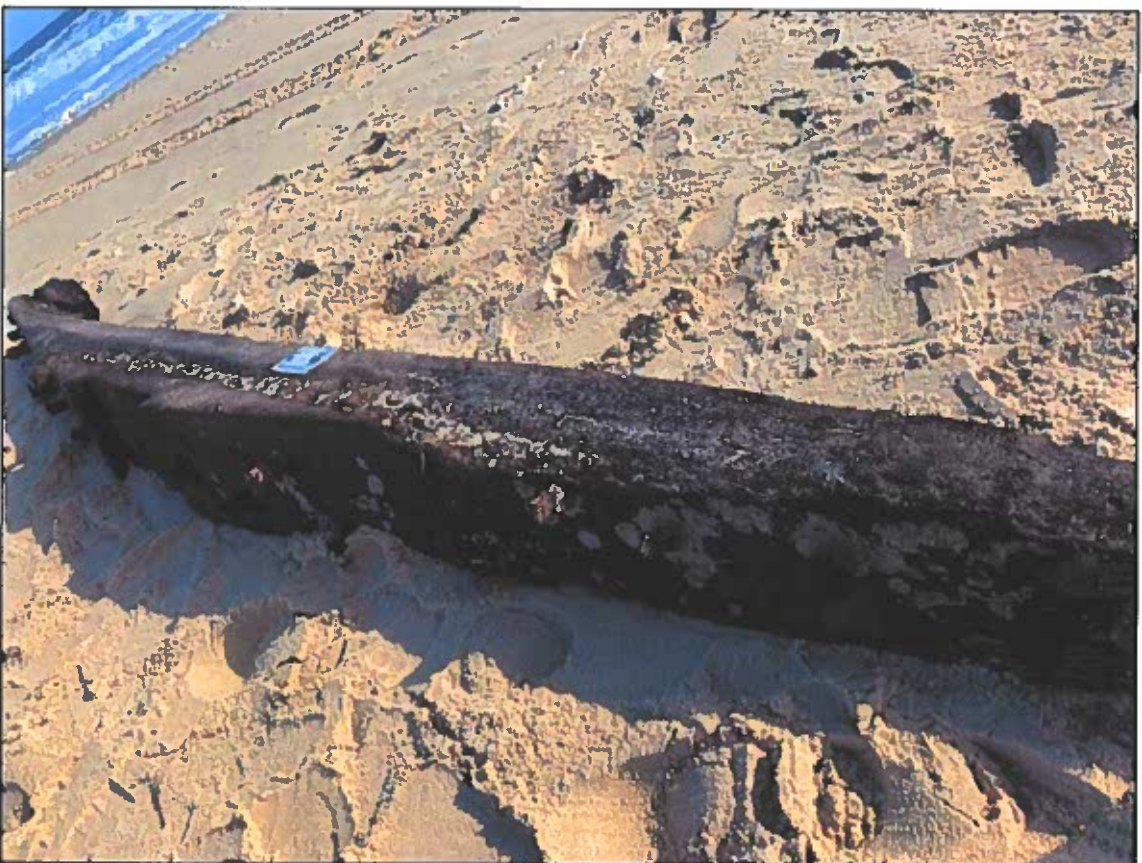
14. Comments: The insertion of the notch at the bottom to seat the timber on the keel, as a separate piece is rare but not unique. This is done as a repair or during construction if that piece of the timber has knots or might be sapwood that will decay faster than the denser heart wood of the rest of the timber.

**Keel notch attached separately (top center). Base of first futtock scarphed to floor timber (below). The floor and futtocks combine to make the ship's frames or "ribs."**

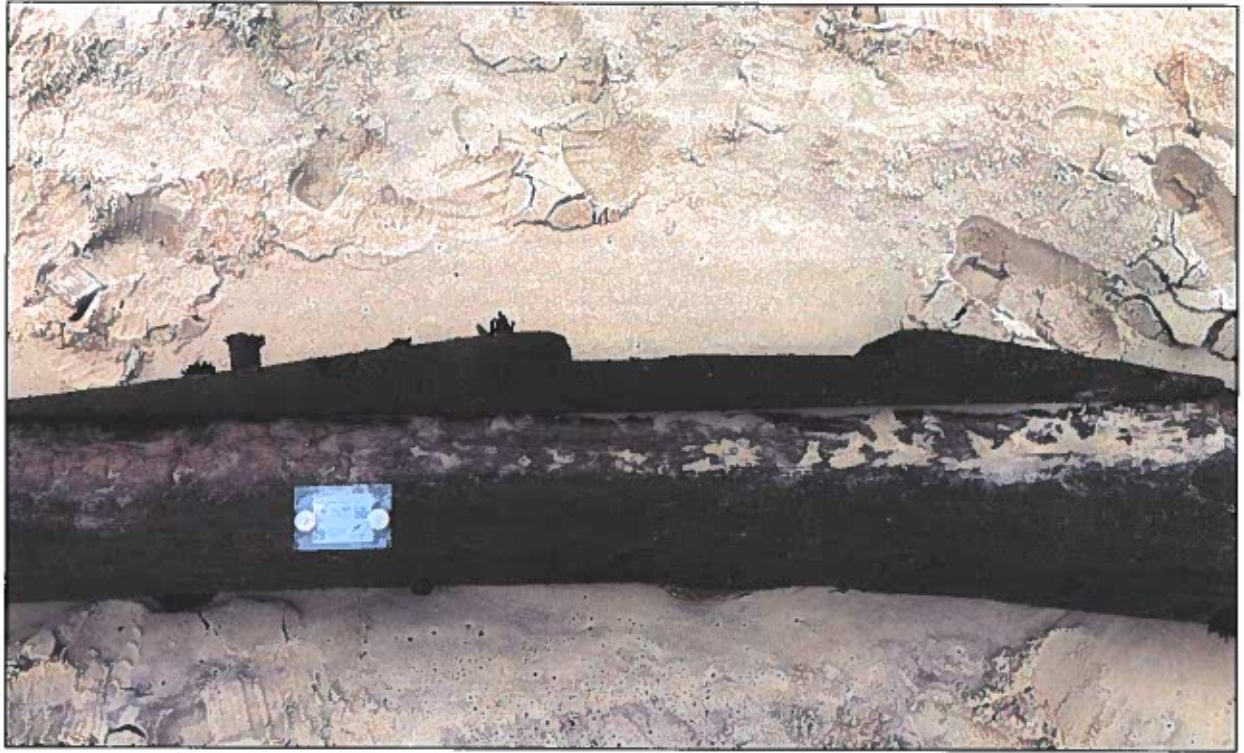
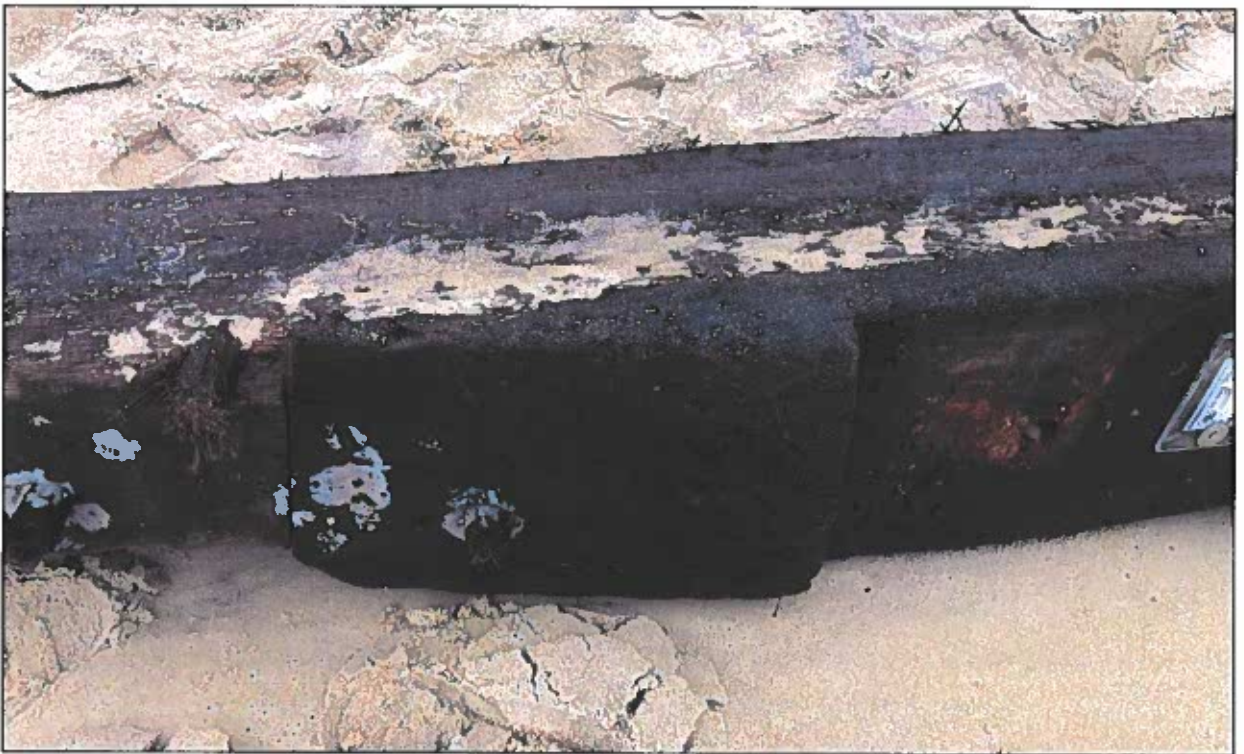
**Treenails or trunnels are wooden pegs used as fasteners instead of metal. Some lathe-turned ones have small wedges or shims driven into the top to hold them in tightly. The keel notch has been scarphed in carefully and may indicate it was done during construction versus as a subsequent repair (below)**

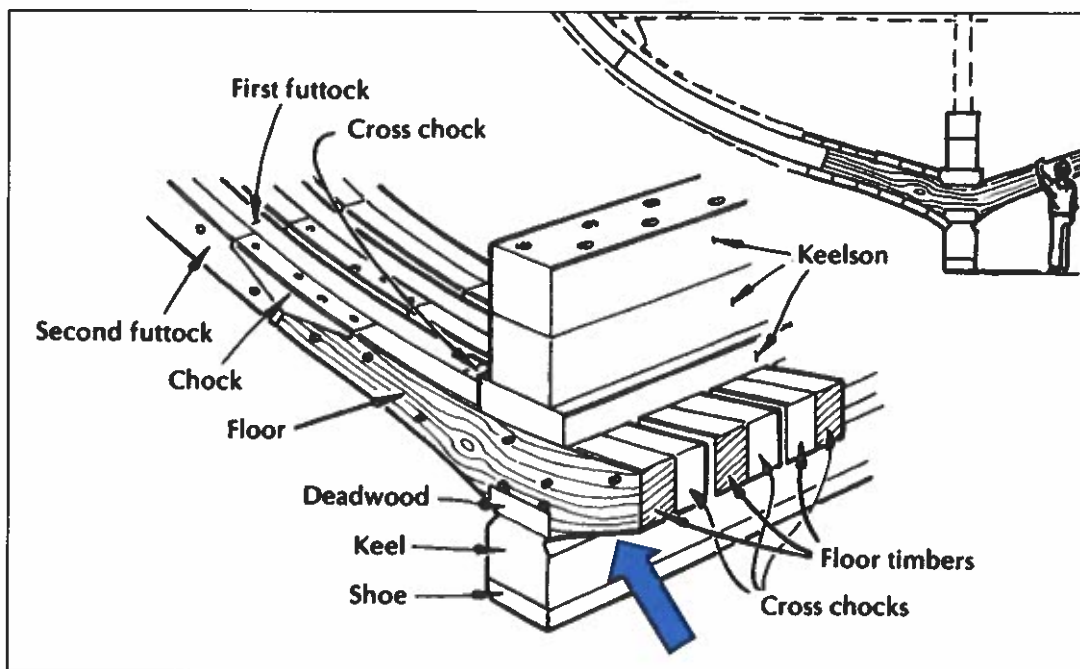
**The blue arrow indicates a floor timber. These form the bottom of every set of frames (ribs)**
