CAPSULE SUMMARY
Paca-Carroll House (AA-677)
St. John's College, Annapolis

Maryland Inventory of Historic Properties Form

Paca-Carroll House, St. John's College, Annapolis
Continuation Sheet

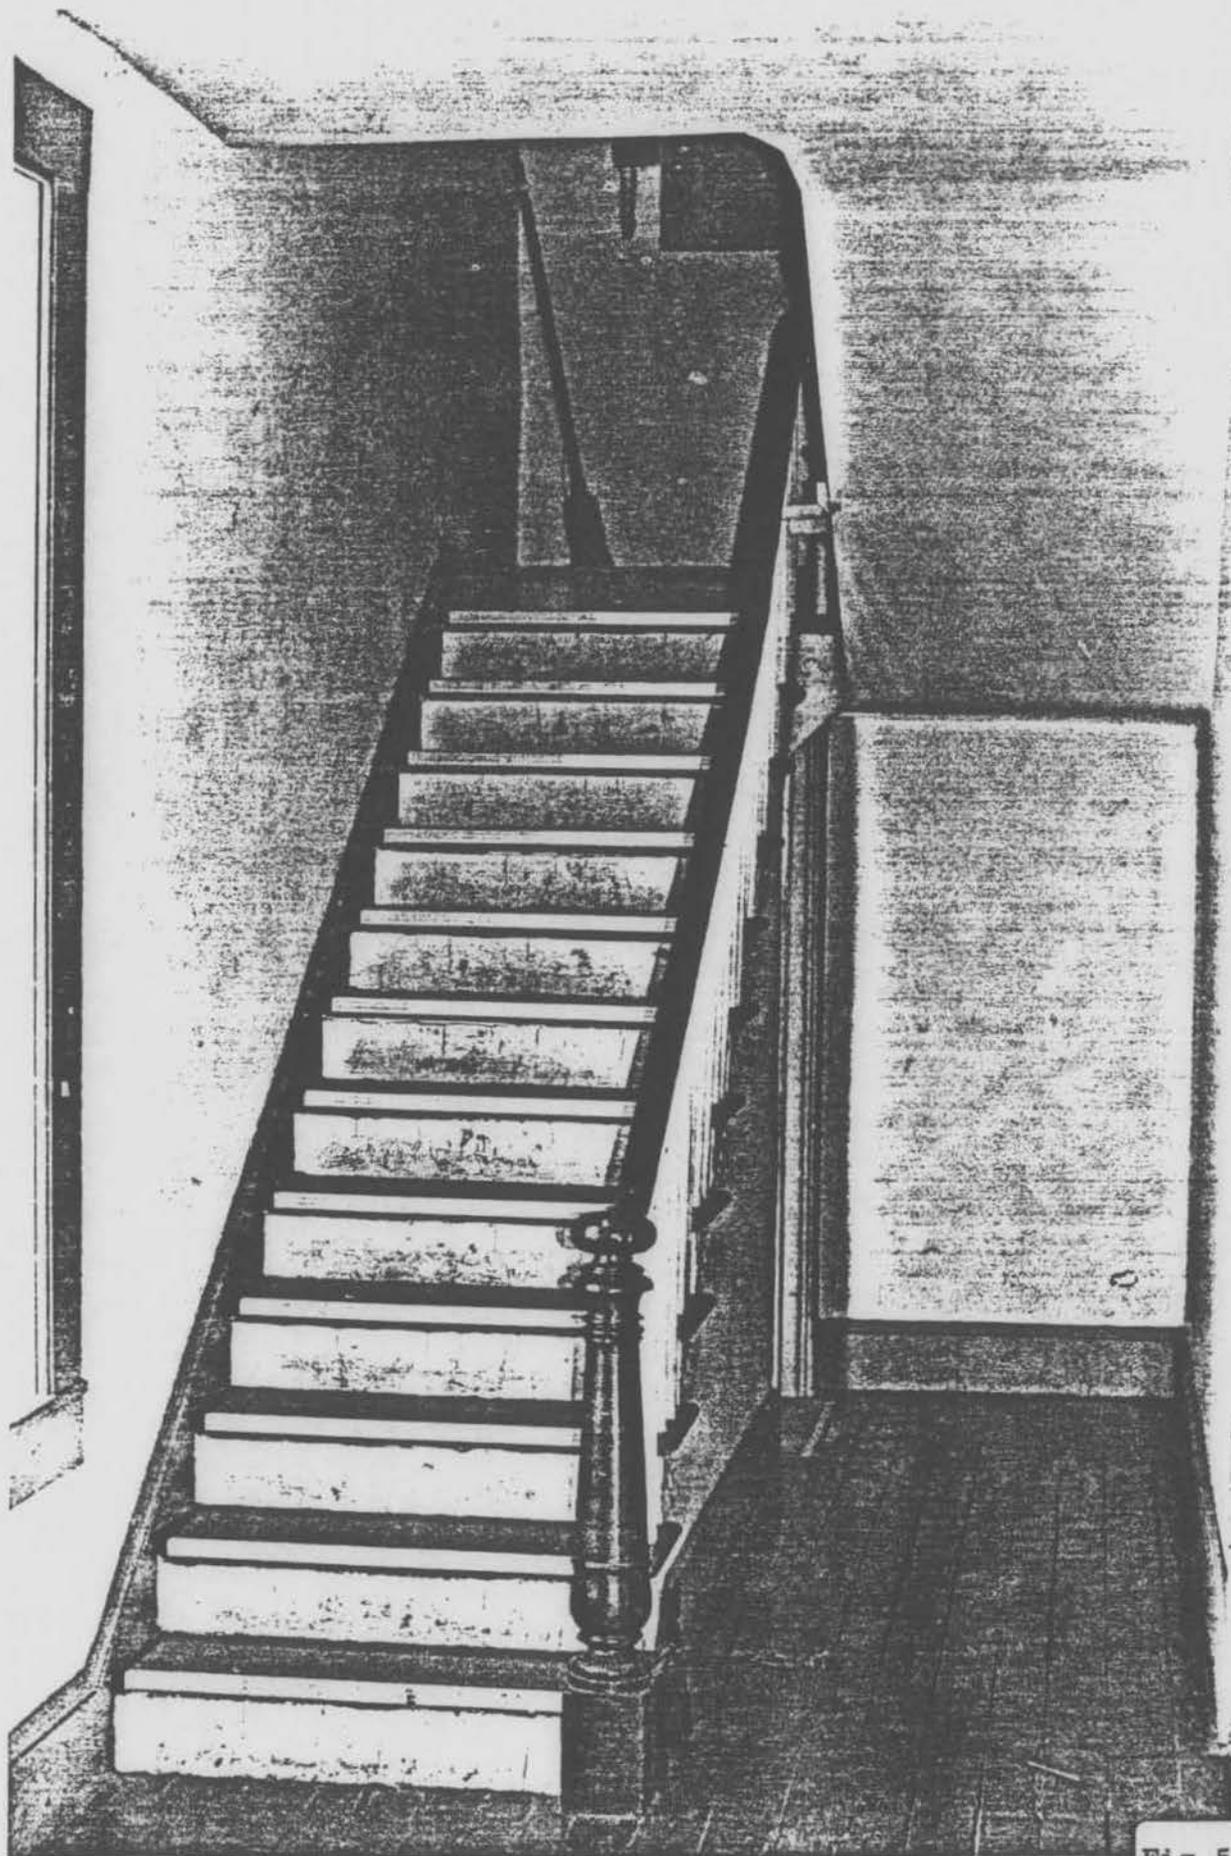
Fig. 5

The staircase (Figure 5) rises at the north end of each hall with intermediate landings; it is open to the third or attic storey. The round walnut rail is supported on a turned walnut bottom newel of moderately stout proportions and round tapered walnut balusters. A newel at the second storey level is a simple plain octagon. Stock jig-sawn scrolls ornament each step end and the landing and floor fasciae.

Ent.Hall & Staircase of South-
westerly house looking NW
April 1979
Photo by J. T. Wollon, Jr.
