## STAMP TAG MD0055

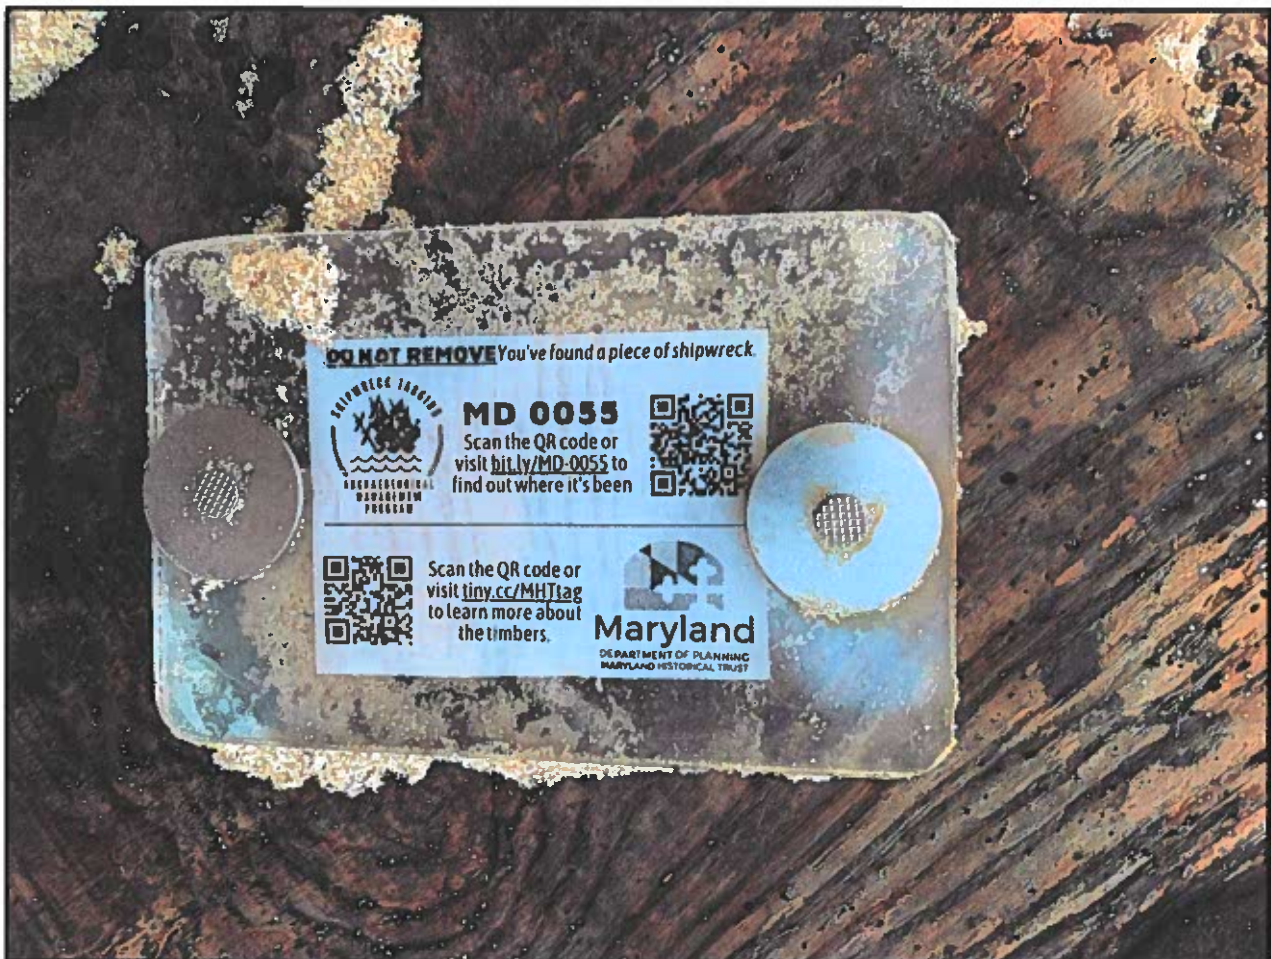
Not enough info to  
determine - timber  
(not plank)

14. **Comments:** *Teredo navalis (shipworm) damage*  
*is evident.*
