CARR-1379

John W. Davis Farm
Taneytown (vicinity)

Maryland Historical Trust State Historic Sites Inventory Form

historic John W. Davis Farm

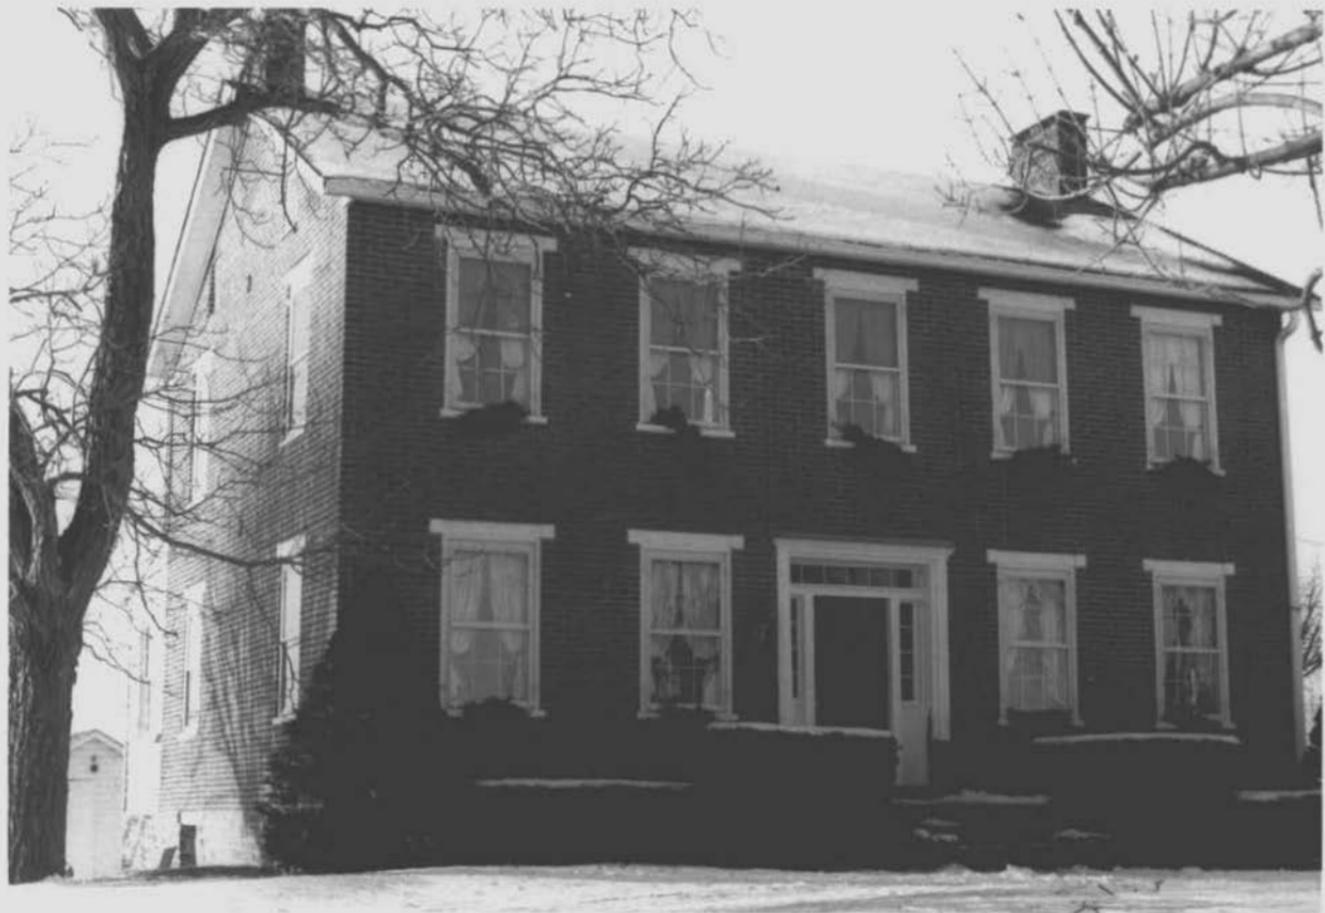
John W. Davis Farm
4780 Piney Creek Rd.
Carroll County, Maryland
Photo: Kenneth M. Short
Date: January 1994
Neg. Loc.: Maryland Historical Trust
House - SW & SE elevations
1/4

The house faces southeast, toward the road, and is a five-bay by two-bay, two-story structure. It has a rubble stone foundation, stretcher bond brick on the southeast elevation, and 6-1 common bond brick elsewhere. The brick has been sandblasted and the mortar joints were cut out with a saw and repointed. According to the owner, the house had been painted and striped before they did this work. The gable roof has asphalt shingles and a northeast-southwest ridge. There is a rebuilt interior brick chimney on each gable end. The southeast elevation has a 6/6 sash in the east bay of the foundation. The ground level appears to have been raised, as the window now sits in

The southwest elevation has two openings in the foundation with wood lintels and corner blocks. The south bay has a vent with wood louvers that are diamond in section and are now covered by a new window. The frame of the vent has a beaded interior edge. The west bay has a metal grate that slides back into the wall, and behind it a six-light sash that has been cut down to fit the opening. There are two 6/6 sash on both the first and second stories and two four-light sash in the gable end. The latter have beaded interior-edge frames, wood sills, and no lintels. There are two star anchors centered on the wall, one at the second floor level and one at the attic floor.

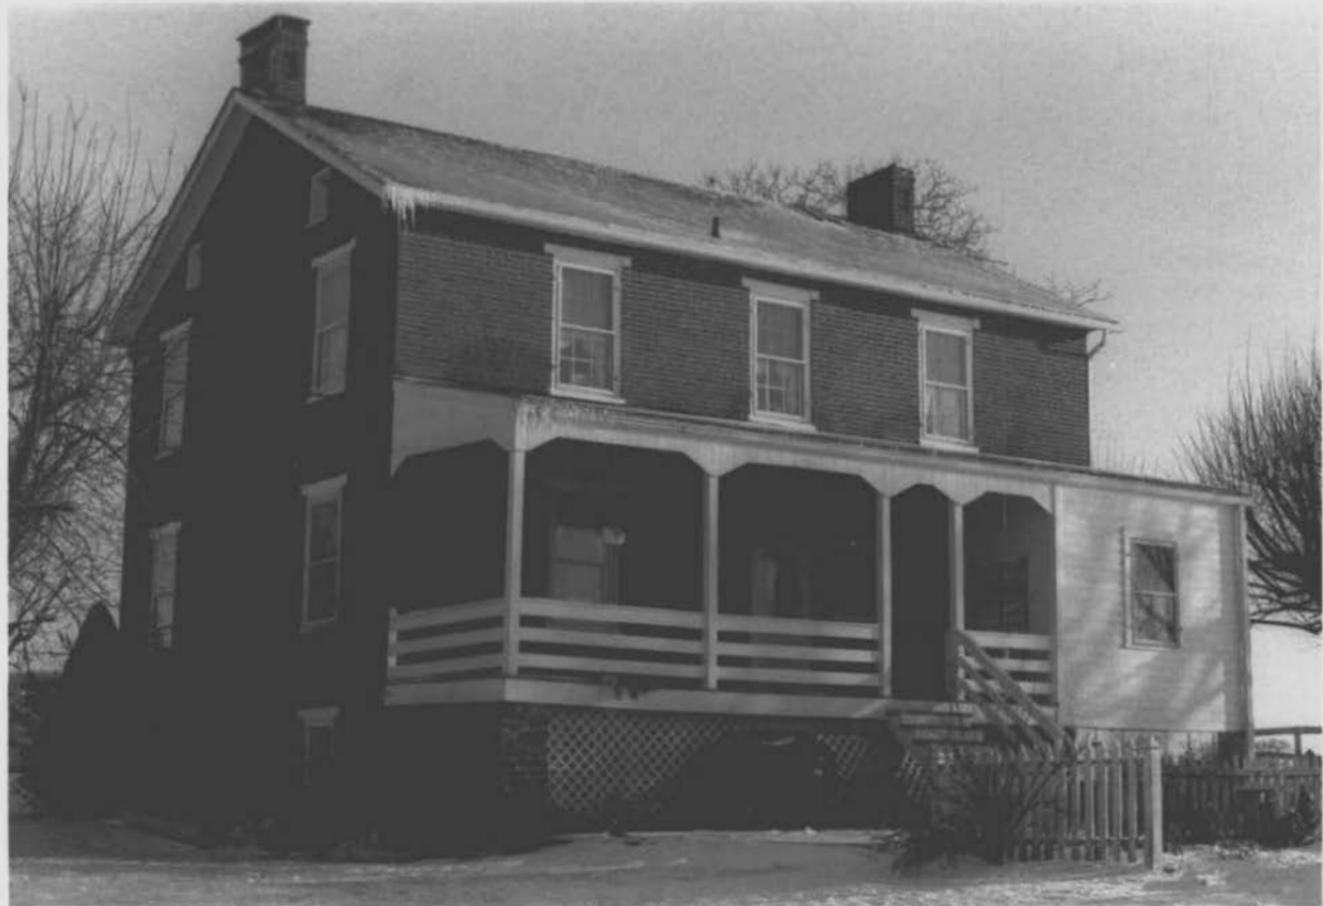
2/4

House - NE & NW elevations

The northeast elevation has two 6/6 in the foundation, first, and second stories, and two four-light sash in the gable end like those on the southwest. There are also two star anchors centered on the ridge, at the second story and attic floor levels.
