CARR-1404

4101 Alesia to Lineboro Road
Alesia (vicinity)

Maryland Historical Trust State Historic Sites Inventory Form

historic Miller-Hoffacker Farm

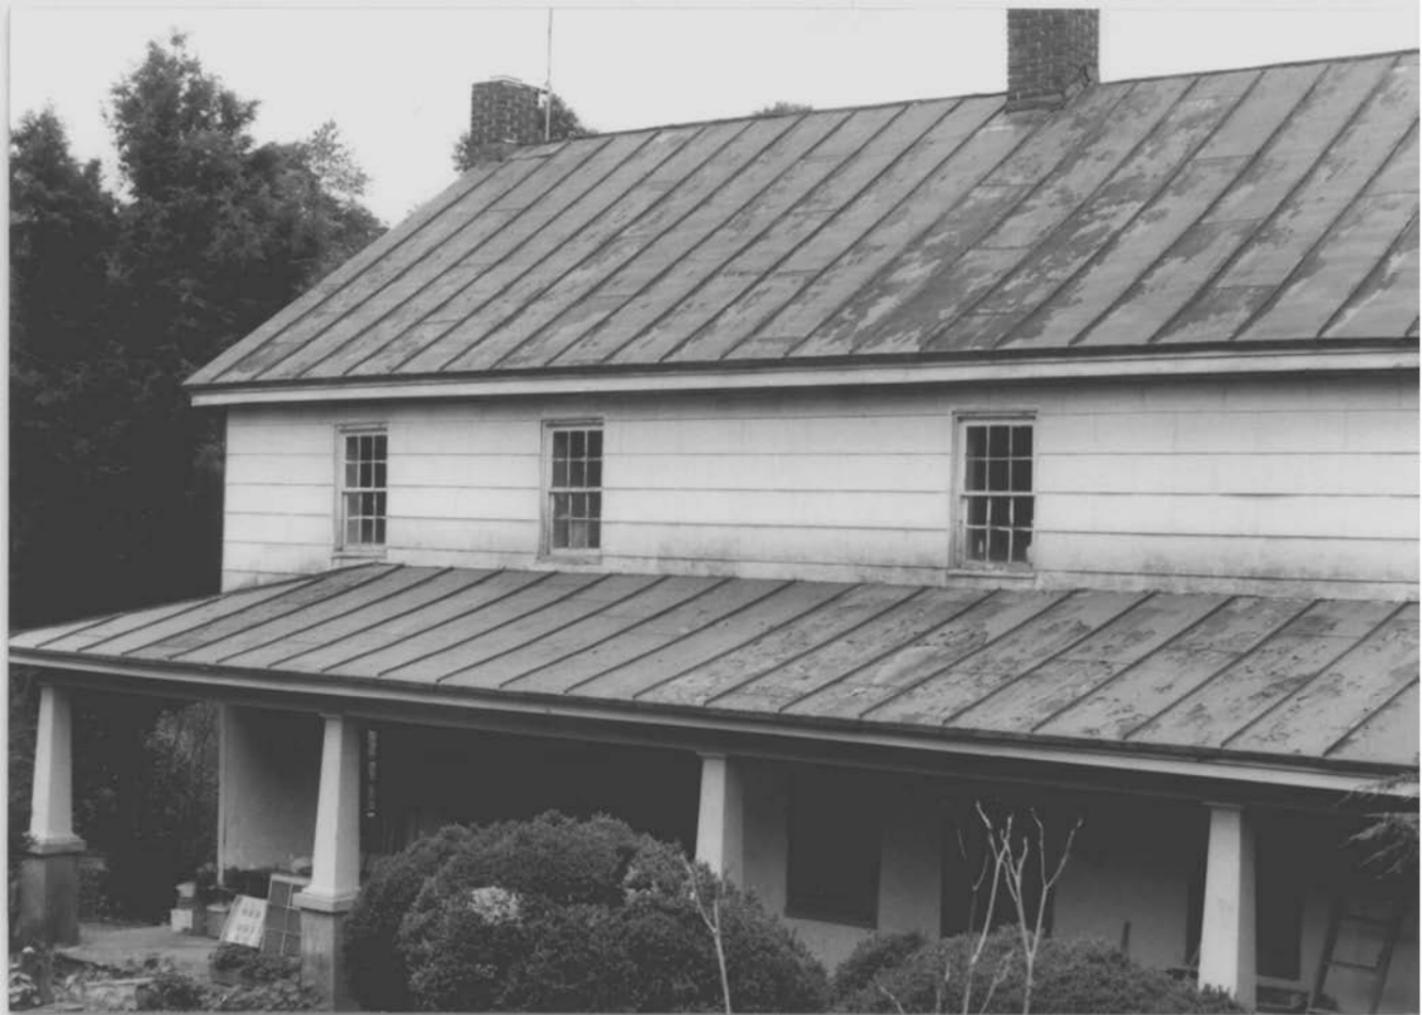
House - southwest elevation

The house currently faces southwest toward the road and is a two-story, five-bay by two-bay structure with a rubble stone foundation and a gable roof of standing-seam metal with a northwest-to-southeast running ridge. The house is banked on the southwest with an exposed foundation wall on the northeast elevation. There is an exterior brick chimney centered on the northwest and an interior brick chimney between the west-center and center bays. The house is built in two sections, but apparently was built all at one time, as there was no obvious break in the foundations. The southeast half has V-notch cornered logs with stone chinking laid in mortar. The northwest half has logs with a vertical post at the south corner. The logs appear to be whitewashed, but only a small portion is exposed to view. The first story of the southwest elevation has horizontal, hand-split lath attached with cut

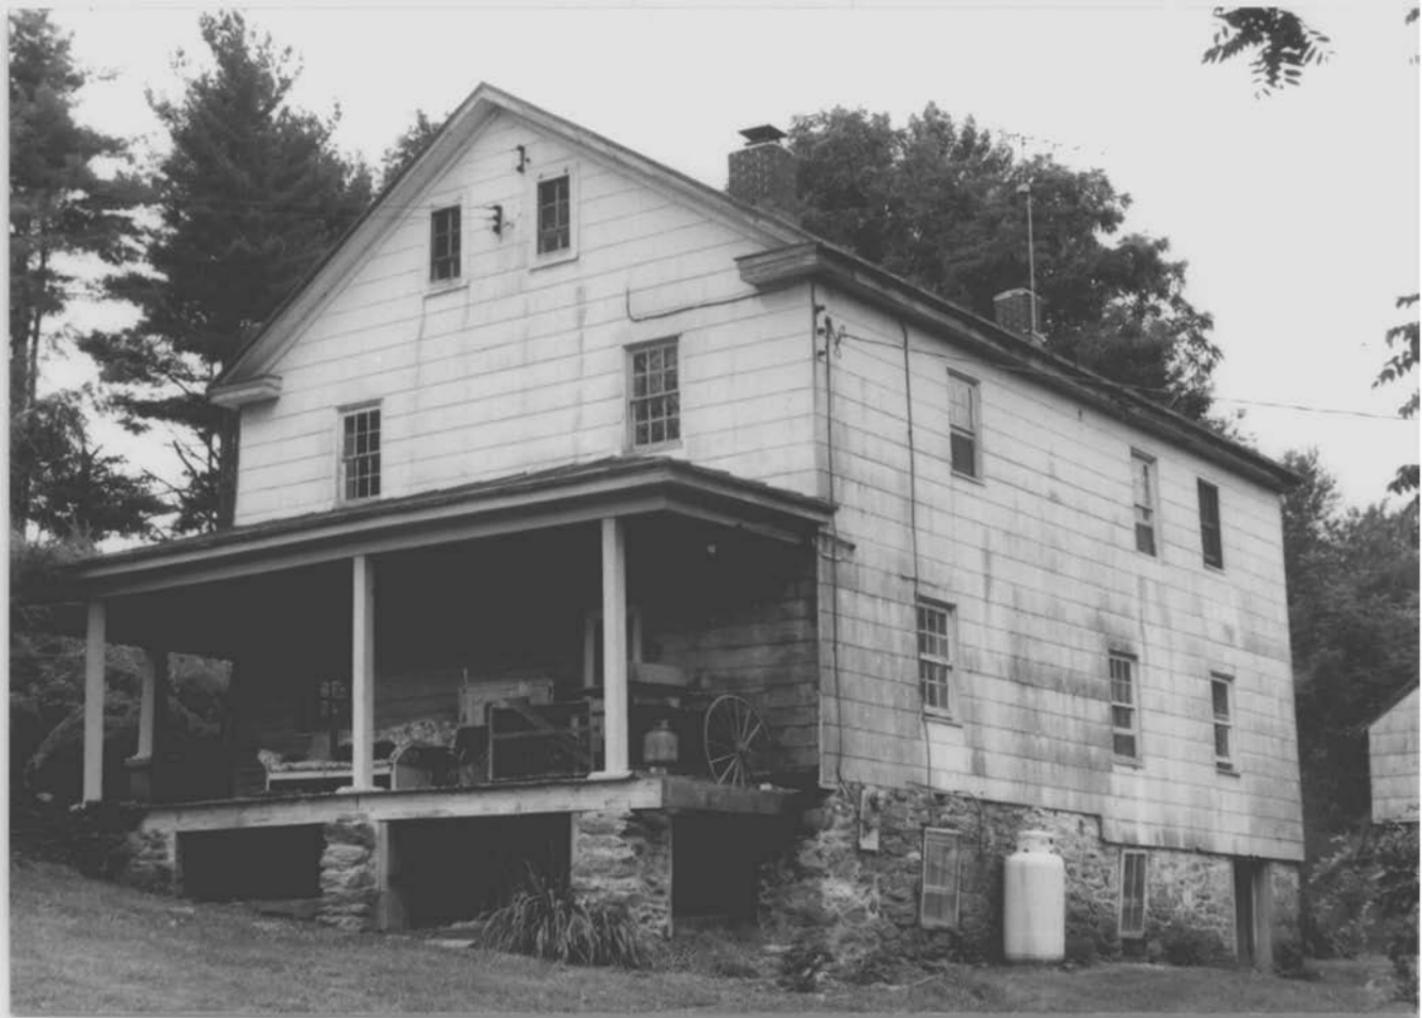
House - southeast and northeast
elevations

On the northeast elevation the foundation retains traces of whitewash. In the east bay of the foundation there is a 6/3 sash with a wood sill and a plain surround. The north-center bay has an identical window. In the north bay is a new vertical-board door constructed with wire nails. The north corner of the foundation has quoins. The first story has, from east to north, a typical 6/6 sash, no opening, no opening in the center bay, a typical 6/6 sash, and a typical 1/1 sash in the north bay. The second story has a typical 6/6 sash set north of the east bay, no openings in the east-center or center bays, a typical 6/6 sash set north of the north-center bay, and a typical 6/6 sash in the north bay. There is a wood box cornice.

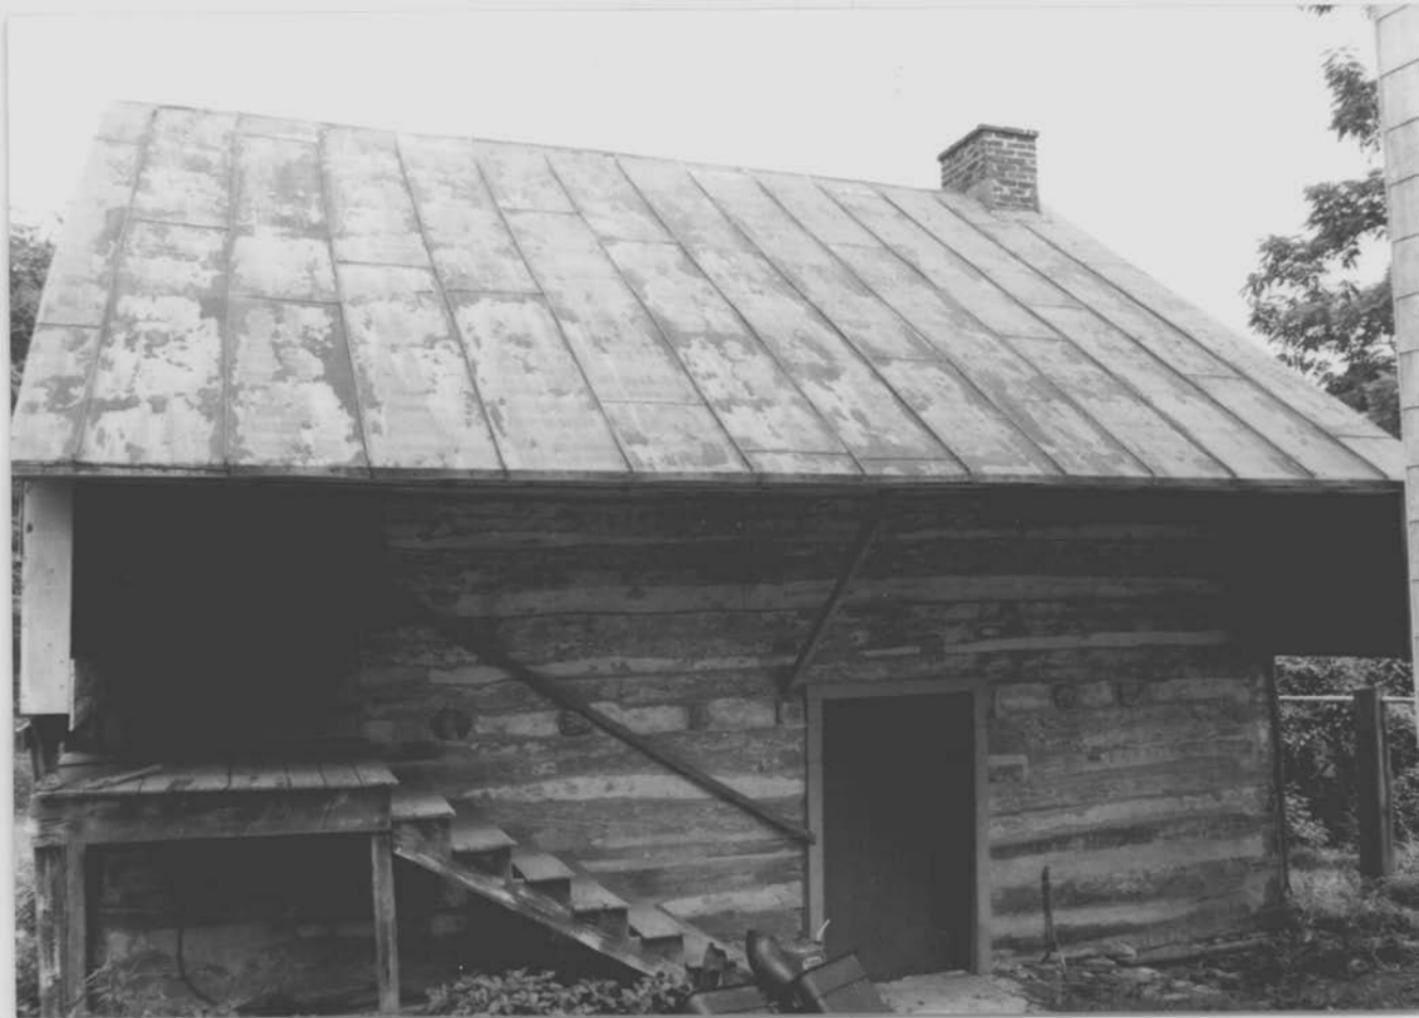
Summer kitchen - southwest elevation

The summer house is located about 10 feet north-northeast of the house. It is a two-story, two-bay by one-bay hewn log structure with V-notch cornering, a rubble stone foundation and a gable roof of standing-seam metal with a northwest to southeast running ridge. It has an interior brick chimney on the southeast. On the southwest elevation the logs are exposed and have been re-chinked and whitewashed. The first-story south bay has a beaded-edge vertical-board door that has been added onto on the top. The original opening was very short. The architrave has a beaded interior edge. The door is hung on interior strap hinges that are tapered and have round ends. To the west are circular-sawn exterior

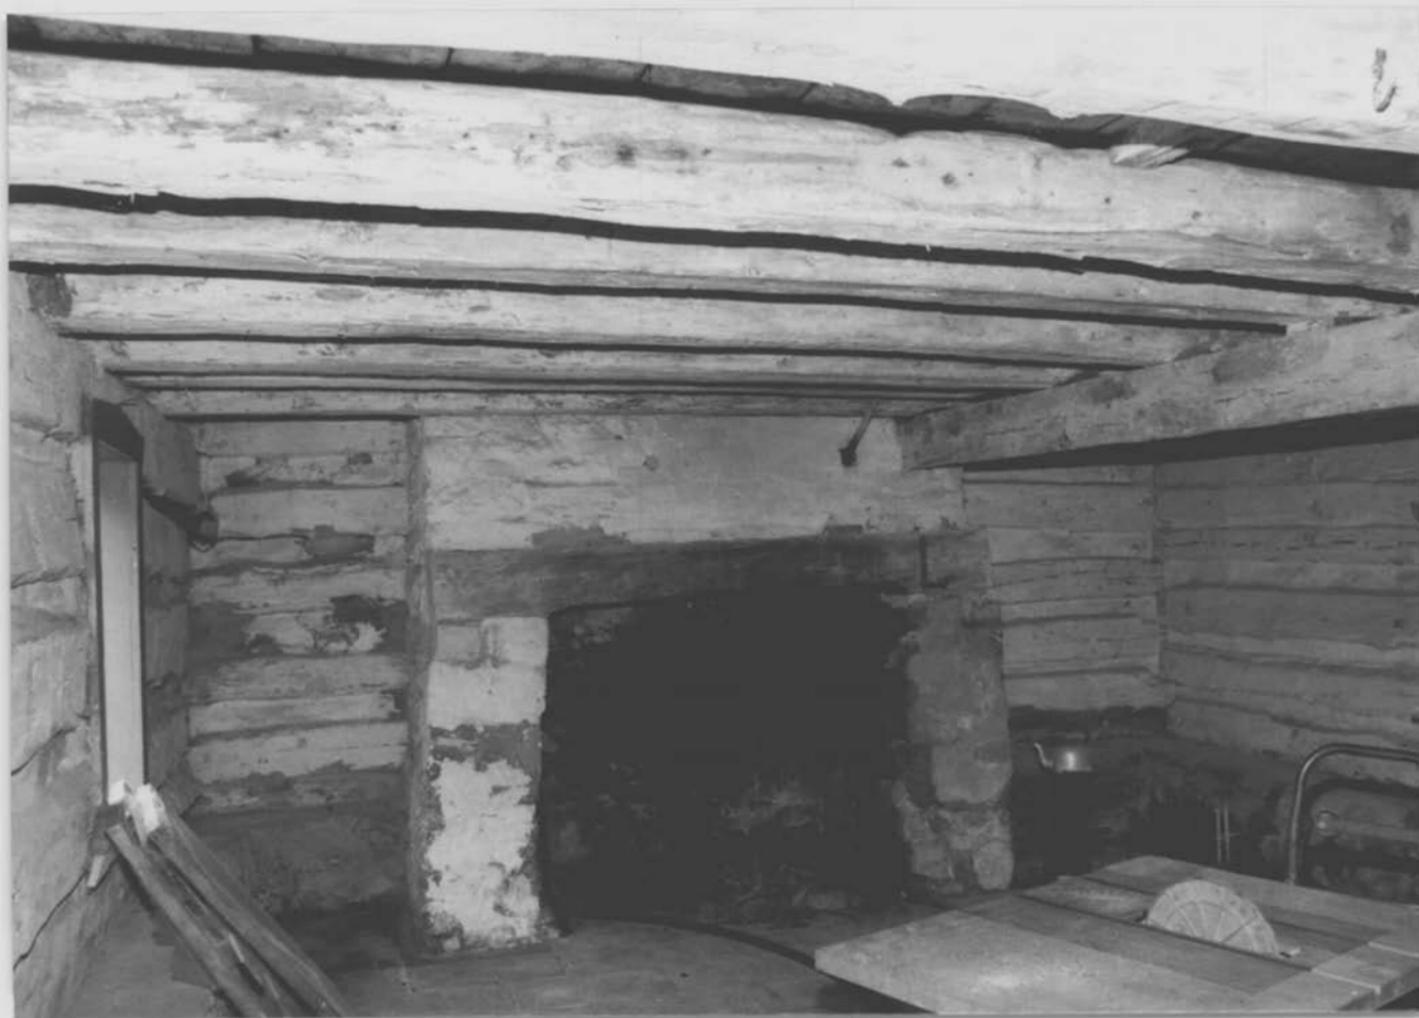
Summer kitchen interior - 1st story
view southeast

There are two steps down to the first story, which is one room with a concrete floor covered with roofing slates. The rubble stone foundation wall is exposed in the room. There is a large stone fireplace centered on the southeast end. It has straight jambs and a hewn wood mantle tree. On the outer ends of the southwest and northeast sides of the fireplace are hewn horizontal beams set in the stone work, and the mantle tree rests on these beams. Above the mantle tree the fireplace is stone on the outer sides with brick in the middle. There is a hole on the southwest side of the front of the fireplace with an iron bar set in it that is not attached to anything. It is not clear if this bar is original or later. The openings have plain surrounds with pediments above them. This trim work is wire-nailed. There is a summer beam that runs northwest to southeast. It is hewn on all four sides and is 8½ to 9 inches square. The joists run northeast to southwest. Most of them are hewn on top and bottom. They rest on top of one of the outer log walls and the log above the joist ends is notched on the bottom of the interior of the building only. These joists are 7 to 10 inches wide by 6 to 7 inches deep and are spaced 22½ to 29½ inches on centers. One log that was used in the wall to fill a wide gap between other logs is not structural and has notches in it that make it appear to be re-used plate. Another log similarly used has an end with a notch in it, either to hold a rafter foot or a tilted false plate. The logs are whitewashed on the interior. There is a concrete trough in the northeast end of the room. The flooring above is random-width, mill-sawn, tongue-and-groove boards.
