Johannes Hann Farm (Crookabout)
1200 Trevanion Road

CARR 70	Crookabout	First Floor Plan	April 1993		
	1200 Trevanion Rd.		Kenneth M. Short

Maryland Historical Trust State Historic Sites Inventory Form

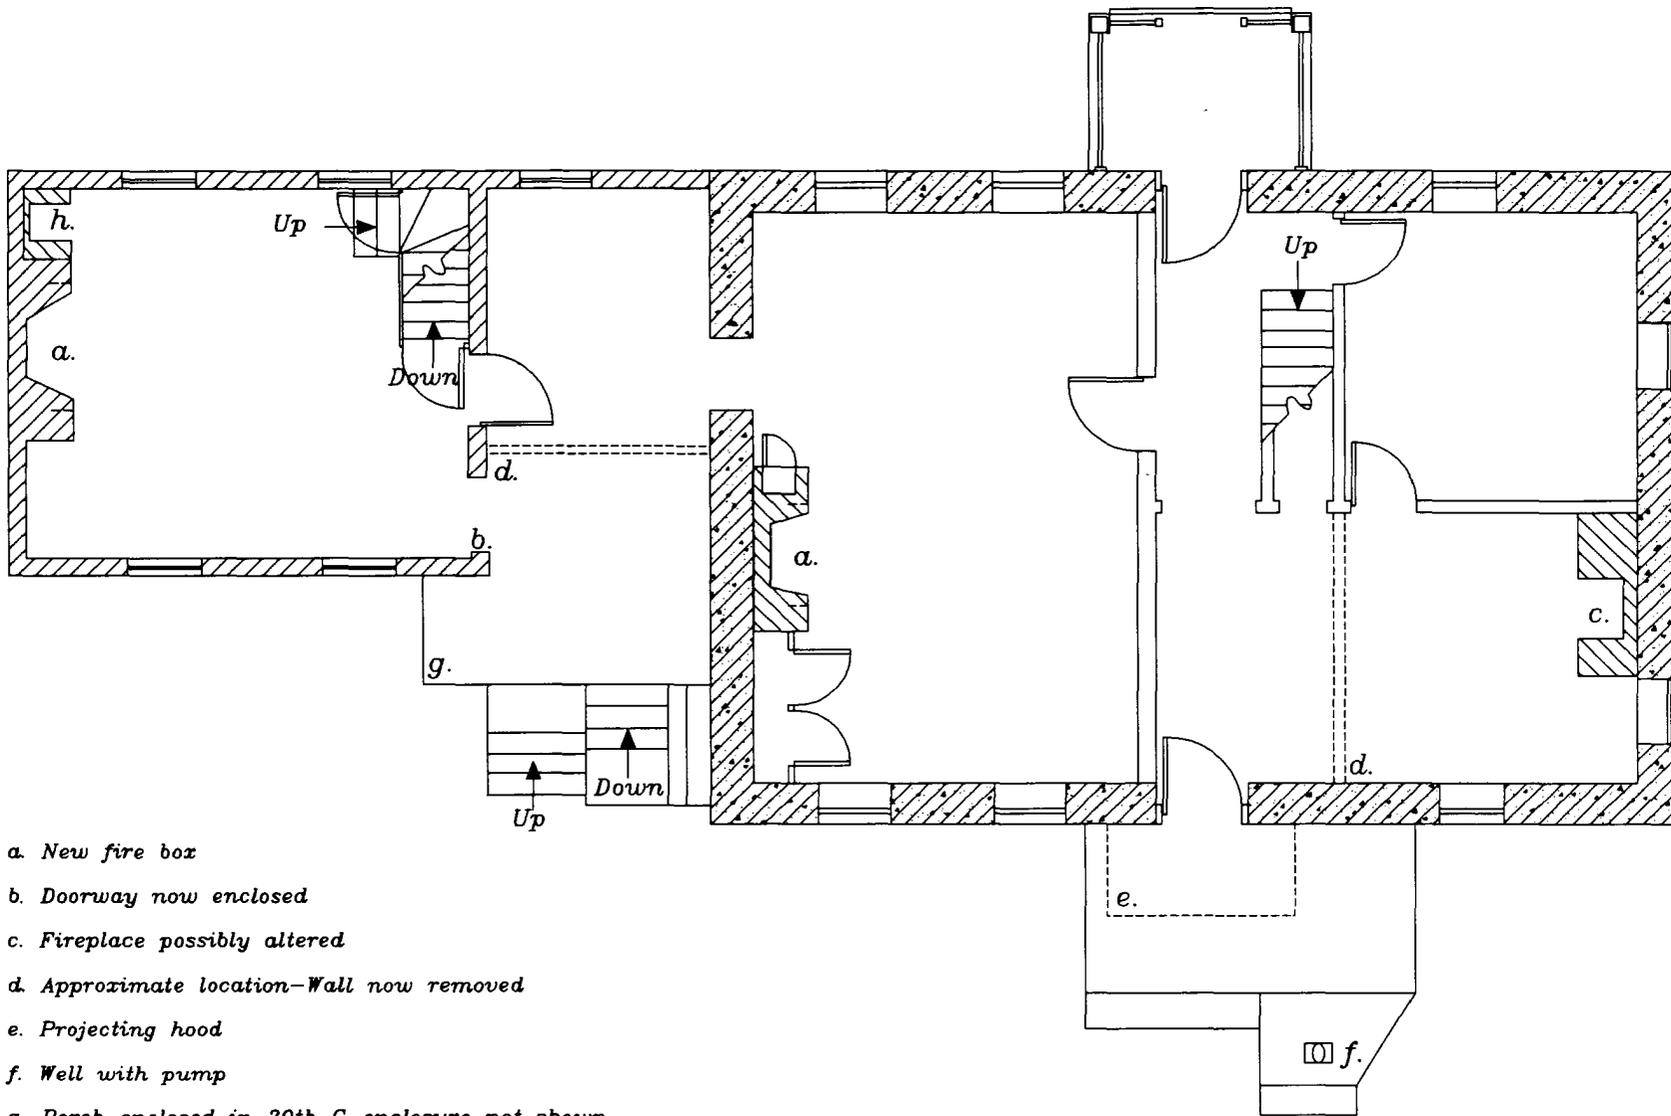
- a. New fire box
- b. Doorway now enclosed
- c. Fireplace possibly altered
- d. Approximate location—Wall now removed
- e. Projecting hood
- f. Well with pump
- g. Porch enclosed in 20th C—enclosure not shown
- h. Masonry enclosure possibly for Rumford oven - now altered

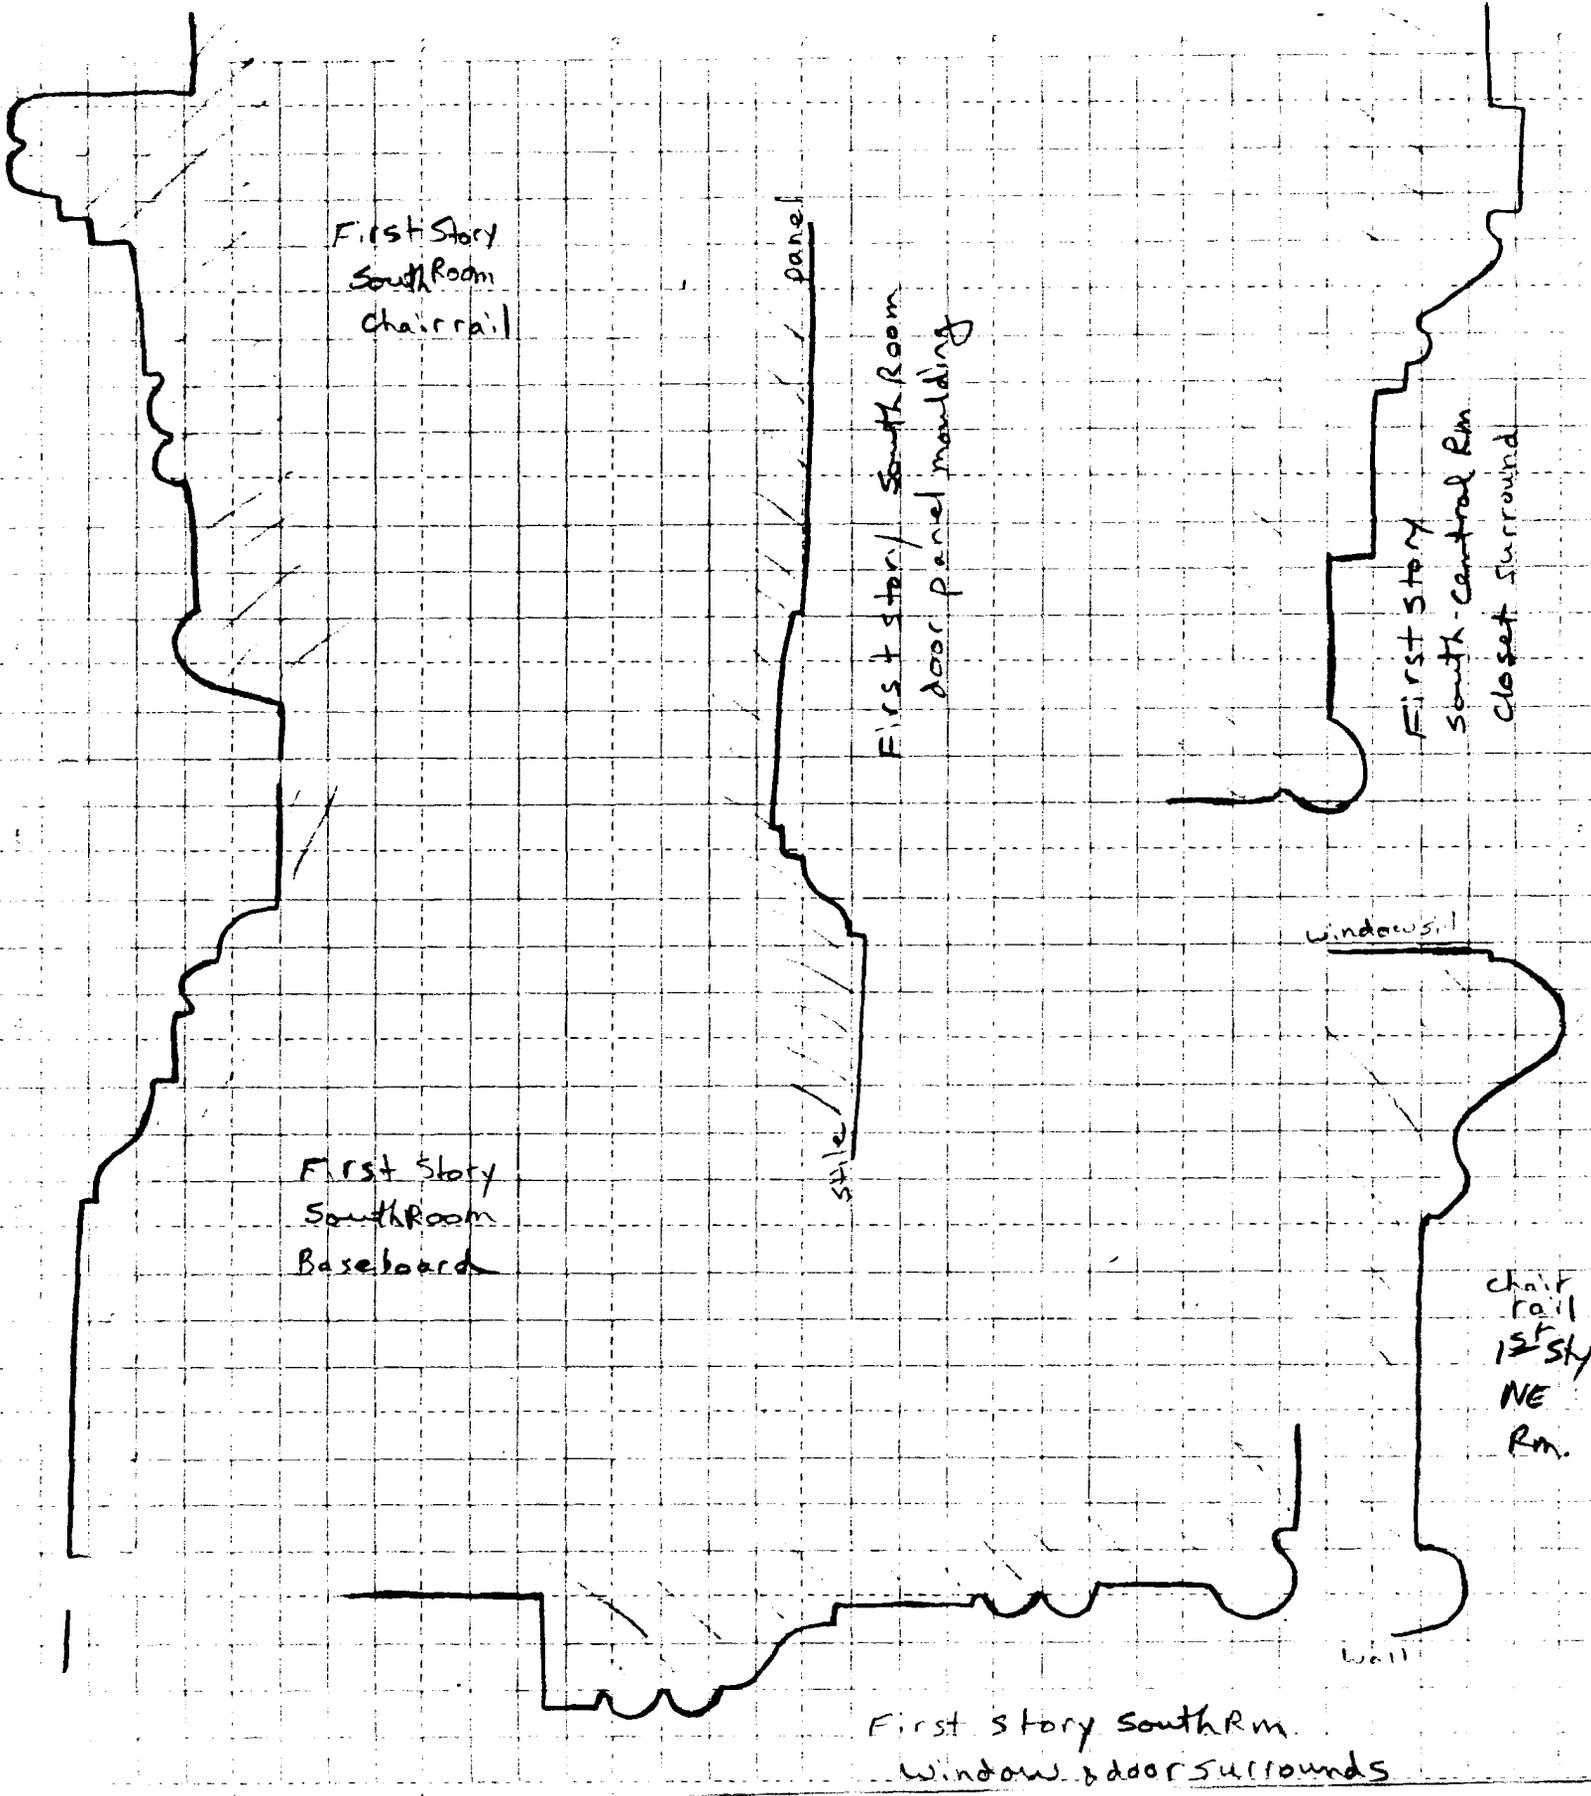
1200 Trevanion Rd.
Moulding Profiles

First Story
South Room
Chairrail

First story South Room
door panel moulding

First story
South-Central Rm
Closet Surround

First Story
South Room
Baseboard

window sill

chair
rail
1st story
NE
Rm.

First story South Rm.
window & door surrounds

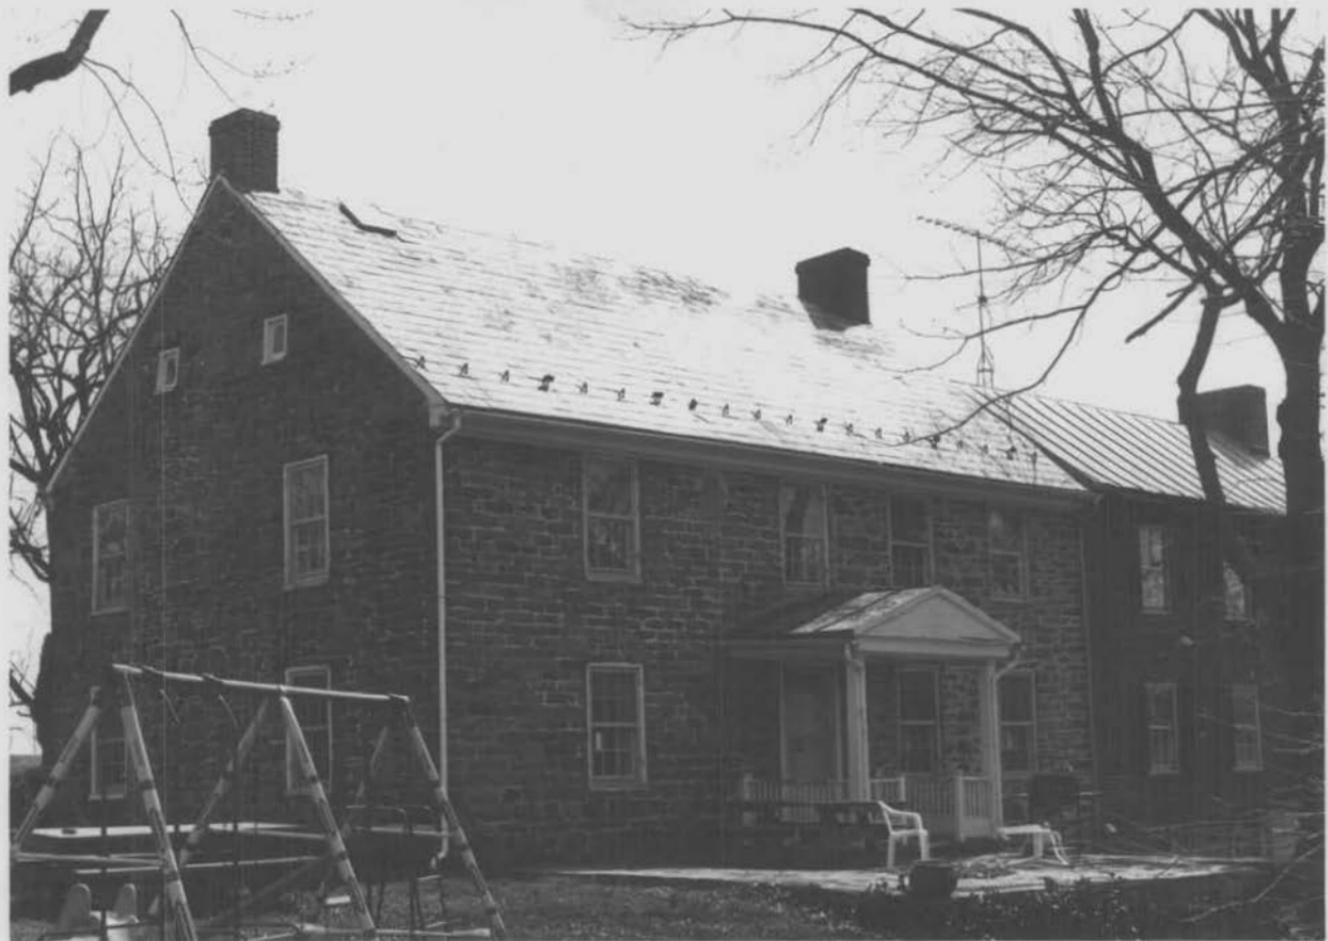
1/12

house - north : west elevations

The central two bays of the west elevation are rubble fieldstone that has been repointed in the past year. The first and second stories have two 6/6 sash in bullnose moulded frames, with wood sills. The cornice and roof match those to the north and are continuous, and there is an interior brick chimney on the south end of this section, centered on the ridge. The cellar is partly exposed, as the ground slopes away to the south here, and there is a single four-light sash in the center of the foundation. The southern three bays have an exposed rubble stone foundation with rough quoining. There is a four-light sash in the north bay, and a new 6/6 sash in a bullnose frame in the center bay. Both have splayed brick jack arches. The south bay has a clapboard addition with an asphalt shingle shed roof and a concrete foundation. This covers a six-panel door with sunk panels, ogee panel moulds, and a panelled soffit and jambs. The wall above is of Flemish bond brick. The first and second stories each have three 6/6 sash in bullnose frames, with wood sills, splayed brick jack arches, and exterior wood blinds. The cornice has four courses of corbelled brick and the gable roof is standing-seam, with a north-south ridge. It has a slightly lower pitch than the roof on the stone sections. There is an interior brick chimney on the south end that has been rebuilt within the past year.

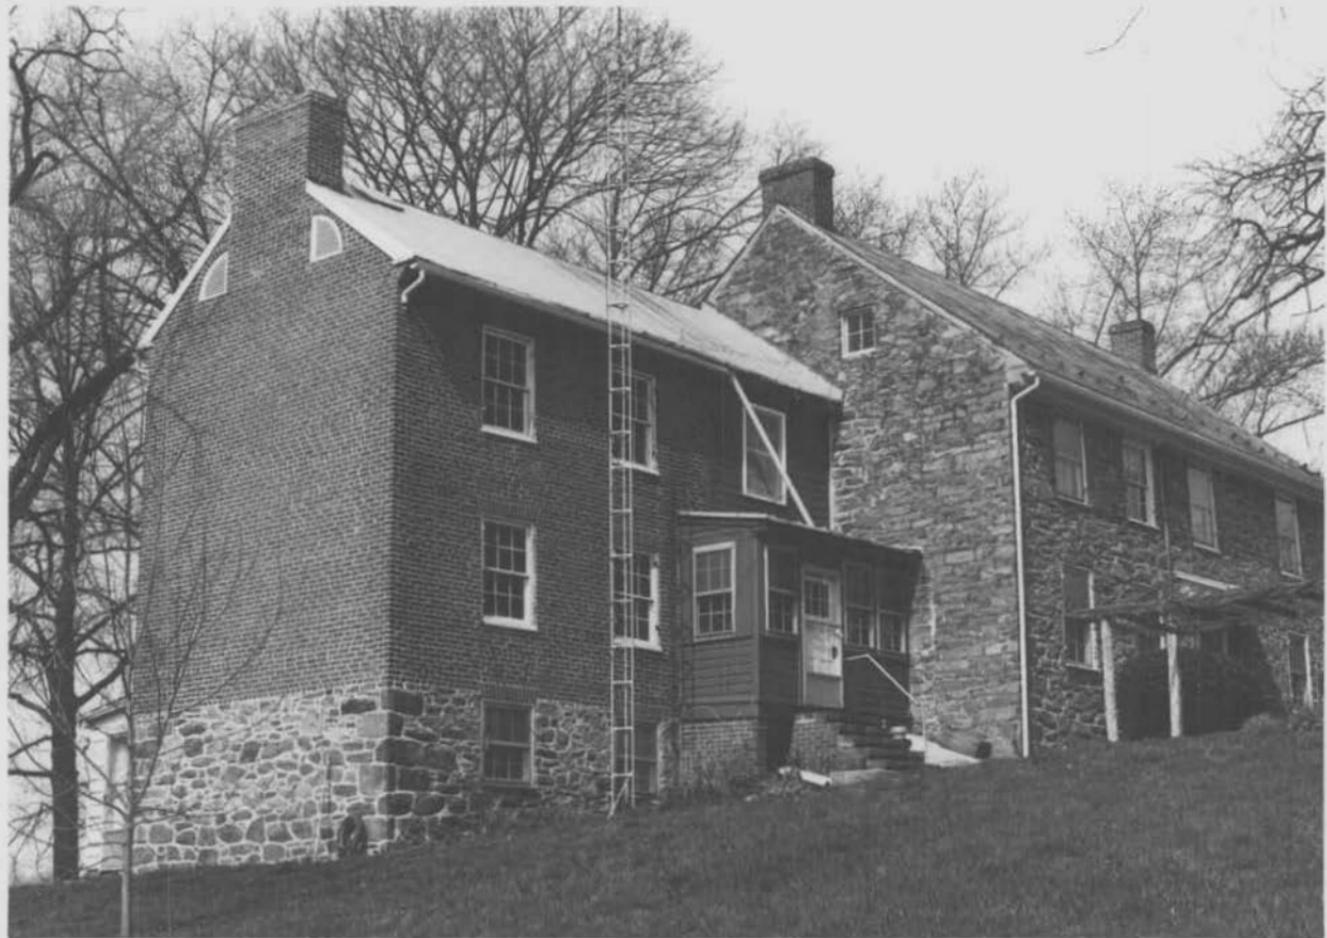
2/1

house - south & east elevations

The south elevation has a rubble stone foundation, 5-1 common bond brick walls, and two new quarter-round louvered metal vents in the gable end. There are no other openings. The eaves have tapered rake boards. The east elevation has a 6/6 sash in the south and center bays of the stone foundation that match those on the west, and the first and second stories of these bays also have 6/6 sash that match the west. The north bay has a projecting one-story enclosed porch that rests on a stone foundation wall on the north side and a brick wall on the south side. There is a chamfered corner post on the

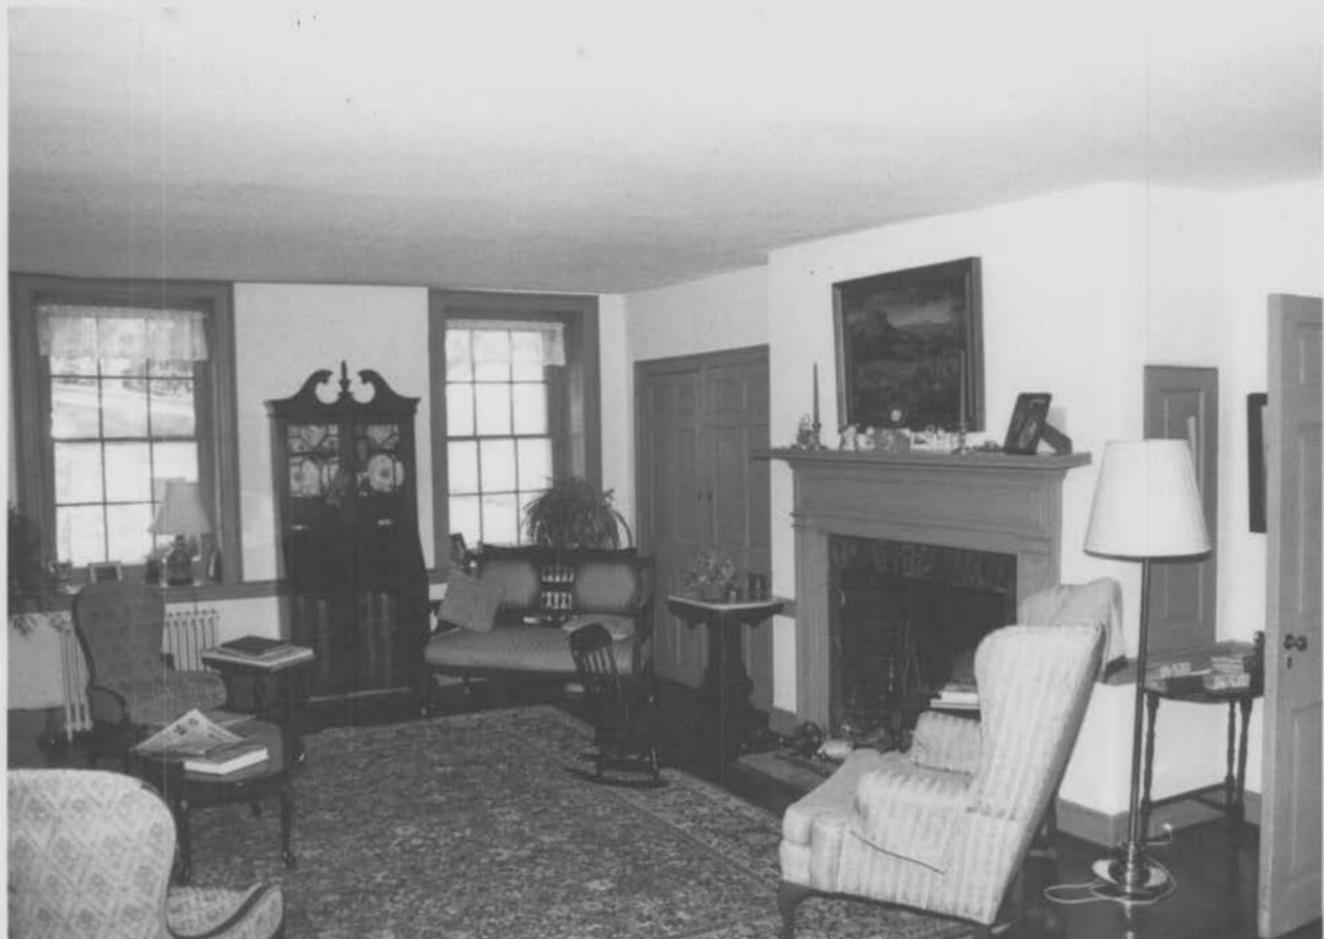
4/12

interior - 1st story, center room - southeast:
Southwest
elevations

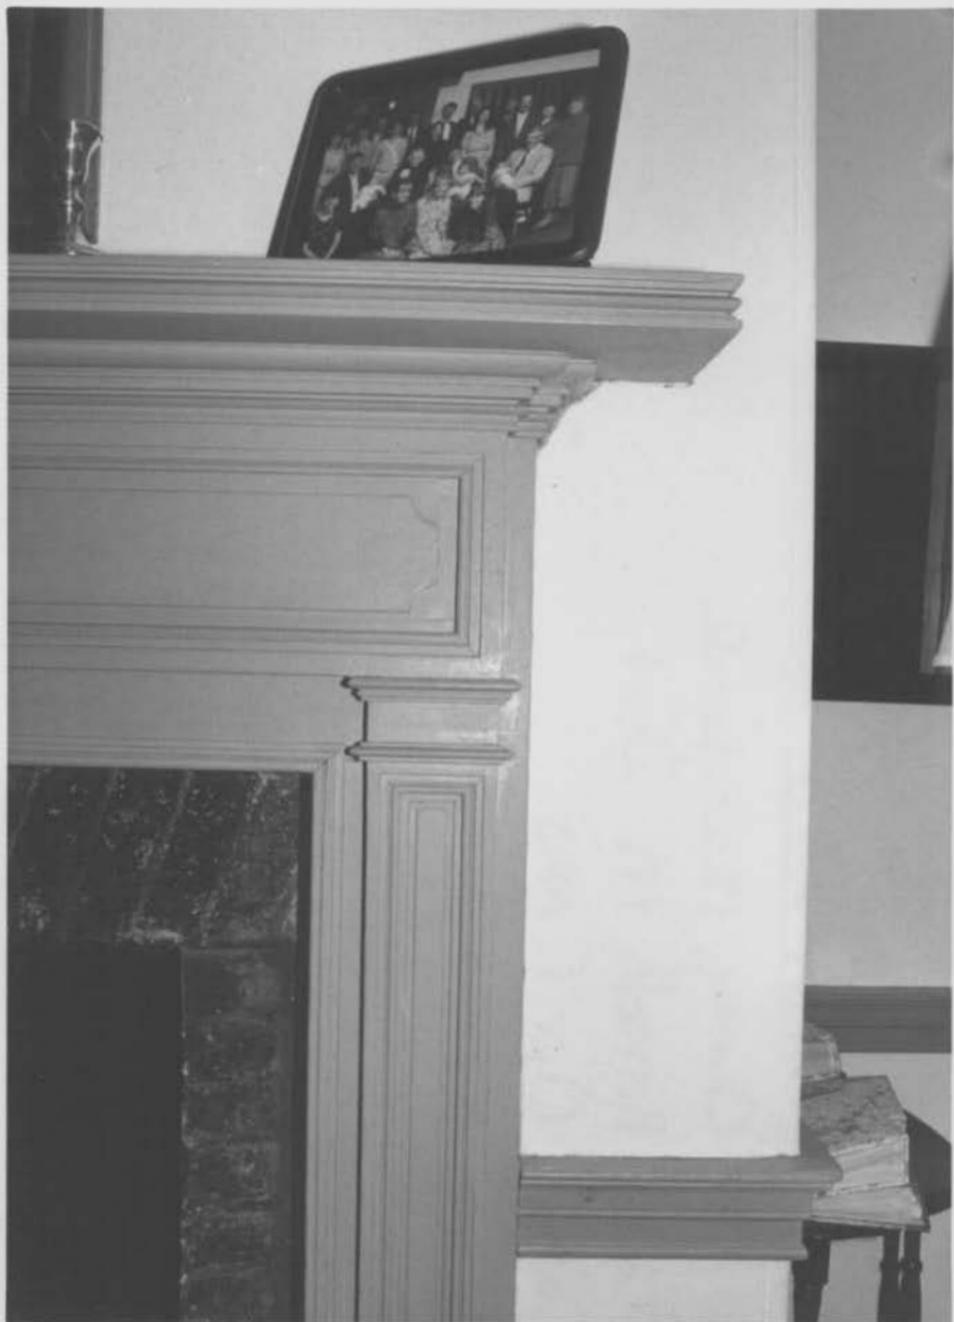
5/12

interior - 1st story, center room, southwest
mantel detail

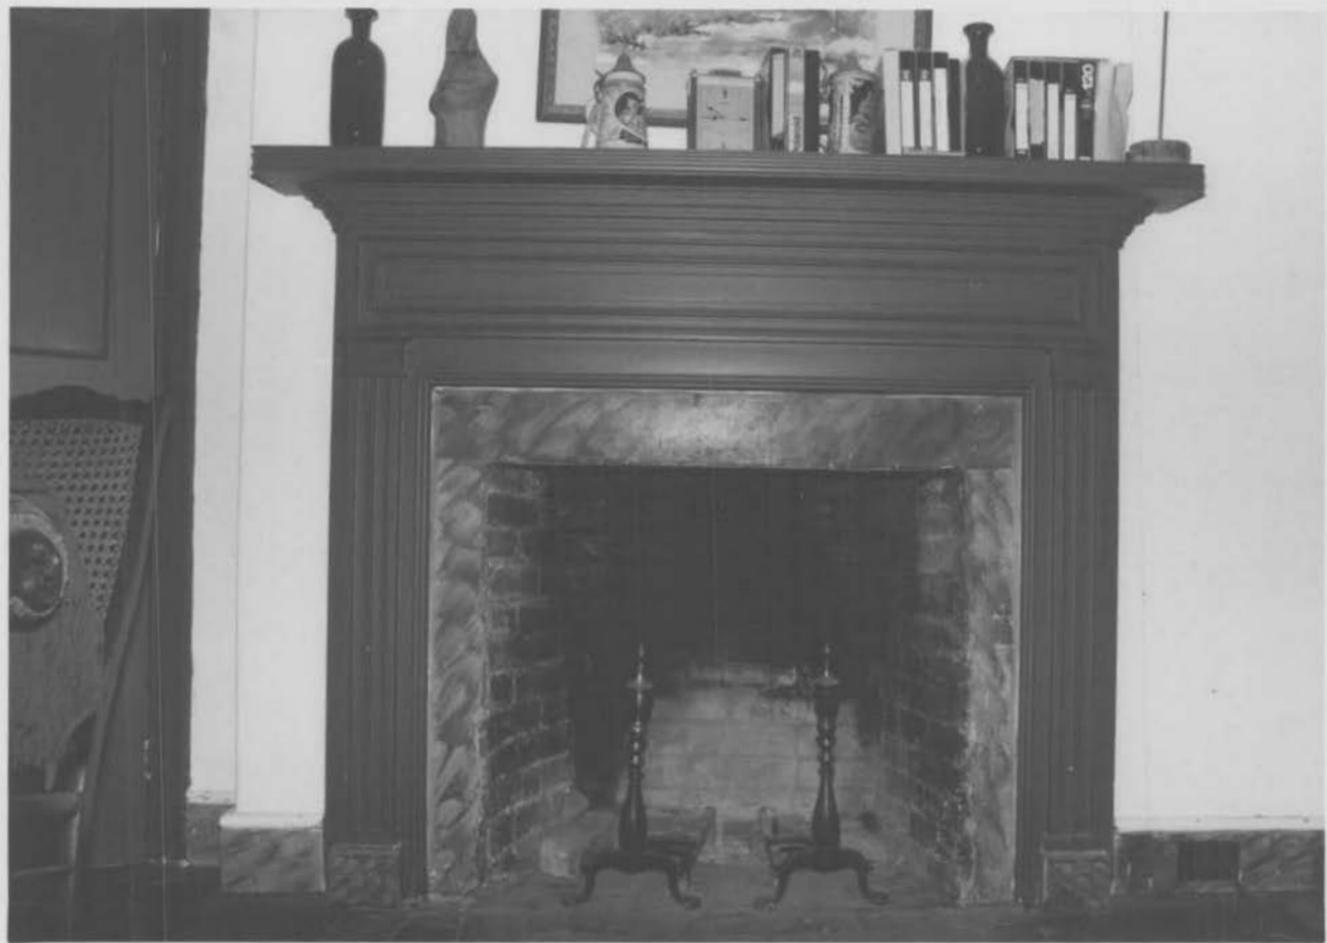
6/2

interior - 2nd story, center room mantel

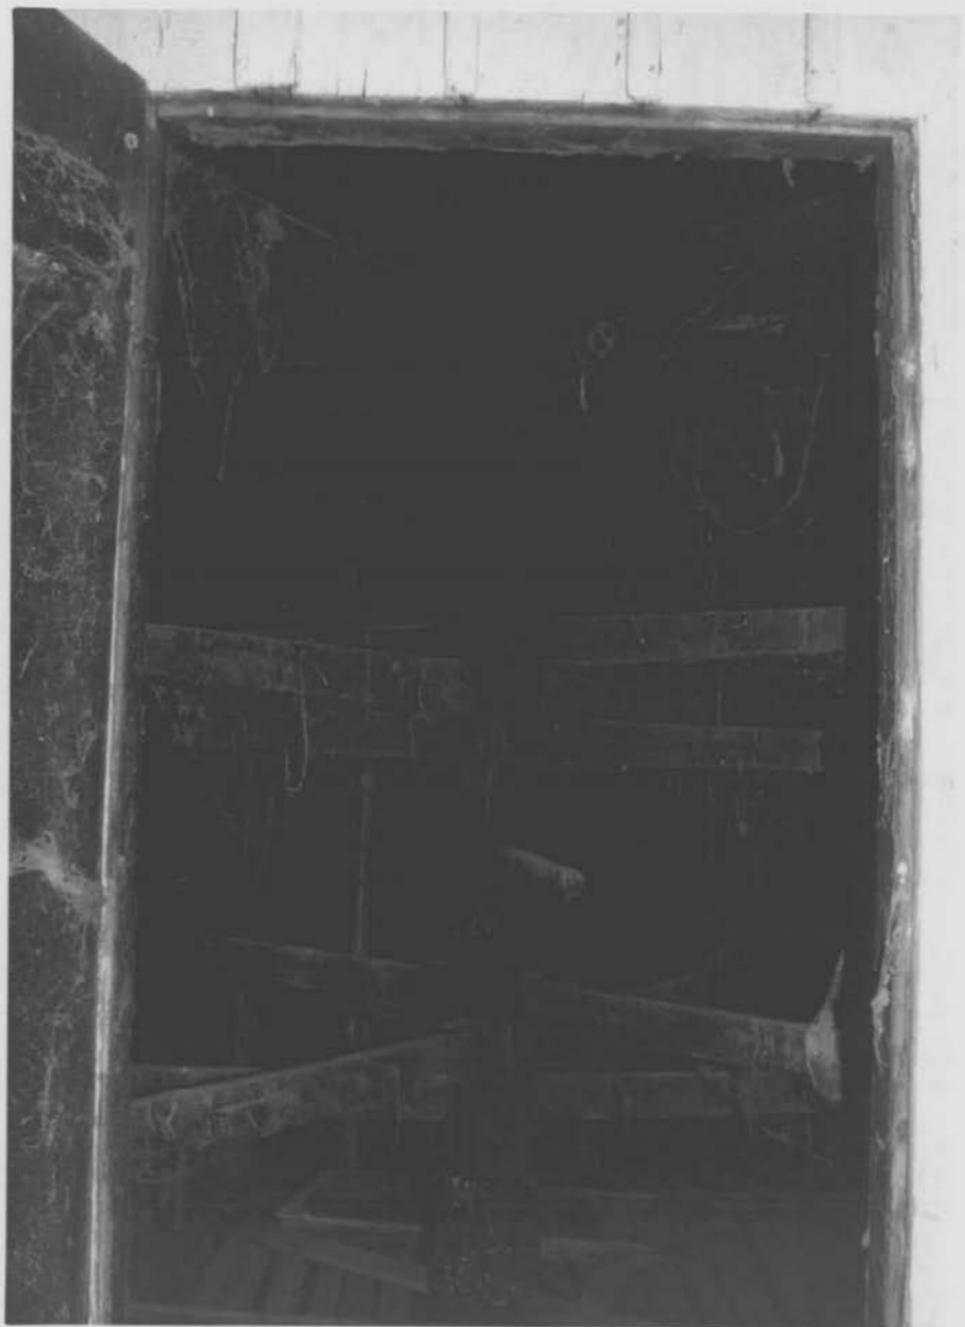
3/12

Smokehouse - interior

South of the summer kitchen is a smokehouse with a rubble stone foundation, board-and-batten siding, and a gable roof with an east-west ridge and corrugated metal. The north elevation has a vertical board door on strap hinges. The structure appears to be made of sawed logs, and has a large summer beam that runs east-west and holds an octagonal tree that pivots. The tree has horizontal boards approximately 1x4 inches that pass through mortises in the tree. There are three boards at the bottom, creating six arms, and the boards are set one above the other. There are three more boards in the center of the tree, and another tier of three boards at the top. Each arm has three metal pegs for hanging meat. There is a second summer beam, at the top, that runs east-west

and holds the top of the tree in place. There are sawn rafters, mitered at the ridge, with lath and wood shingles under the current metal covering. The floor of the building is wood boards. The south elevation of the foundation has a short, beaded-edge vertical board door. The foundation is completely open, instead of having a small firebox.

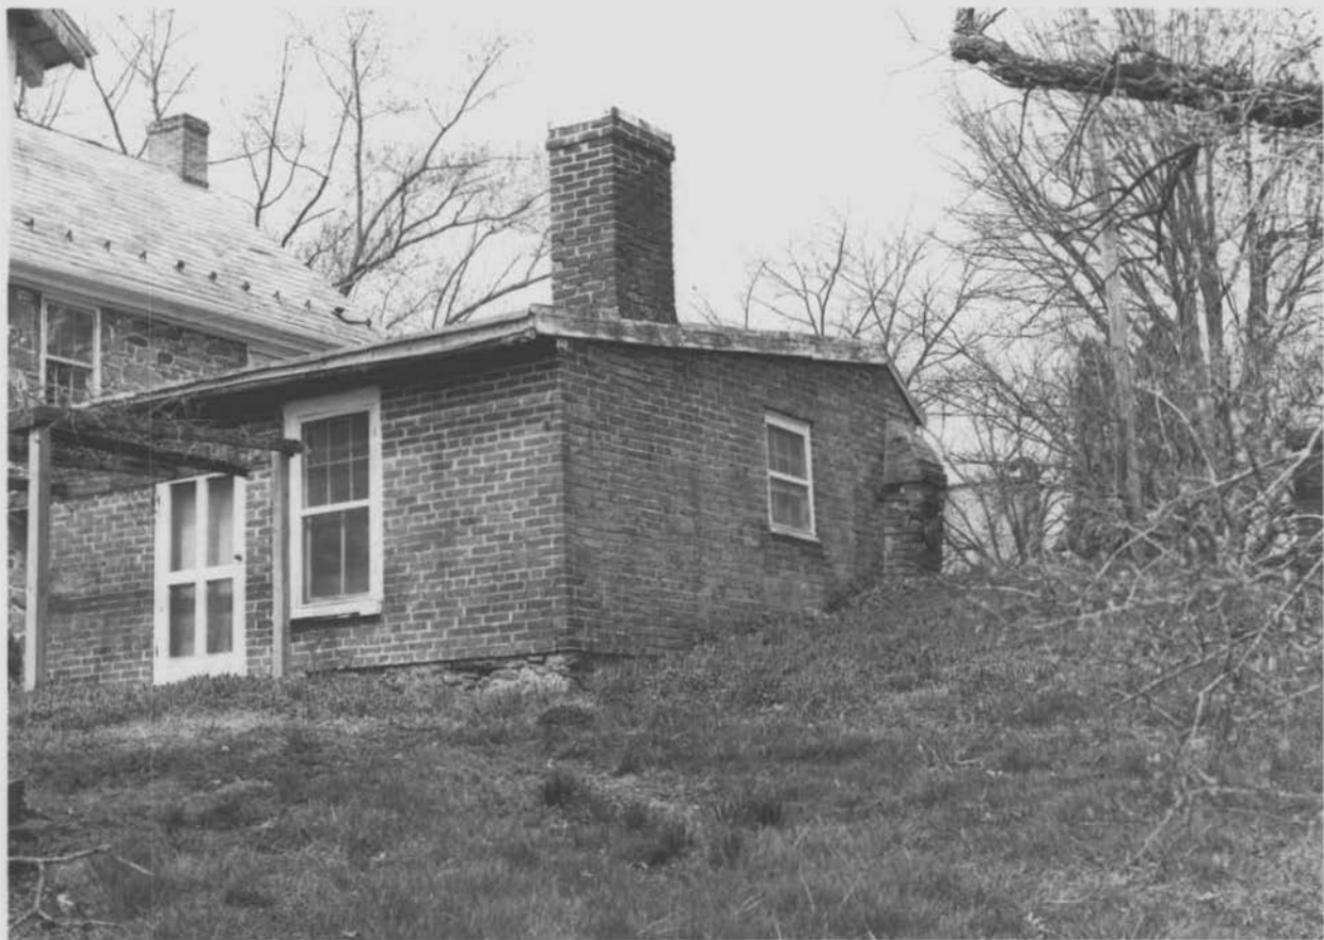
7/2

Summer Kitchen: ground cellar

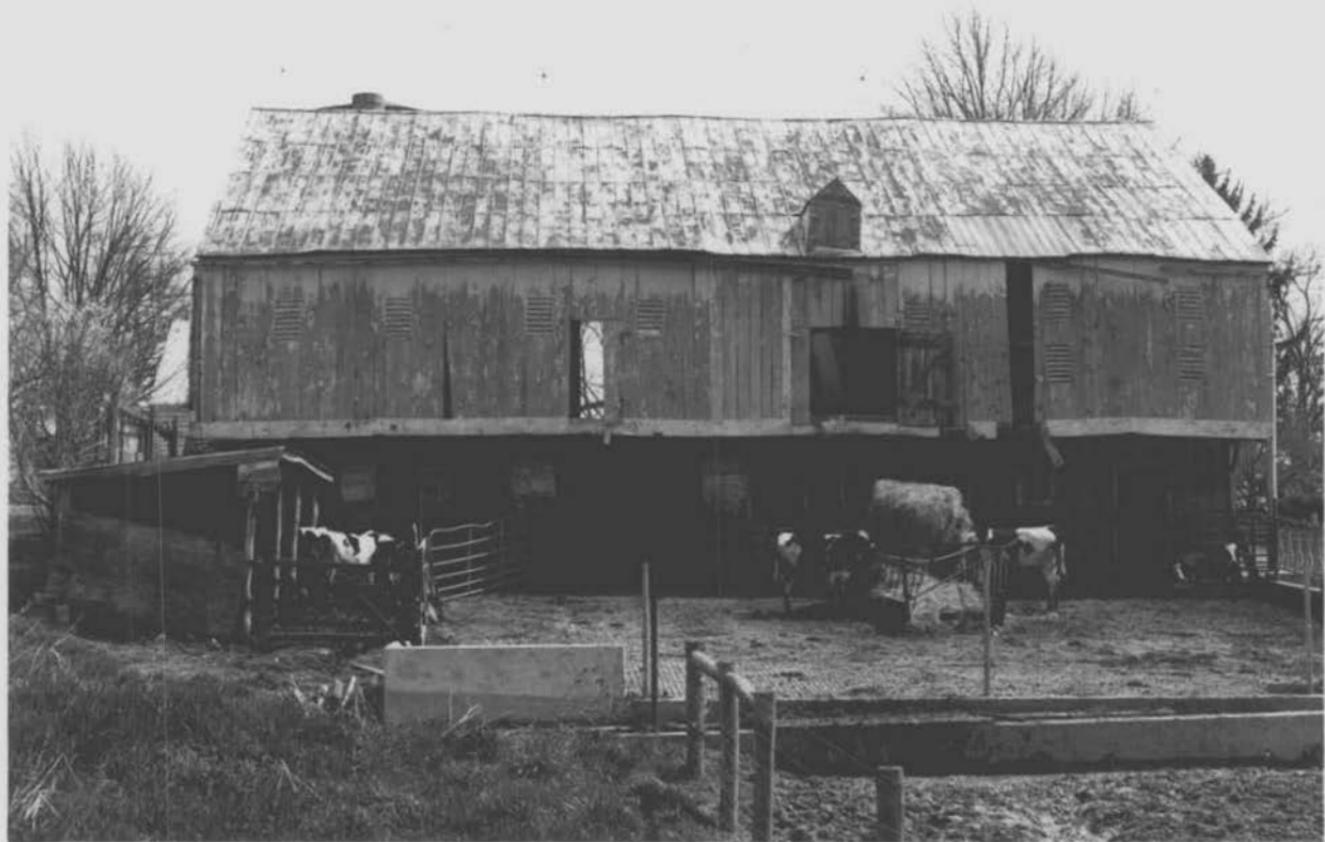
9/12

bank barn - south & east elevations

Northwest of the house is a complex of farm buildings. The bank barn has a forebay that faces west, with a ramp on the east. The lower story has rubble field stone on all four elevations, and that on the west is semi-dressed and generally coursed, with semi-dressed quoins at the corners. There is a similar stone wall under the north end of the forebay. The west elevation of the lower story has, from north to south, a door, an opening, a door, a wide modern opening, a door, an opening, a door, a six-light sash, and a door. Most of the doors are now missing; the survivals are vertical board dutch doors on strap hinges. The openings are the same size as that with the six-light sash. The upper story has, from north to south, three wood louvered vents, a vertical board door, a vent, vertical board double doors, a vent, and two vents set above two other vents. Above the double doors is a dormer with small double doors. The upper story has vertical board siding and the gable roof has inverted-V-seam metal on the west side and standing-seam metal on the east, and a north-south ridge.

The lower-story stall arrangement has been altered. There is one summer beam, and it appears to be a sawn replacement. The joists are hewn on top and bottom only where they are inside the barn, but on all four sides where they are exposed under the forebay. The upper story has a hay mow on each end, with two threshing floors between. There is no granary, but probably was one in the northeast corner originally. There are stairs down to the stable in the northeast corner of the south mow, and a hatch in the southeast corner of the north mow. The barn has a hewn heavy-timber braced frame with pegged mortise-and-tenon joints. Each of the five bents has three posts. The forebay has shorter end posts. The roof is supported by a purlin-post truss. Originally the feet of the west rafters over the bulk of the barn were set into notches on the purlin,
