HO-1022
Smith Family Farm
15751 Bushy Park Road
Demolished

Maryland Historical Trust Maryland Inventory of Historic Properties Form

Inventory No. HO-1022

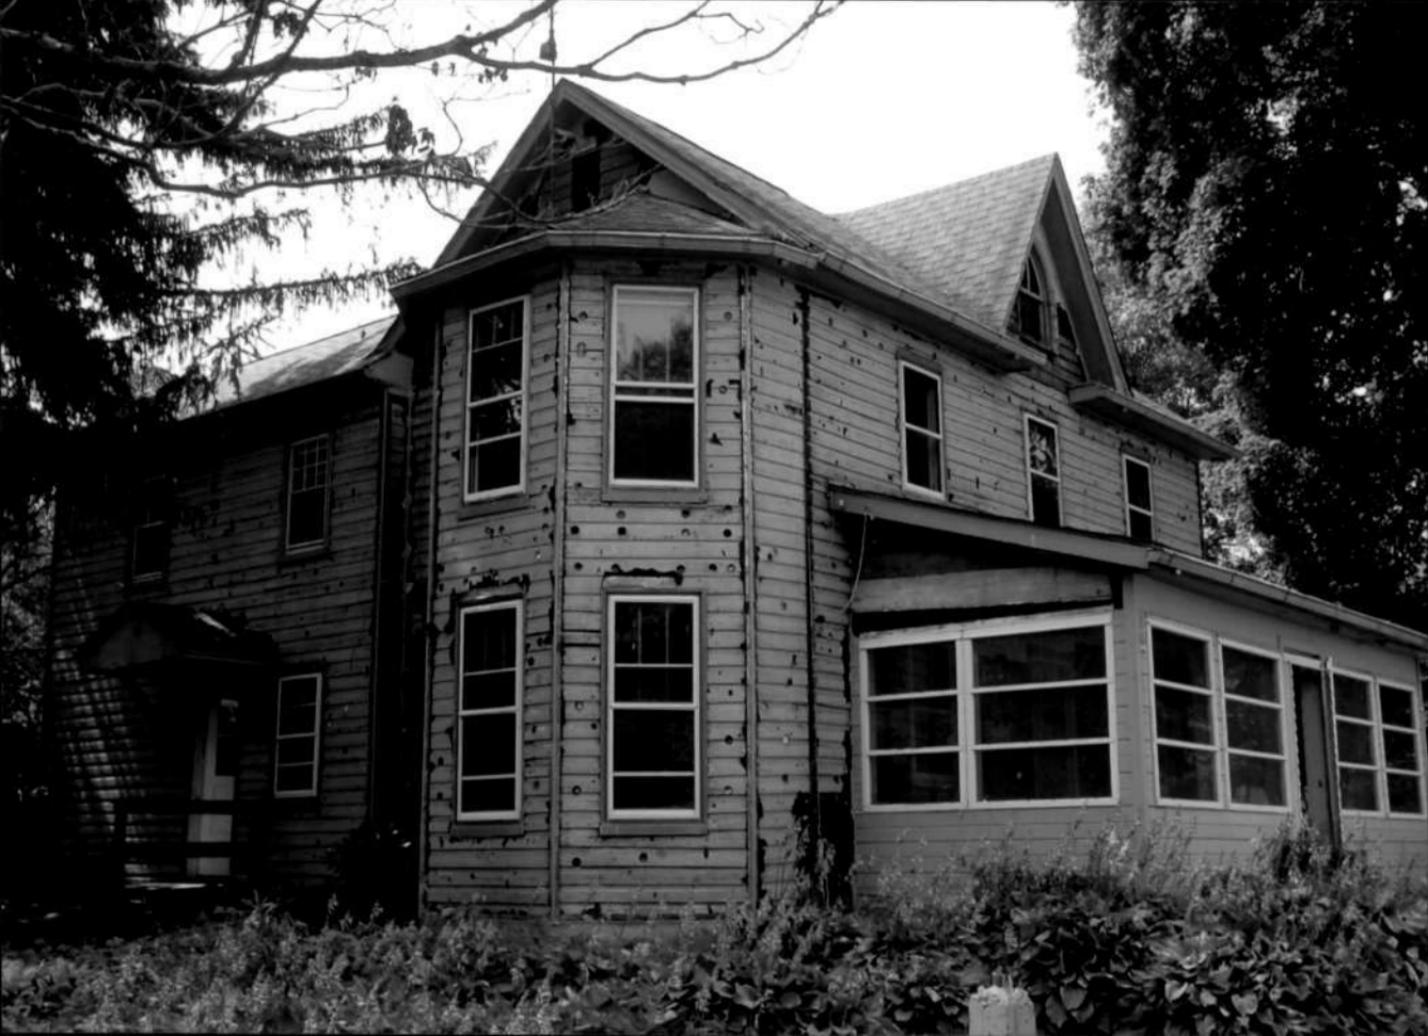
1 of 6

House, northeast + northwest elevations

The house is a 2½-story, three-bay by two-bay frame structure with a rubble stone foundation, German siding, and a gable roof with asphalt shingles and a northeast-southwest ridge. There is a modern exterior brick chimney on the southwest gable end. The house has a two-story, two-bay by two-bay frame ell on the southeast that has a rubble stone foundation, German siding, and a gable roof with asphalt shingles and a northwest-southeast ridge. On the northwest elevation the first story has an enclosed porch that is all modern and has a shed roof with asphalt shingles. The original exterior wall has a center door with a new one-over-one sash to each side. The second story has three windows, and only part of a two-over-two sash survives. There is a wood box cornice that is broken at the center where a cross-gabled dormer is located; this dormer has a lancet-profile two-over-two sash with applied turned mouldings. At the north end of the house the siding was covered by a corner board, and the

HO-1022_2010-07-08_01
House, northeast & northwest elevations

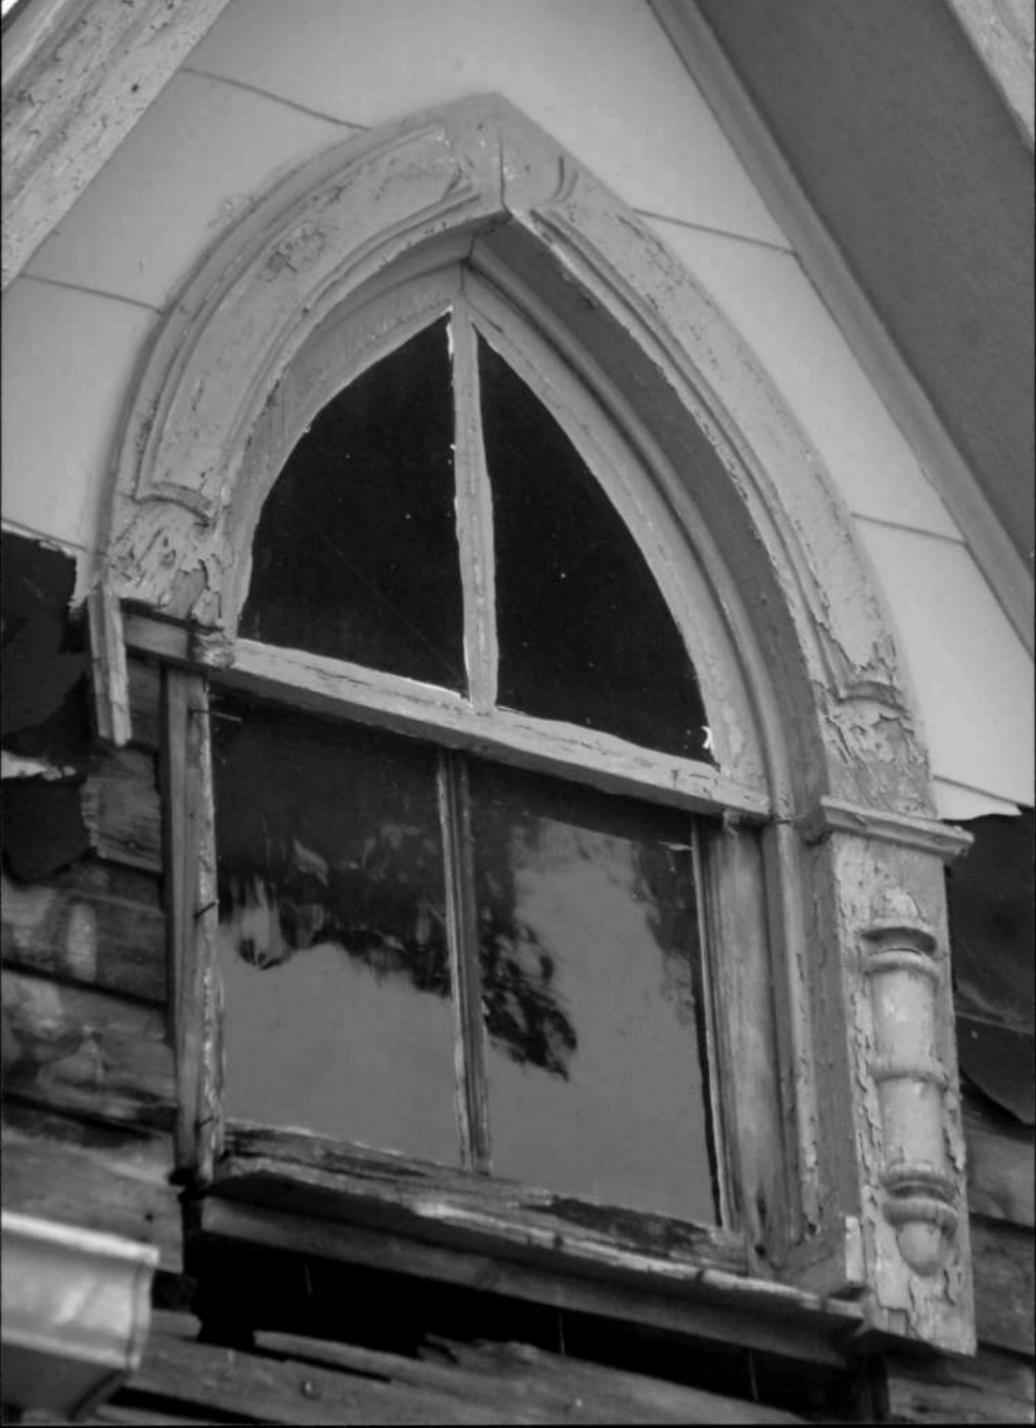
2 of 6

House, northwest elevation, cross-gable
window

HO-1022_2010-07-08_02
House, northwest elevation, cross-gable
window

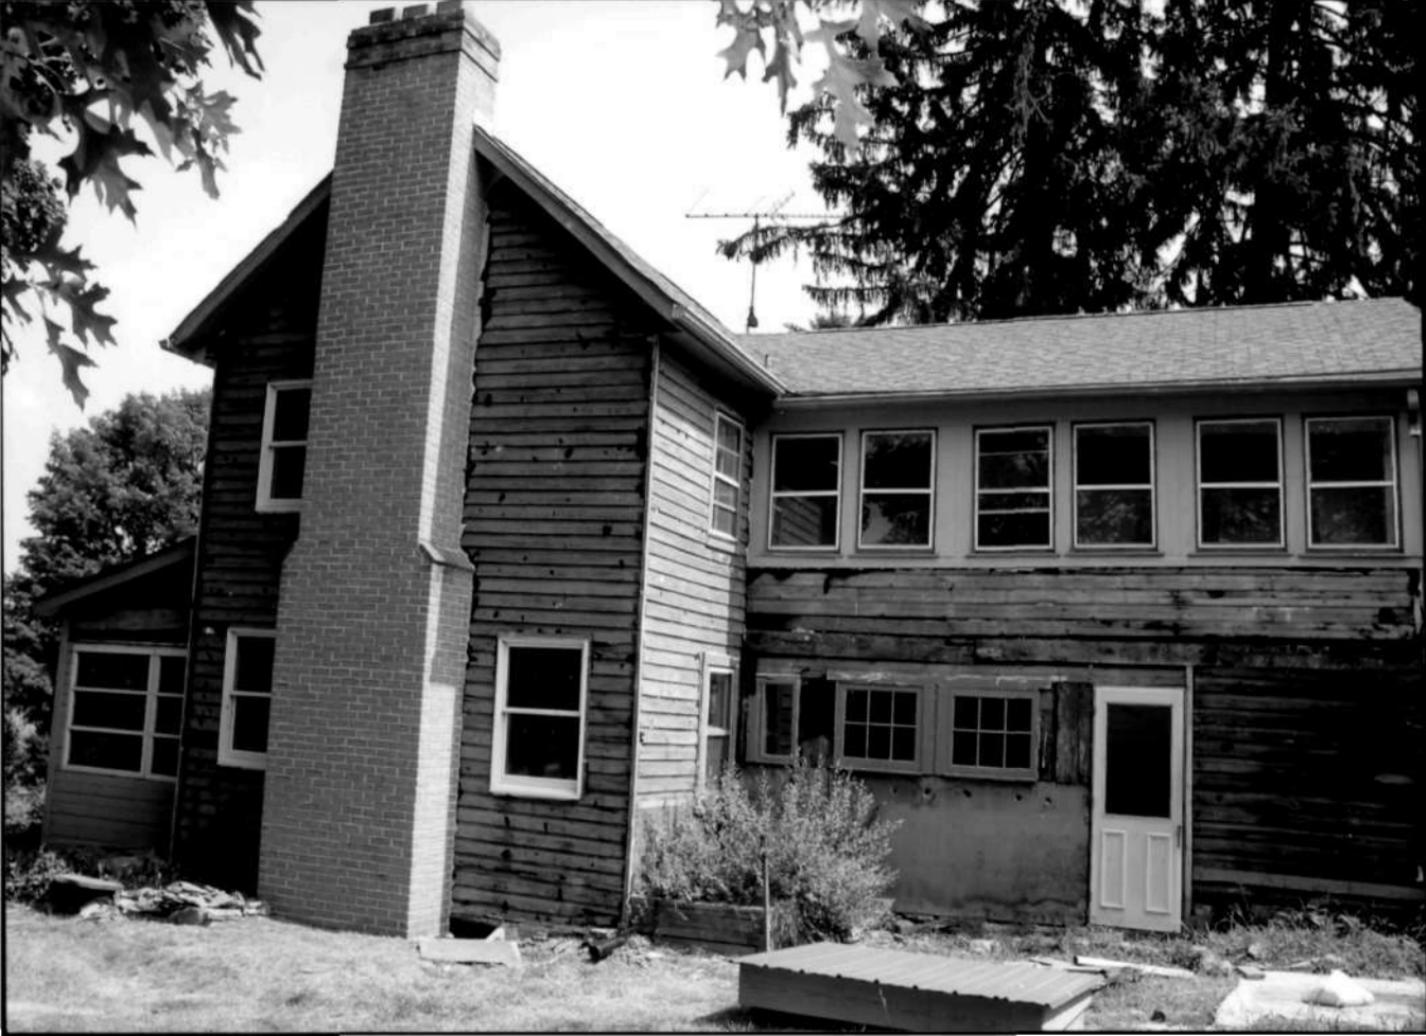
3 of 6

House, southwest elevation

HO-1022_2010-07-08_03
House, southwest elevation

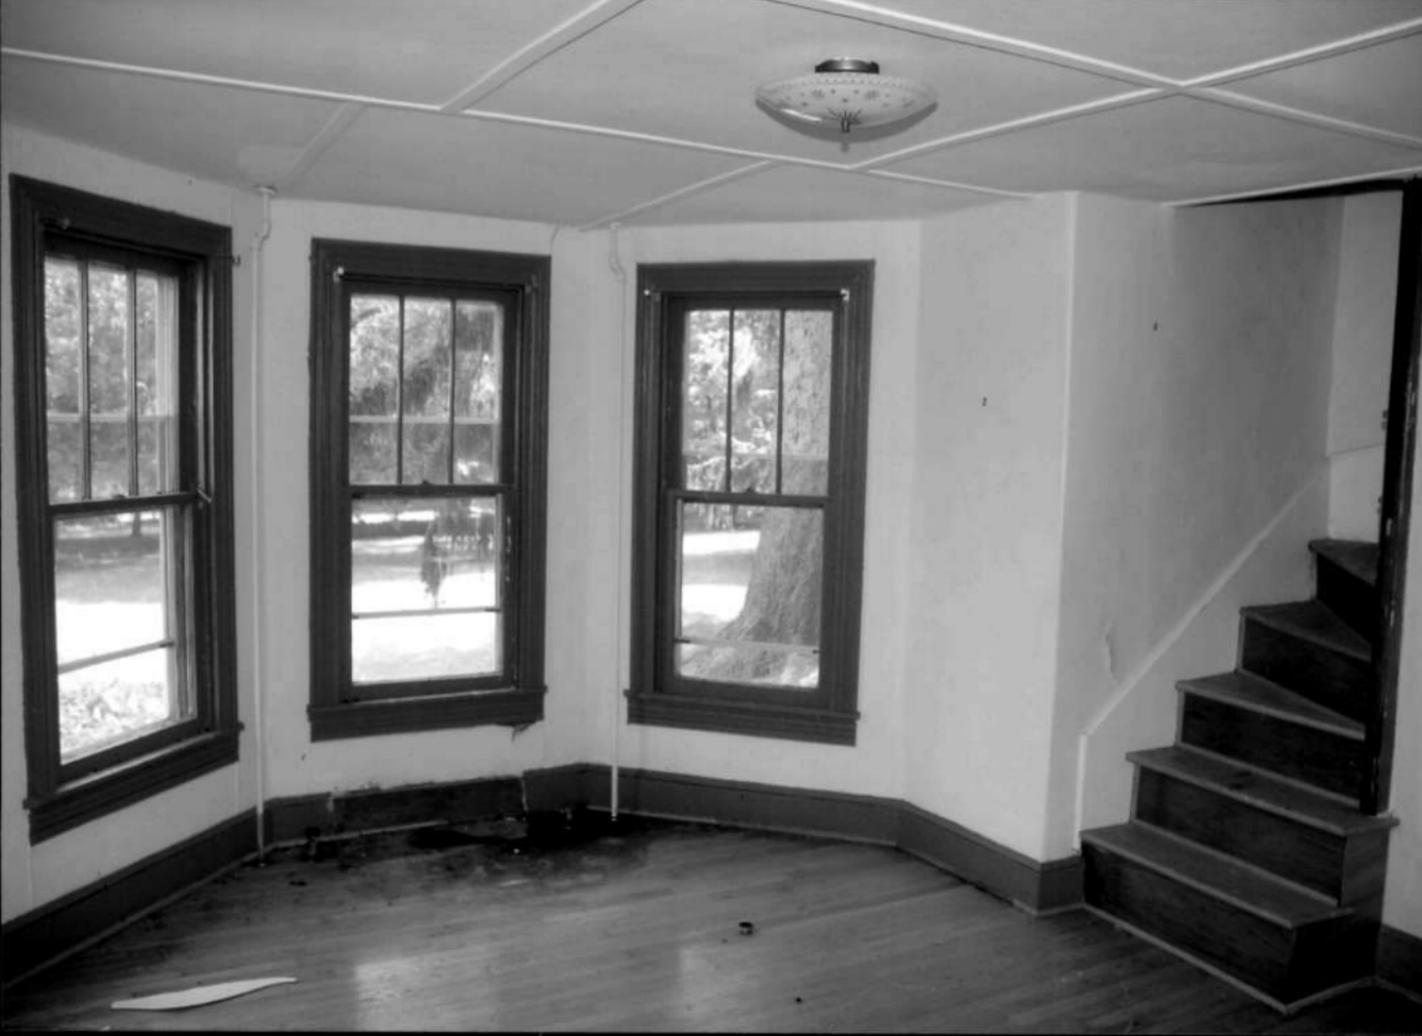
4 of 6

House, north east room, vw, east

HO-1022_2010-07-08_04
House, northeast room, vw. east
