K-163

White House Farm  
Massey  
4th quarter 18th Century

White House Farm, Massey

Summary: "Whitehouse Farm - Massey", to distinguish it from the other Whitehouse Farm in Kent County, is a gambrel roof frame house, 3 bays long with a 2 bay, 2 story wing, slightly lower than the gambrel roof section. The entrance is located in the center of the wide mass and has a 6 panel door with transom. All windows are  $\frac{6}{6}$  and have green trim. The dormers are flat headed — ~~the~~ Almost every thing is covered with white stucco, even the lower pitch of the gambrel roof. Consequently the exterior is very unimpressive.

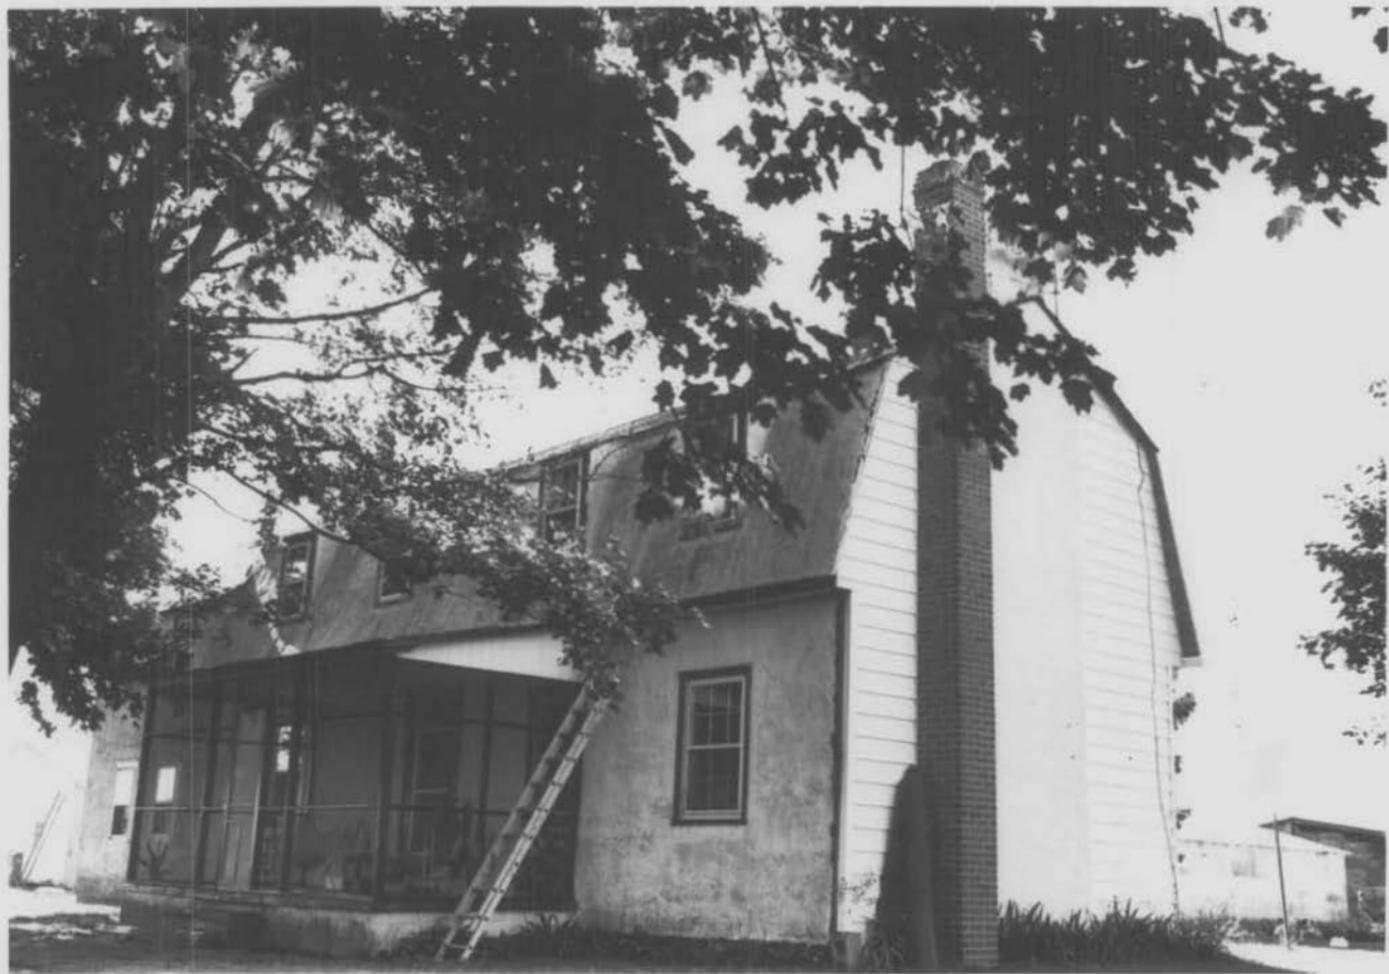
K-163

White House Farm, Massey

Rt. 313, near Massey

M. Q. Fallaw - 6/25/86

View to northwest
