K-623

Old Millington Bank

Millington

Maryland Historical Trust State Historic Sites Inventory Form

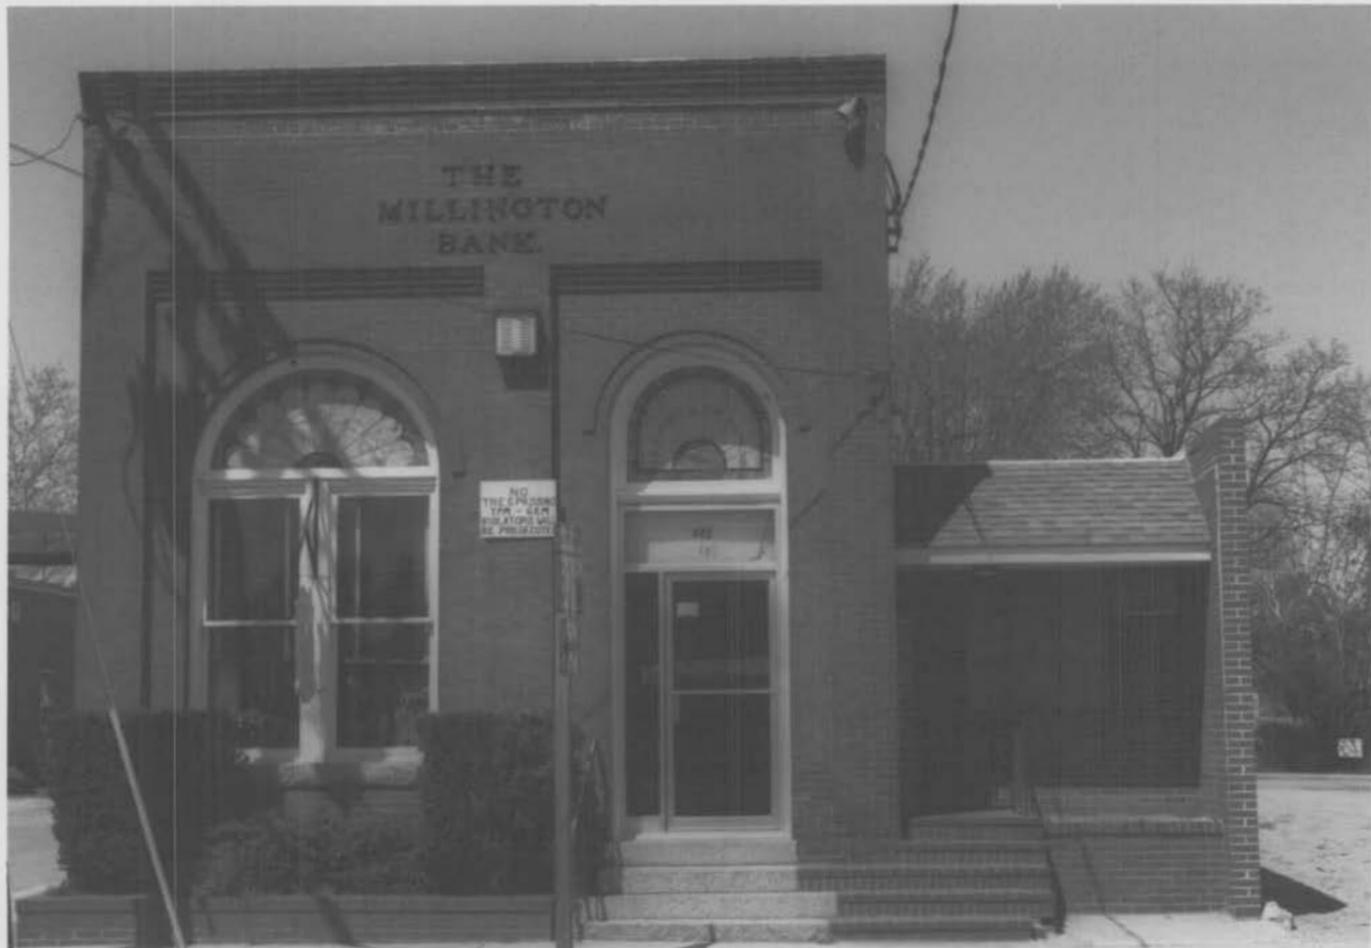
K 623 - 9

K-623

Old Millington Bank

Cypress Street, Millington

M. Q. Fallaw - 4/23/86

View to north

The main entry is in the east bay of the south end. Leading to it are four wide granite steps, the top two narrower but deeper than the lower two. Above the top granite step there is now a terrazo sill, and the floor inside is similarly treated. There is a modern metal balustrade on the west side. These steps now adjoin and are continuous with the brick steps of the side wing. The entry architrave is about 15 feet high at the arch's apex. The door jambs are quite recessed beyond the face of the brick (about 5-1/2"). Everything below transom bar level has been replaced, probably in the 1950-1970 period. There is now a glass and mill-finish aluminum door with sidelight, very much
(continued)

out of keeping with the architrave. Very likely double doors originally were in the c. 53" wide opening. The original transom bar remains. It is bold and compound, befitting the scale of the architrave. From the bottom, it includes dentils, a cyma reversa, fairly small cove with fillets, and a plain cap. The same bar is used at the paired windows. The stained glass in the entry arch is in a radial, or sunburst, pattern with central arch and outer arches similarly round-headed and repeating the theme. It is similar to but not the same as the glass of the nearby windows. Many somewhat muted, "marbelized" colors are used. The brick arch above the transom is of double headers, the inner one flush with the surrounding wall's brickwork, the outer one set out about 1", producing a somewhat prominent hooded appearance. The brick arch does not extend down to the transom, but only to the springing line. The brick arch of the double window does extend to that window's springing line, which is at the transom; its arch ends are lower than those of the entry.

The tall, paired windows with the arched transom in the facade west bay are double-hung with 1-over-1 lights. Between the windows there is a wide pilaster (7") from which now hangs a projecting sign denoting the town office. The window sills is massive and of granite, as the steps at the entry. It is 7" thick, with with face rough and undressed. The architrave brick-mold edges are compoundly molded, with a small ovolo and bead at the inside corner. The stained glass of the transom, which is one unit above the double windows, is also in a radial (or fanlight) composition. From a dark-banded, dark-green center there are radial segments in white, gold, and other mottled or marbelized colors. There is an intermediate arch of elliptical purple segments. There is an outer bright blue border of large scallops with bright green infill.
