Maryland Historical Trust State Historic Sites Inventory Form

historic Content

and/or common C.C. Harper Farm

Survey No. QA-11

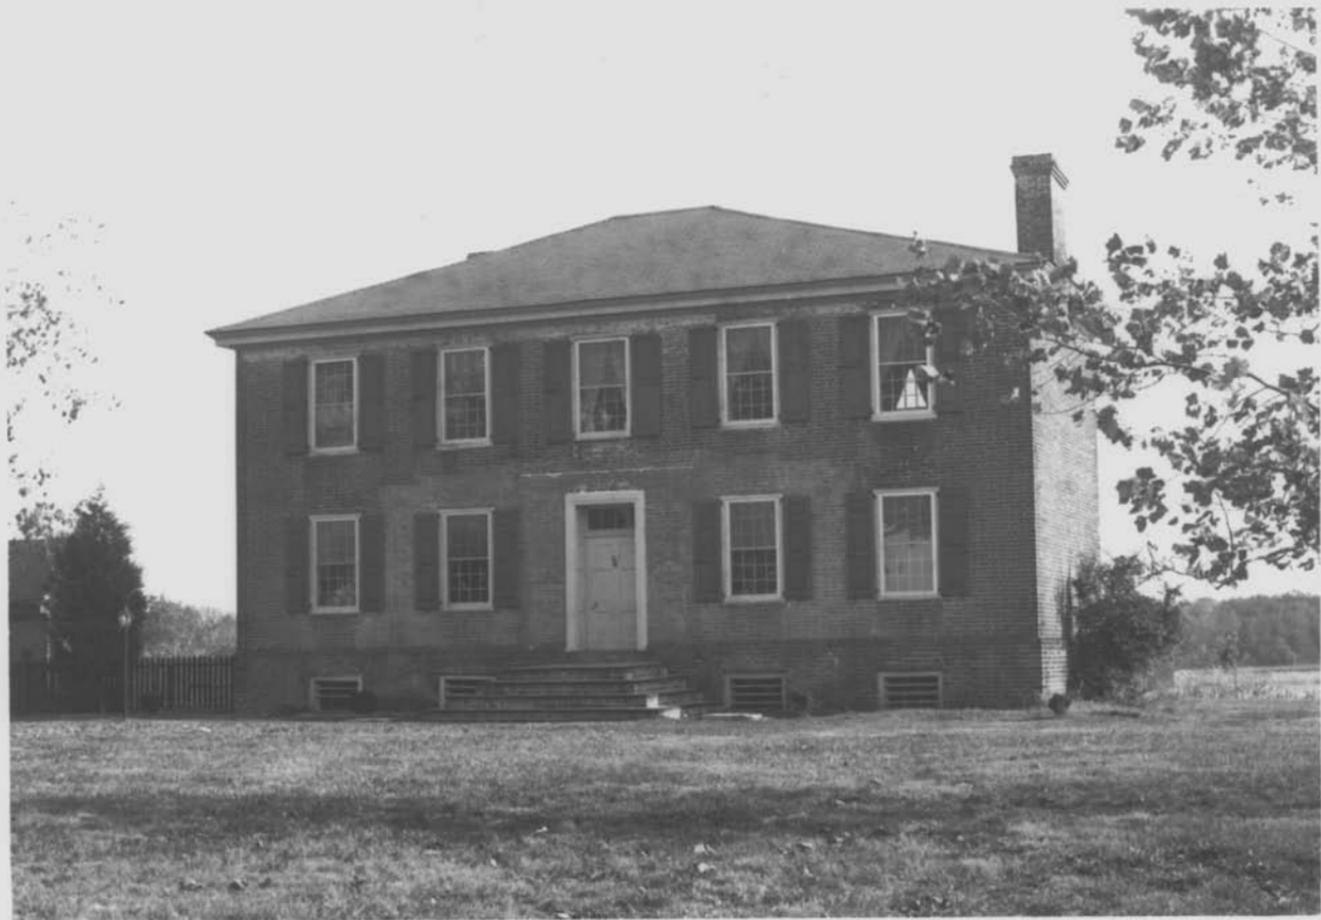
QA-11 C.C. Harper Farm
Centreville vicinity
Orlando Ridout V 1981
Northwest (front) facade

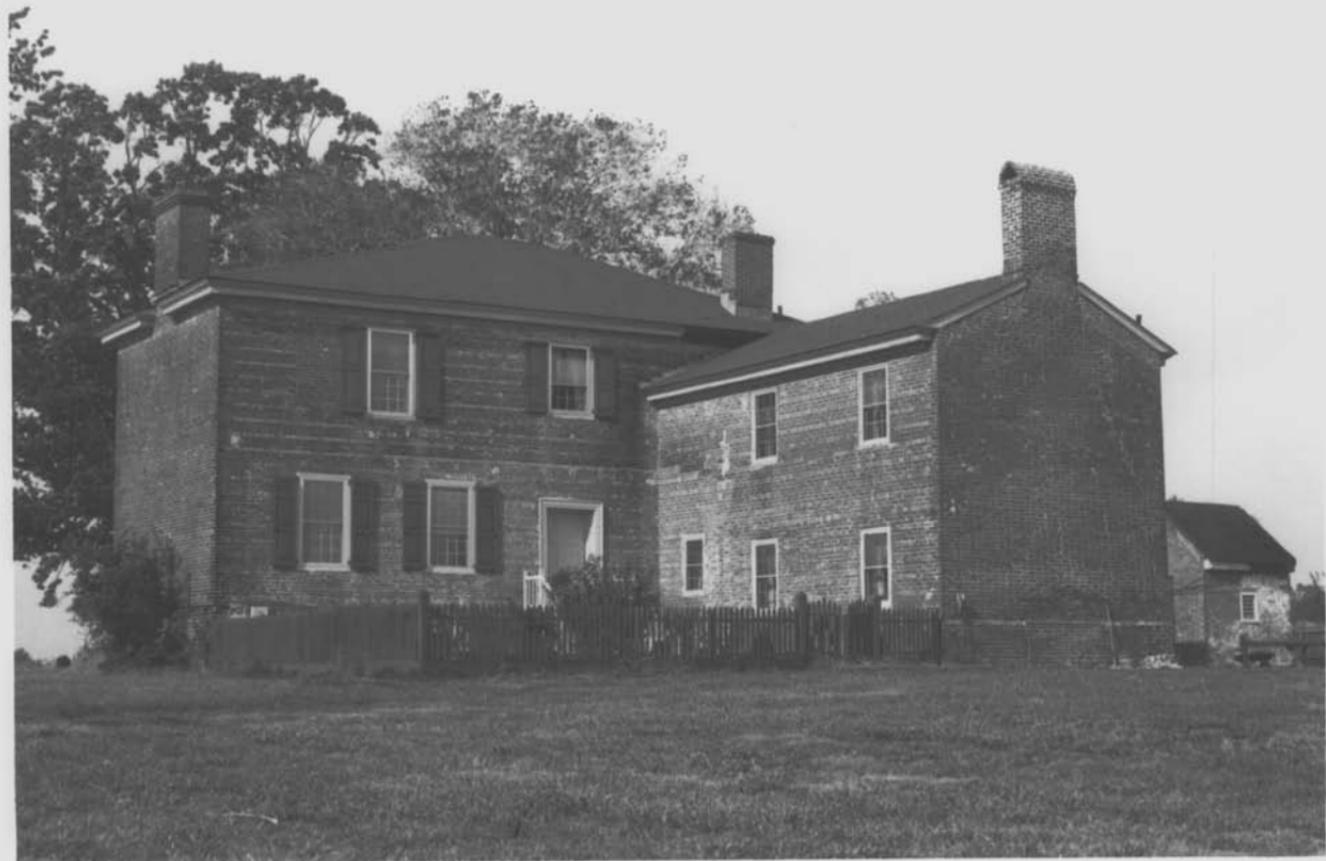
QA-11 C.C. Harper Farm
Centreville vicinity
Orlando Ridout V 1981
Rear facade from South

The southeast gable wall of the wing is also laid in Flemish bond above a molded water table and three-course bond foundation. The outline of the original pitched gable eave line is clearly visible approximately 15 inches below the present rakeboards. A pair of early window openings in the upper gable, flanking the flush center chimney, have also been blocked. A brick repair in the center of the foundation wall is evidence of a modern repair to the kitchen fireplace.

The first story brickwork on the southwest wall of the wing is bonded into the main house while the second story is not. Both the first story and the added second story are laid in three-course bond with bands of glazed headers above a molded water table and three-course bond foundation. Two courses of later brickwork are visible just below the cornice. The fenestration on this wall of the wing originally corresponded to the northeast wall, with a center door flanked by two 6/6 windows on the first story and two 6/6 windows on the second story. The center door was later bricked up and a 6/6 window cut in immediately to the left. The left or northwest windows were also bricked up on both the first and second story and a smaller 6/6 window was cut in farther to the left on the first story.

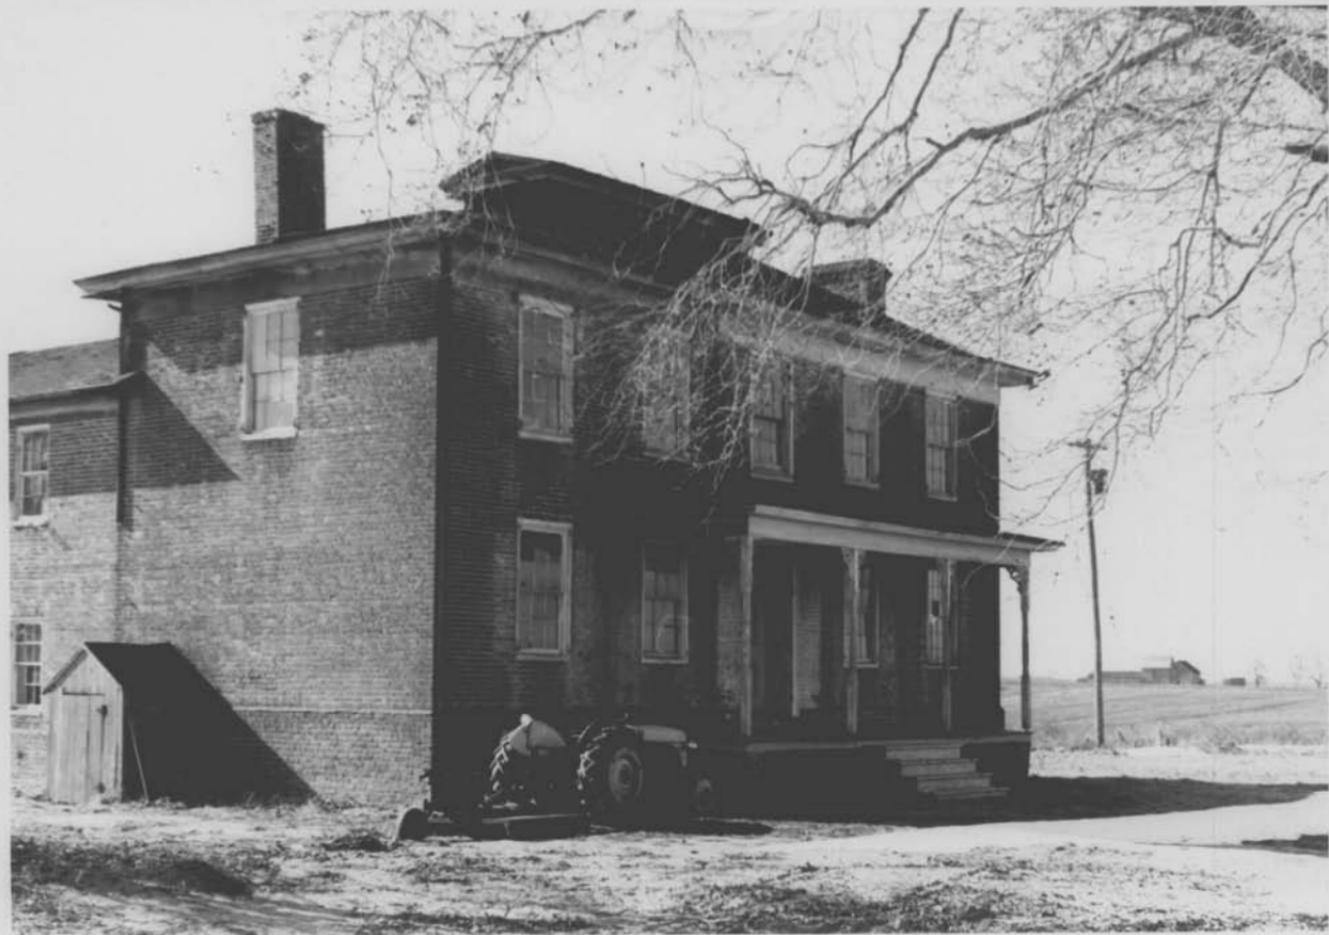
607-34

C.C. Harper Farm
Centreville vicinity
Michael O. Bourne 1968
Front facade from northeast

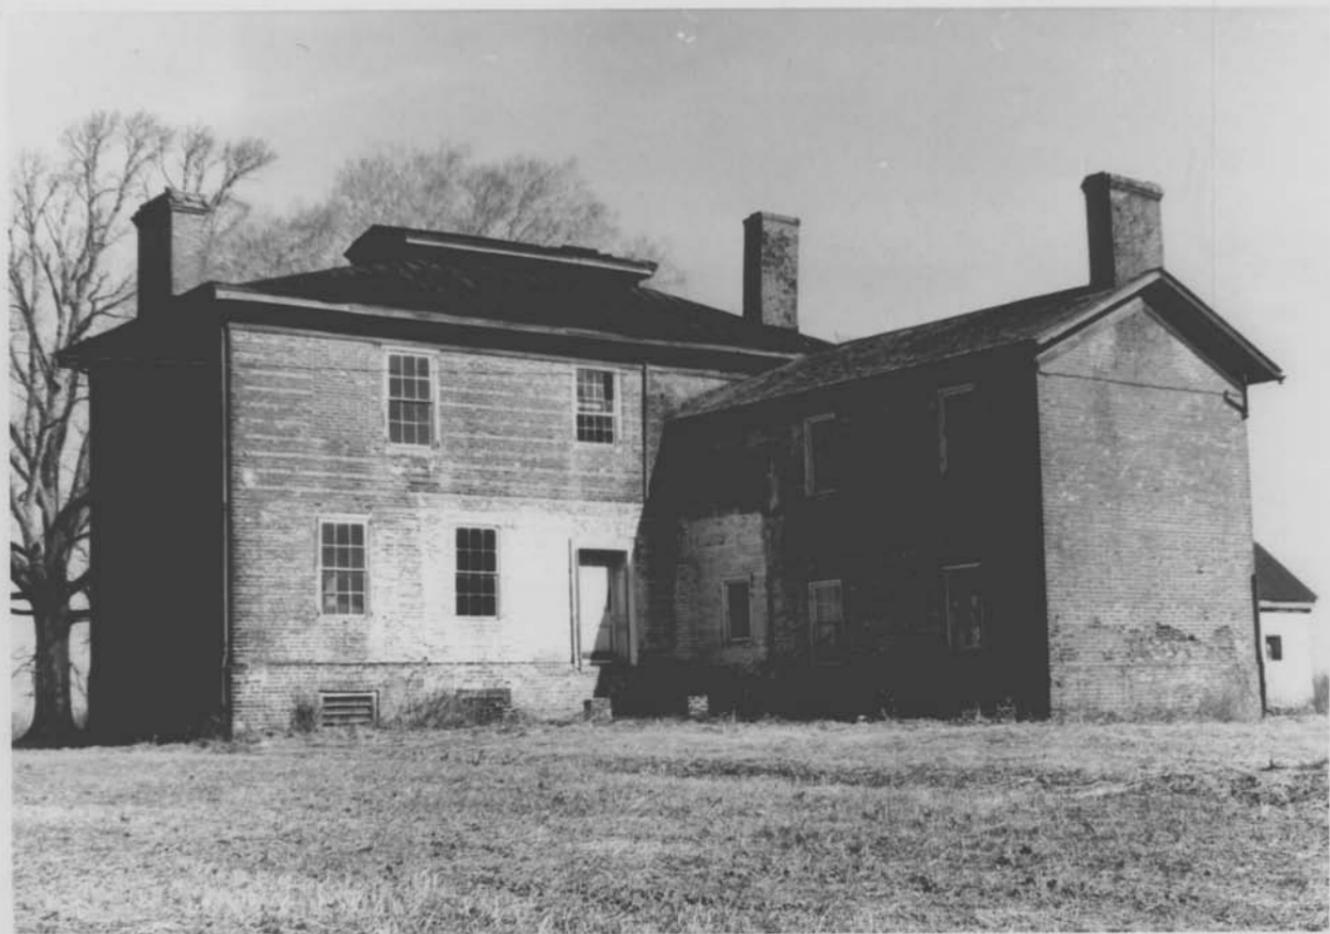
607-36

QA-11 C.C. Harper Farm
Centreville vicinity
Michael O. Bourne 1968
Rear facade from Southeast

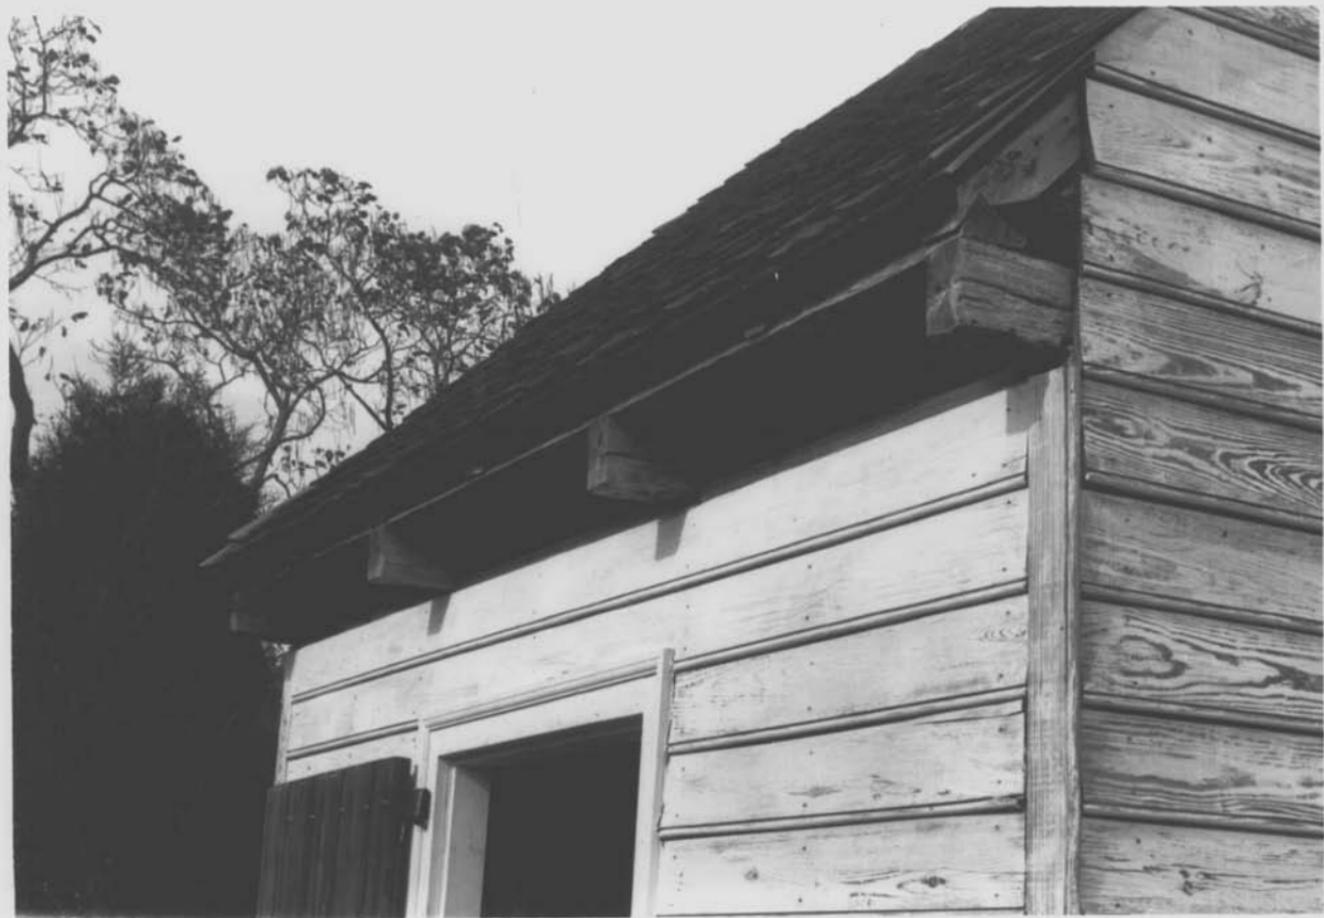
Meat House: eave detail
