QA-100

John Cannon House
Centreville vicinity
Private

INVENTORY FORM FOR STATE HISTORIC SITES SURVEY

The John Cannon Yellow House

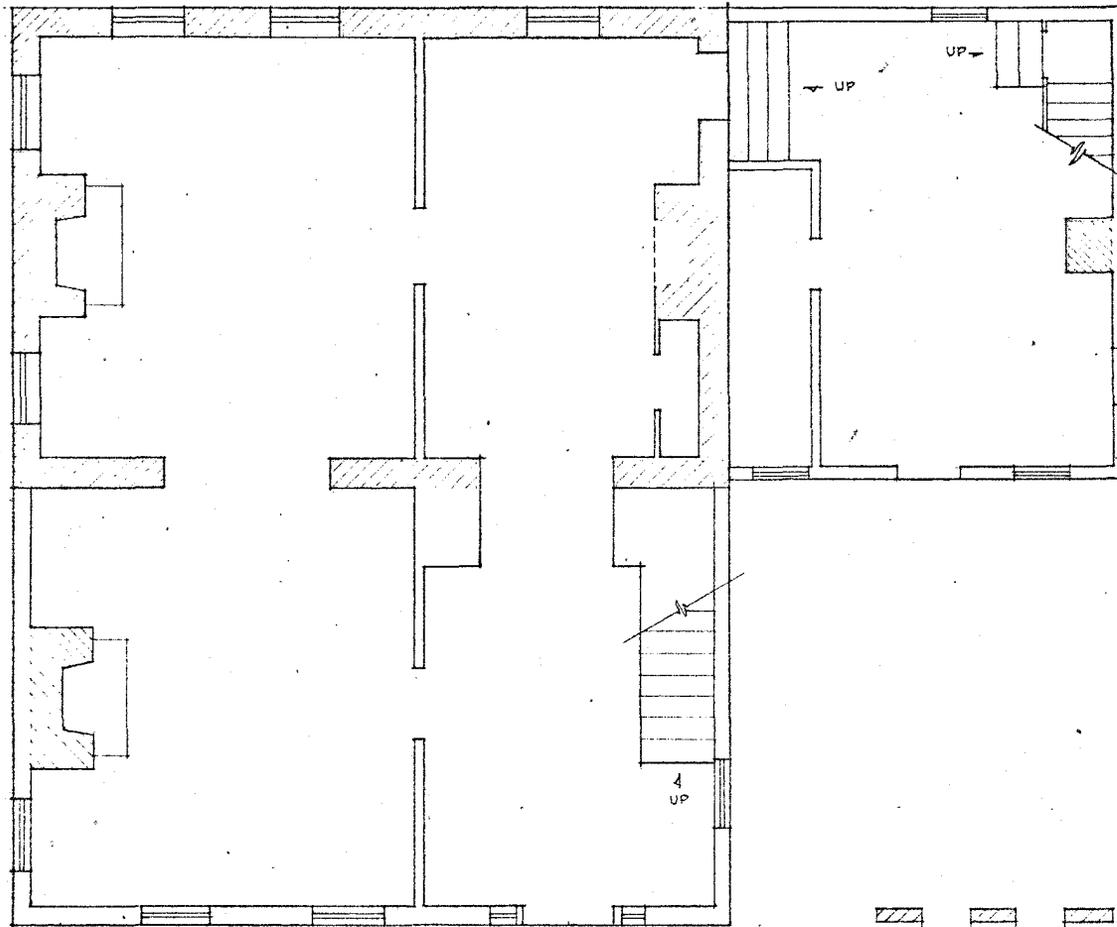
QA-100

JOHN CANNON FARM
CENTREVILLE, MARYLAND

MARCH 15, 1978.

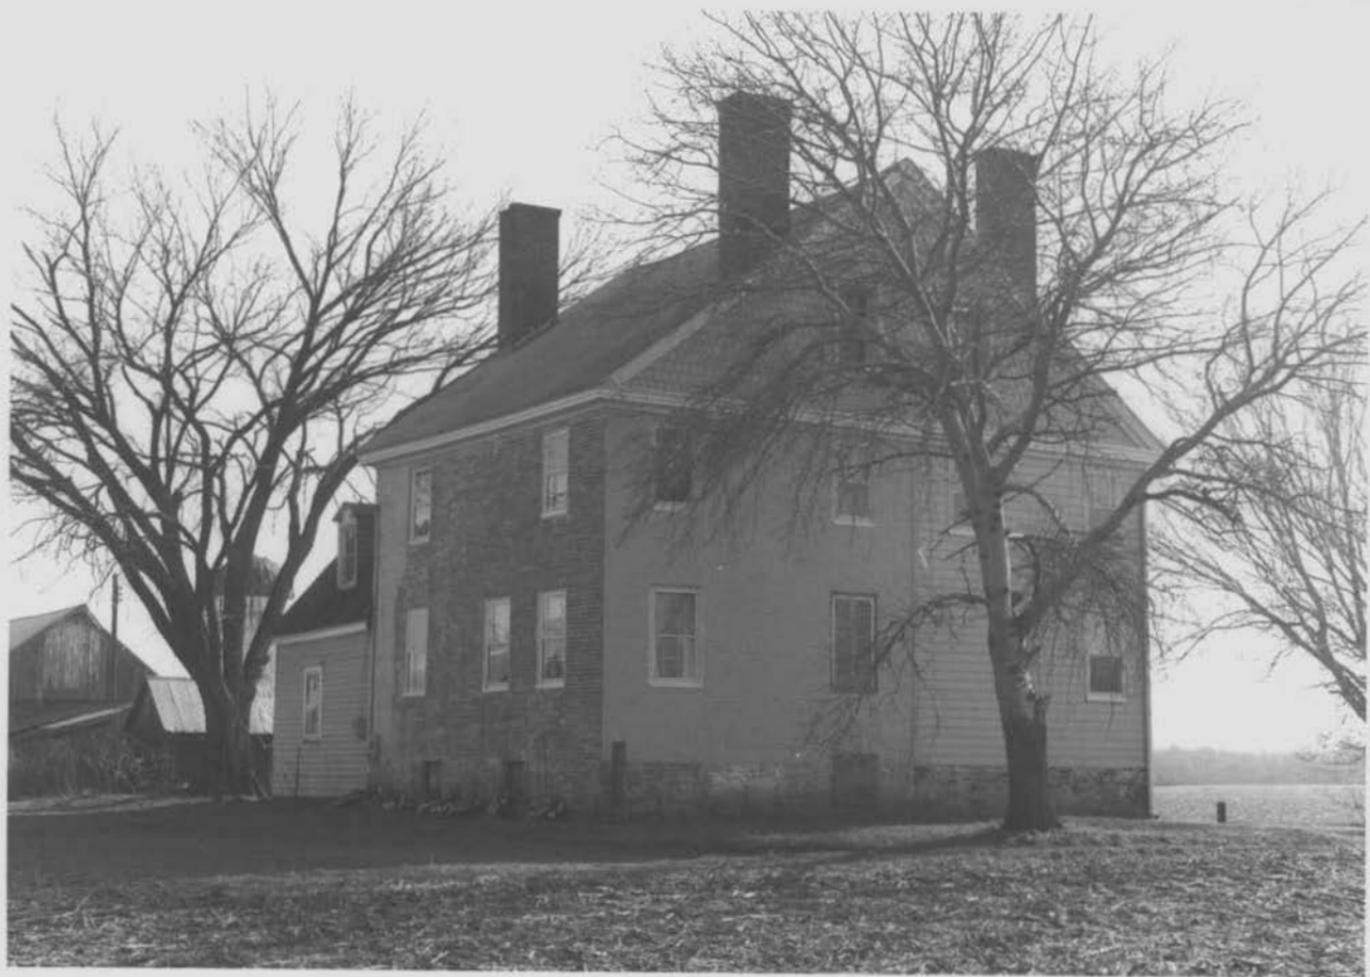
QA-100 John Cannon Farm
Centerville vicinity, Md
Orlando Ridout V, 1978 (MHT)
3/4 view, camera facing SE
