QA-12

Leager Farm or "Woodridge Corrected"  
Millington vicinity  
Private

c. 1790 & 1810

INVENTORY FORM FOR STATE HISTORIC SITES SURVEY

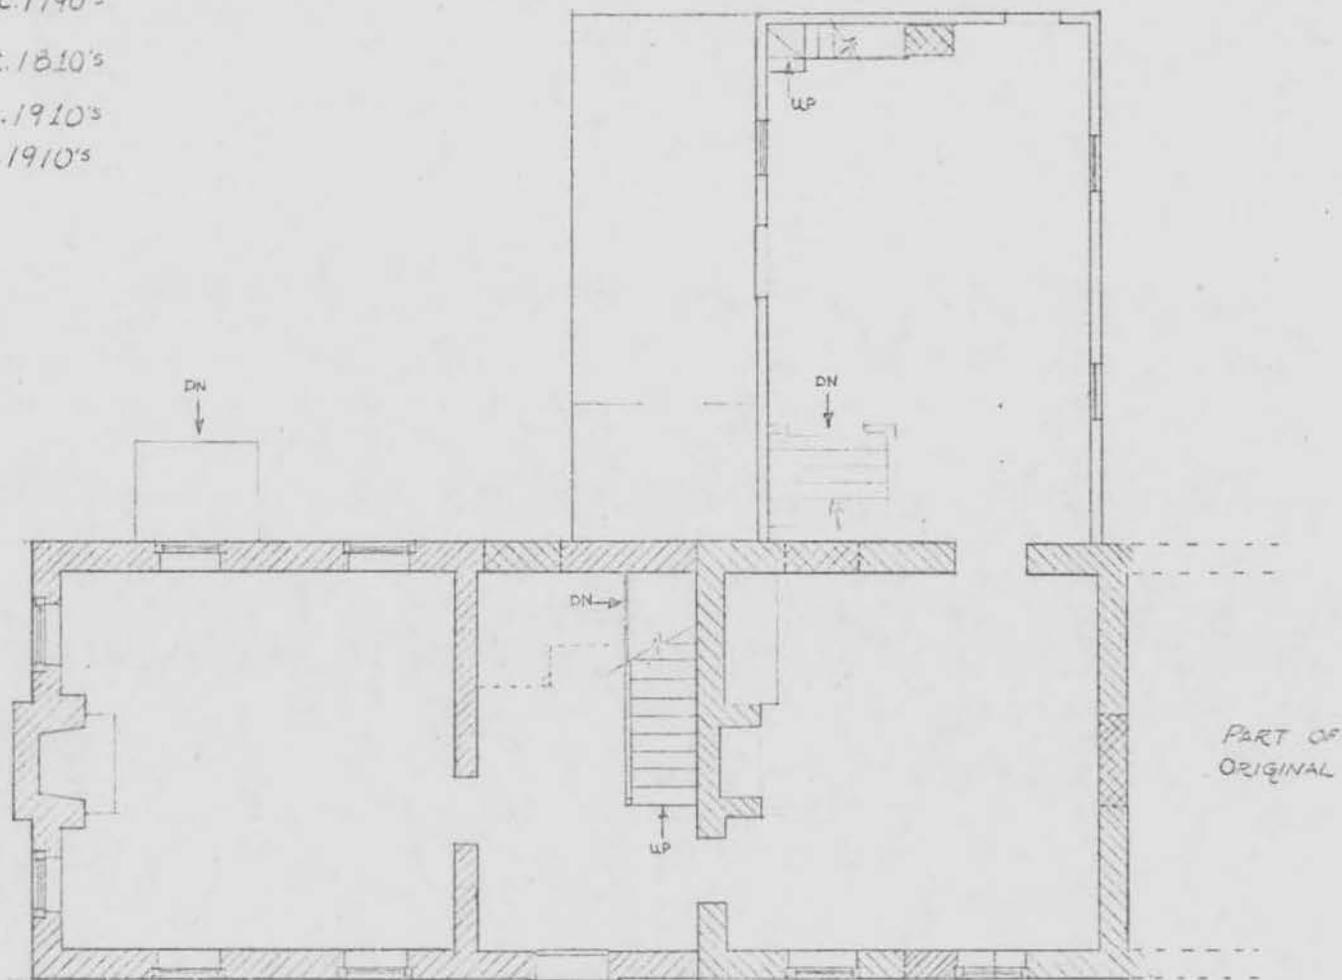
LEAGER FARM HOUSE  
FIRST DISTRICT, G.A. CO.  
FIRST FLOOR PLAN  
SCALE - 1/8" = 1'-0"  
M. BOURNE, JAN. 1933

ORIGINAL DOOR

PART OF ORIGINAL

The house faces southeast and is composed of two brick sections on this facade and a frame wing on the back. The earliest part of the house is the present dining room, on the northeast end, which was constructed around 1790. Twenty to thirty years later, the taller brick structure was added to the southwest gable of the original. Around 1910, a frame two story section with porch was built behind the dining room. From that period very little has happened to the building, with the result that the house has a feeling of antiquity found in few houses of the period.

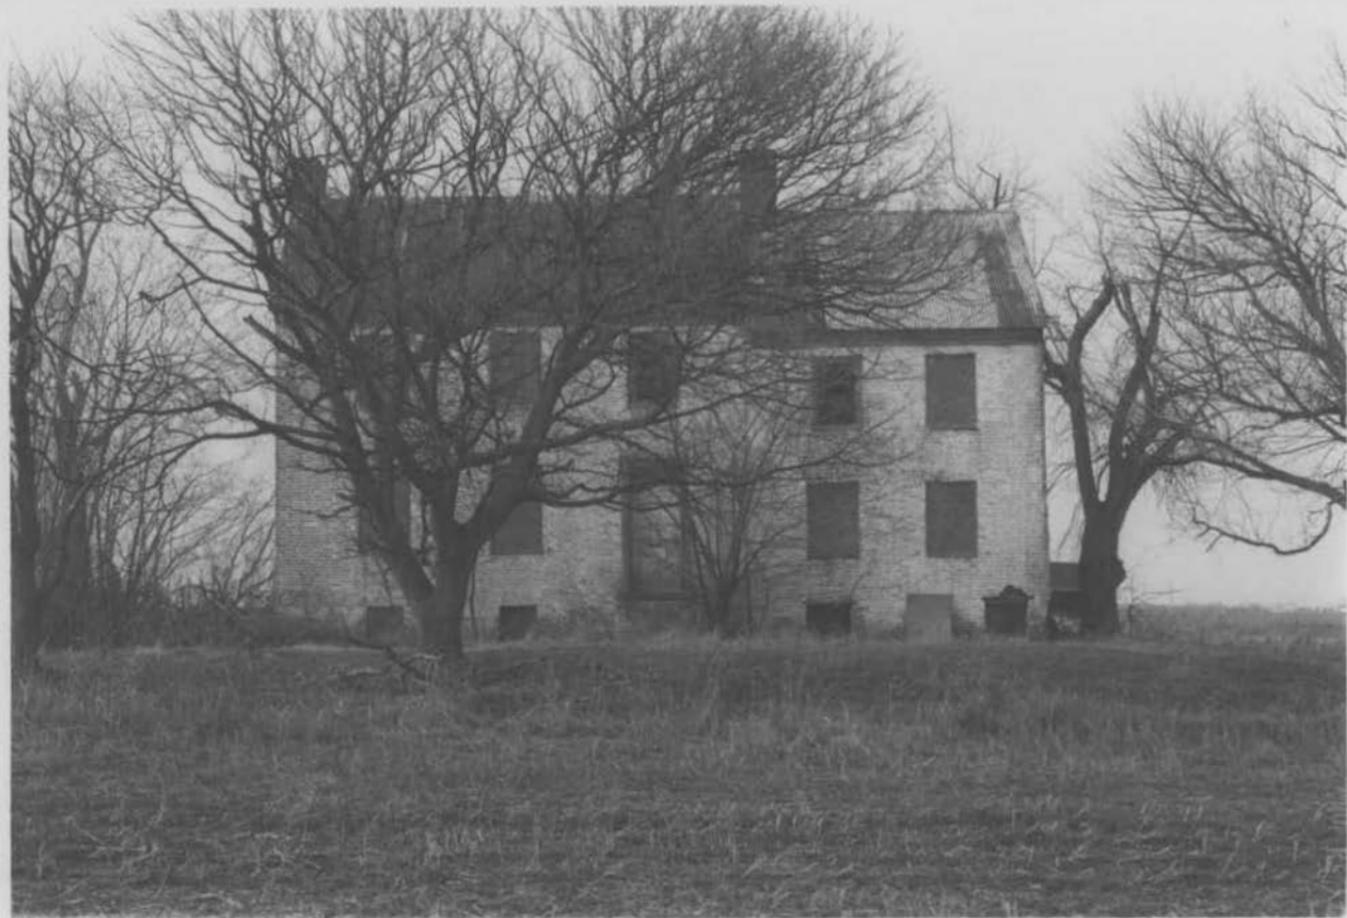
QA-12

Southeast elevation

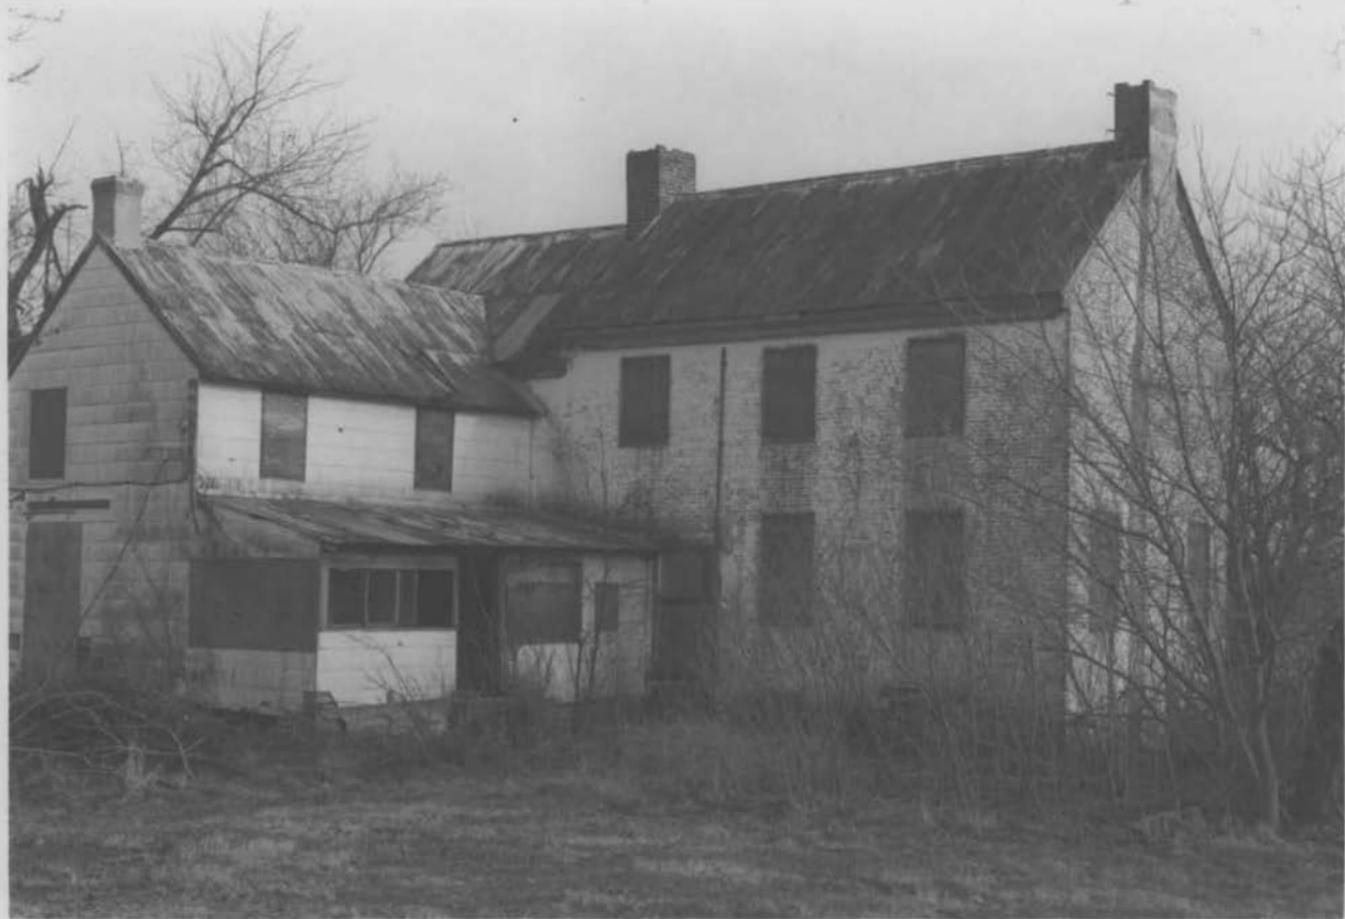
QA-12

West

The frame wing is built on a foundation of old brick probably salvaged from the old kitchen. It is two bays long and the walls are covered with asbestos siding over plain weatherboard. On its south side is a

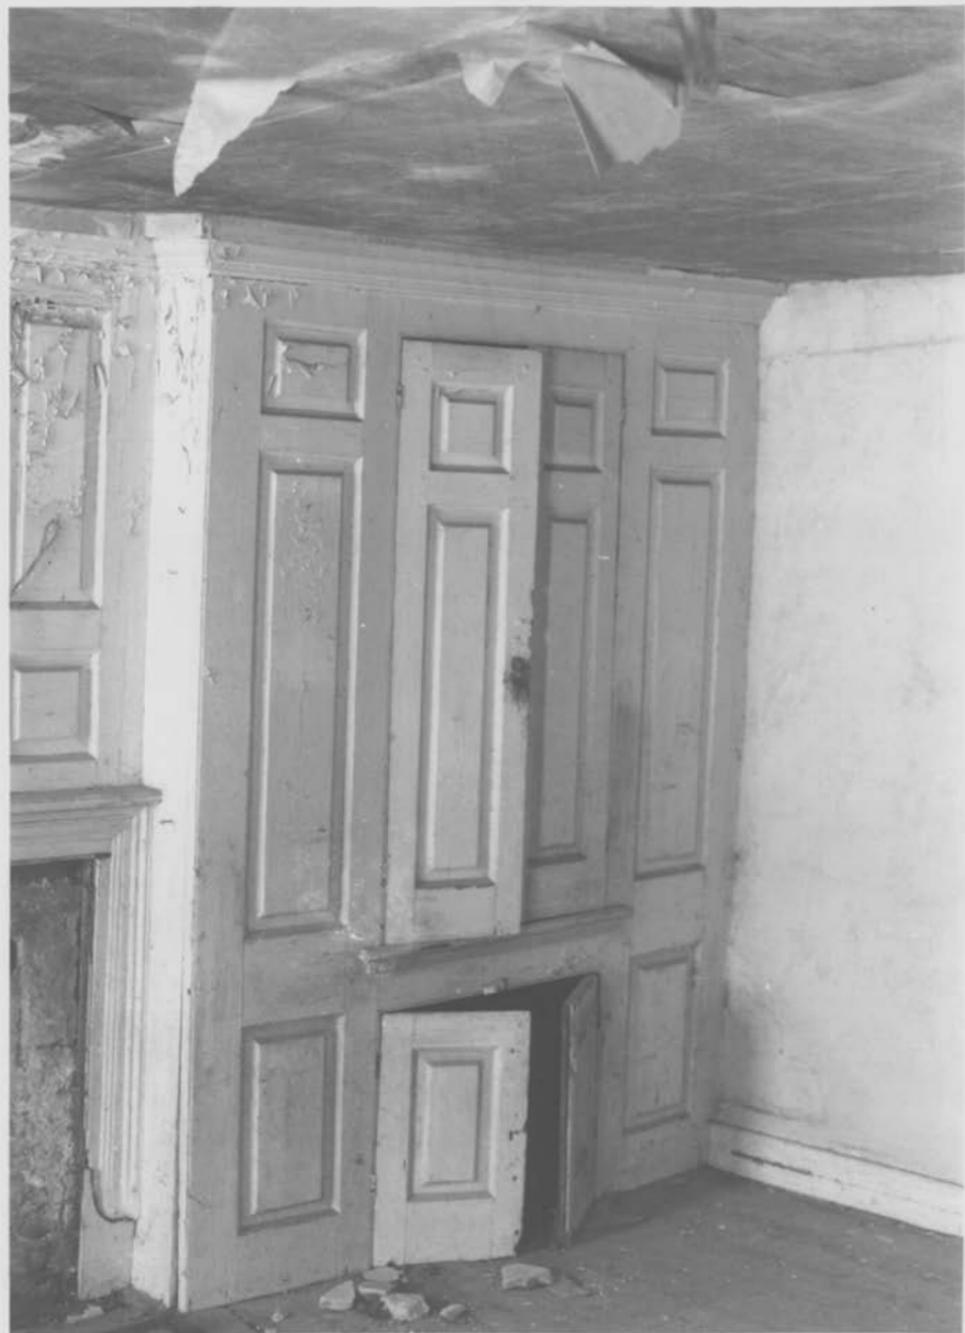
QA-12

Julian Leager Farm  
Sudlersville vicinity  
Michael O. Bourne  
Interior, paneled cupboard

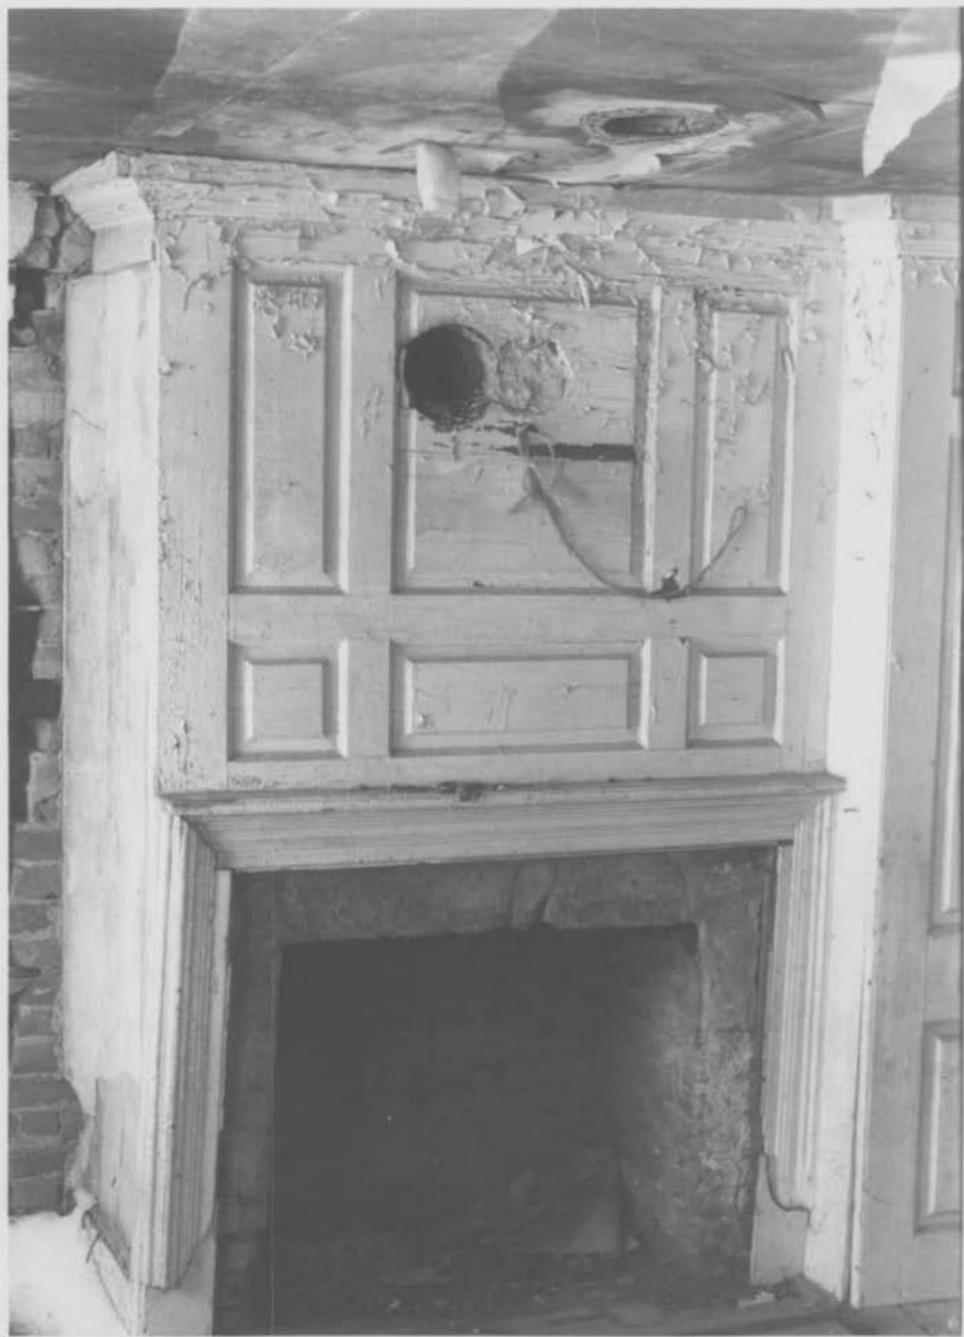
QA-12

Julian Leager Farm  
Sudlersville vicinity  
Michael O. Bourne  
Interior, paneled chimney  
breast
