QA-122

Sally Harris Mill House

Queenstown vicinity

INVENTORY FORM FOR STATE HISTORIC SITES SURVEY

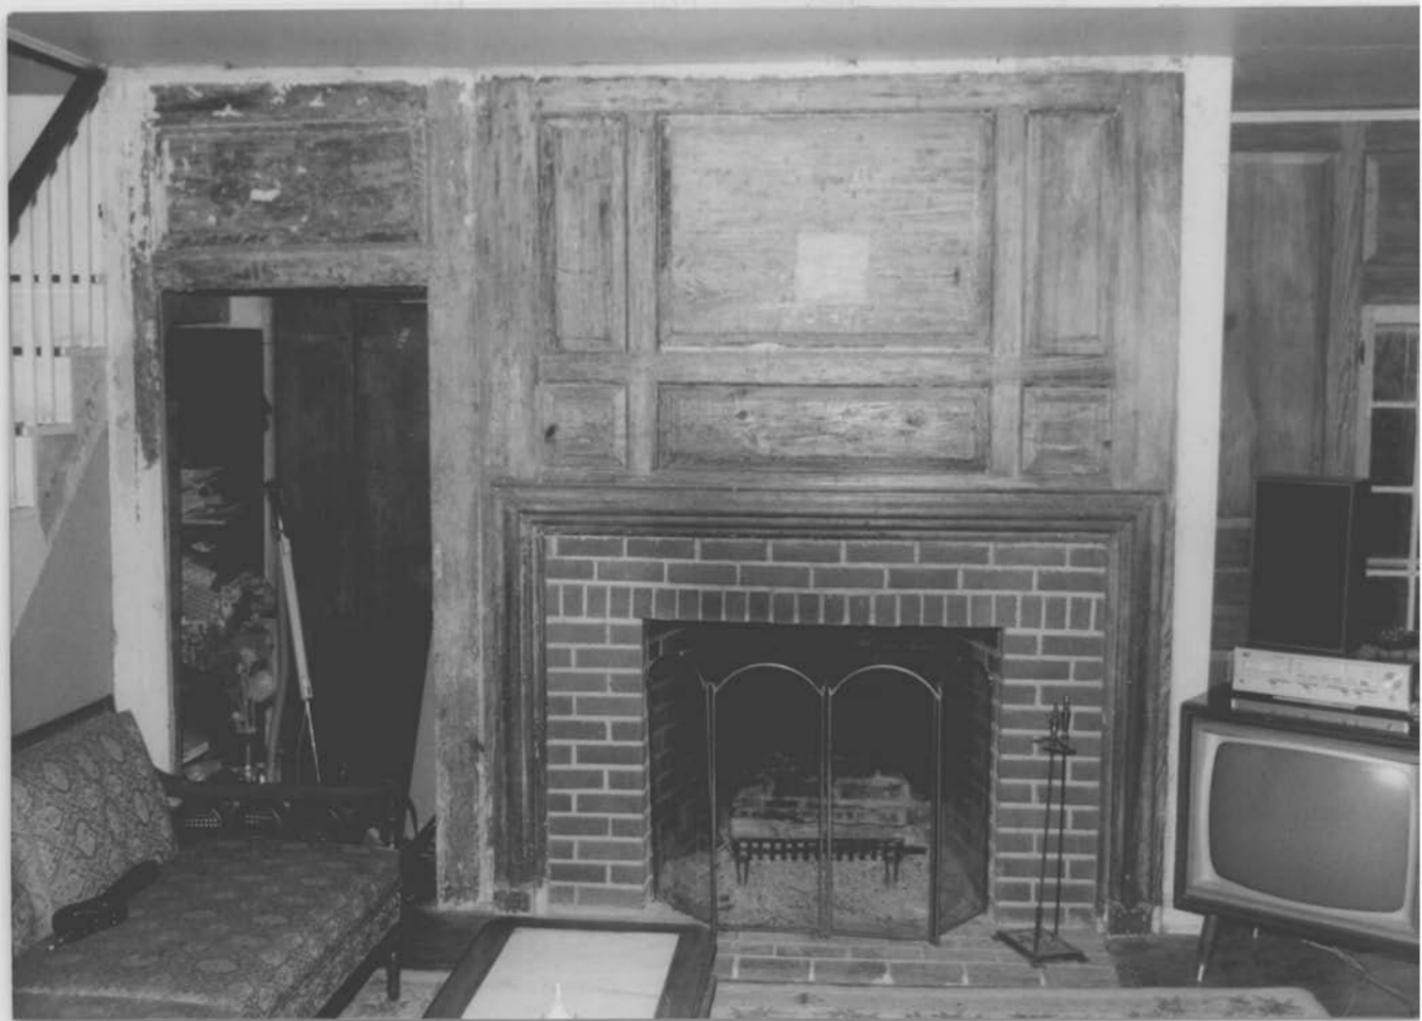
34

QA-122 Sally Harris Mill House
Queenstown vicinity, MD
Orlando Ridout V, 1978 (MHT)
Interior, North wall of hall
