QA-130  
Lloyd's Meadows  
Wye Mills vicinity  
Private

mid-18th century,  
circa 1798-1815

The brick house on the Hamner Farm, historically known as Lloyd's Meadows, was constructed in two separate stages. The original section, dating to the latter half of the 18th century, was 1 1/2 stories high, three bays wide and two rooms deep with a side passage plan. This early house was enlarged circa 1798-1815 two additional bays to the north and was raised to a full two stories. The interior was completely renovated and the story-and-a-half wing was added at this time.

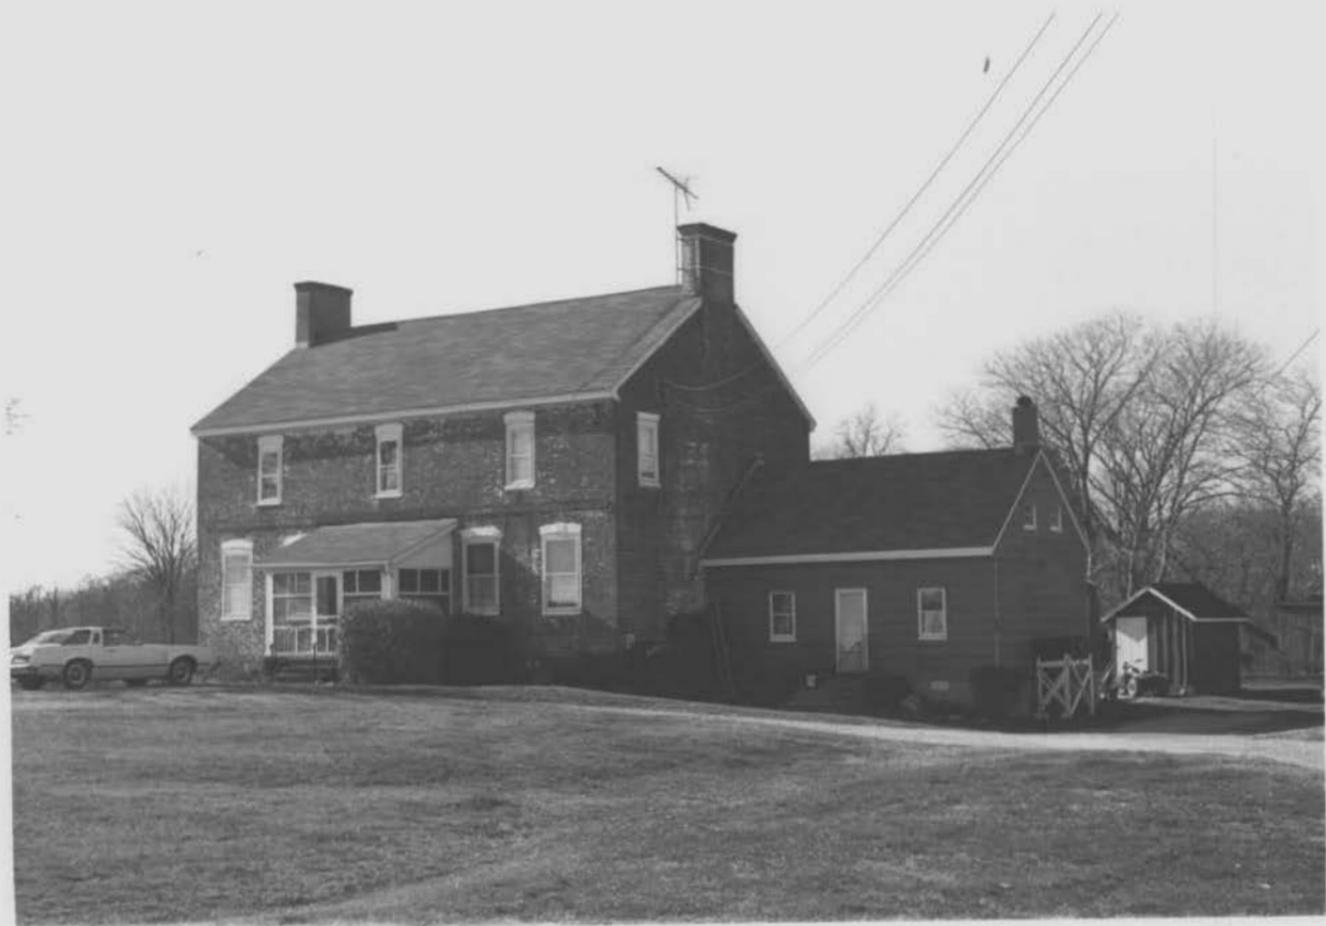
QA-130 Margaret Hammer Farm  
Wye Mills vicinity  
Orlando Ridout V 1981  
Front facade from Northeast

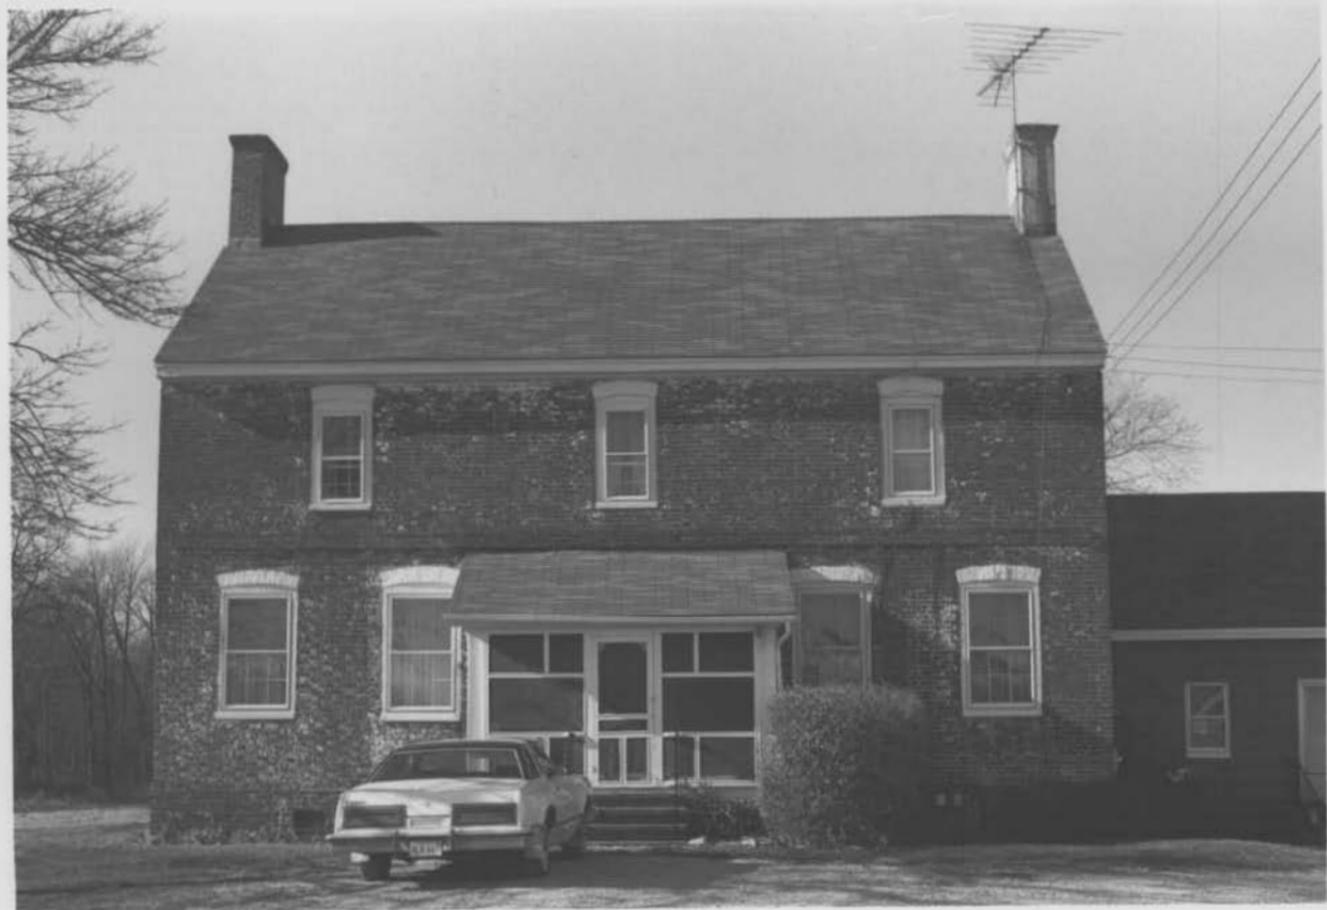
QA-130 Margaret Hammer Farm  
Wye Mills vicinity  
Orlando Ridout V 1981  
Front facade from East

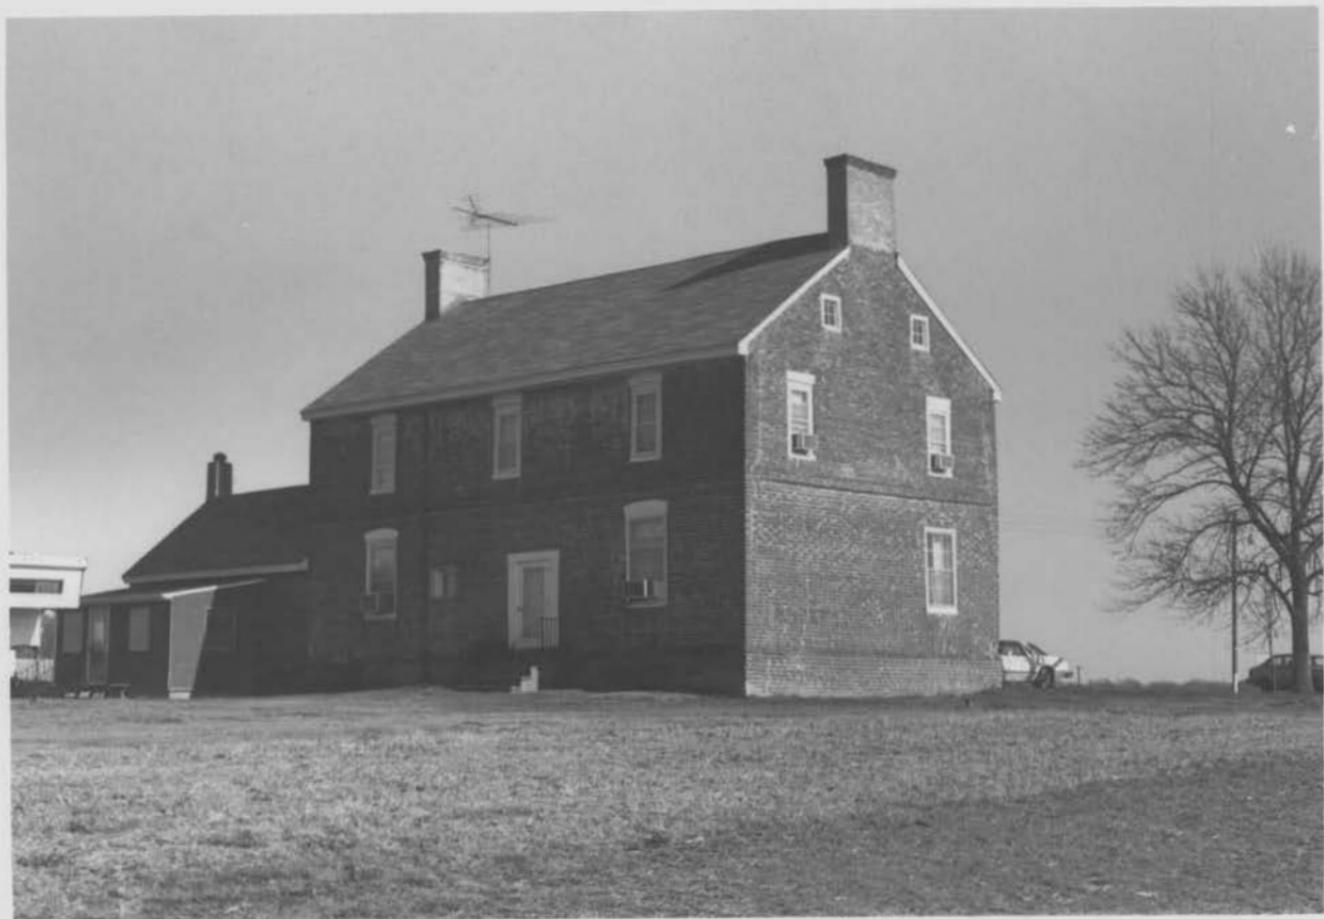
QA-130 Margaret Ham<sup>n</sup>mer Farm  
Wye Mills vicinity  
Orlando Ridout V 1981  
Rear facade from Southwest
