QA-230
Locust Hill
Centreville
Private

circa 1790-1815

Locust Hill is a large frame house with Federal details and a frame wing that incorporates an earlier one story frame structure. The house was probably constructed either by the Nicholson family in the period circa 1790-1812 or by Thomas B. Turpin circa 1812-1815. The house has been carefully preserved by successive generations of the Turpin family. In addition to the house and wing a brick meat house and a second building believed to be a slave quarter have survived as well as a 19th century garden and the Turpin family cemetery, one of the largest and most carefully maintained family graveyards in the county.

INVENTORY FORM FOR STATE HISTORIC SITES SURVEY

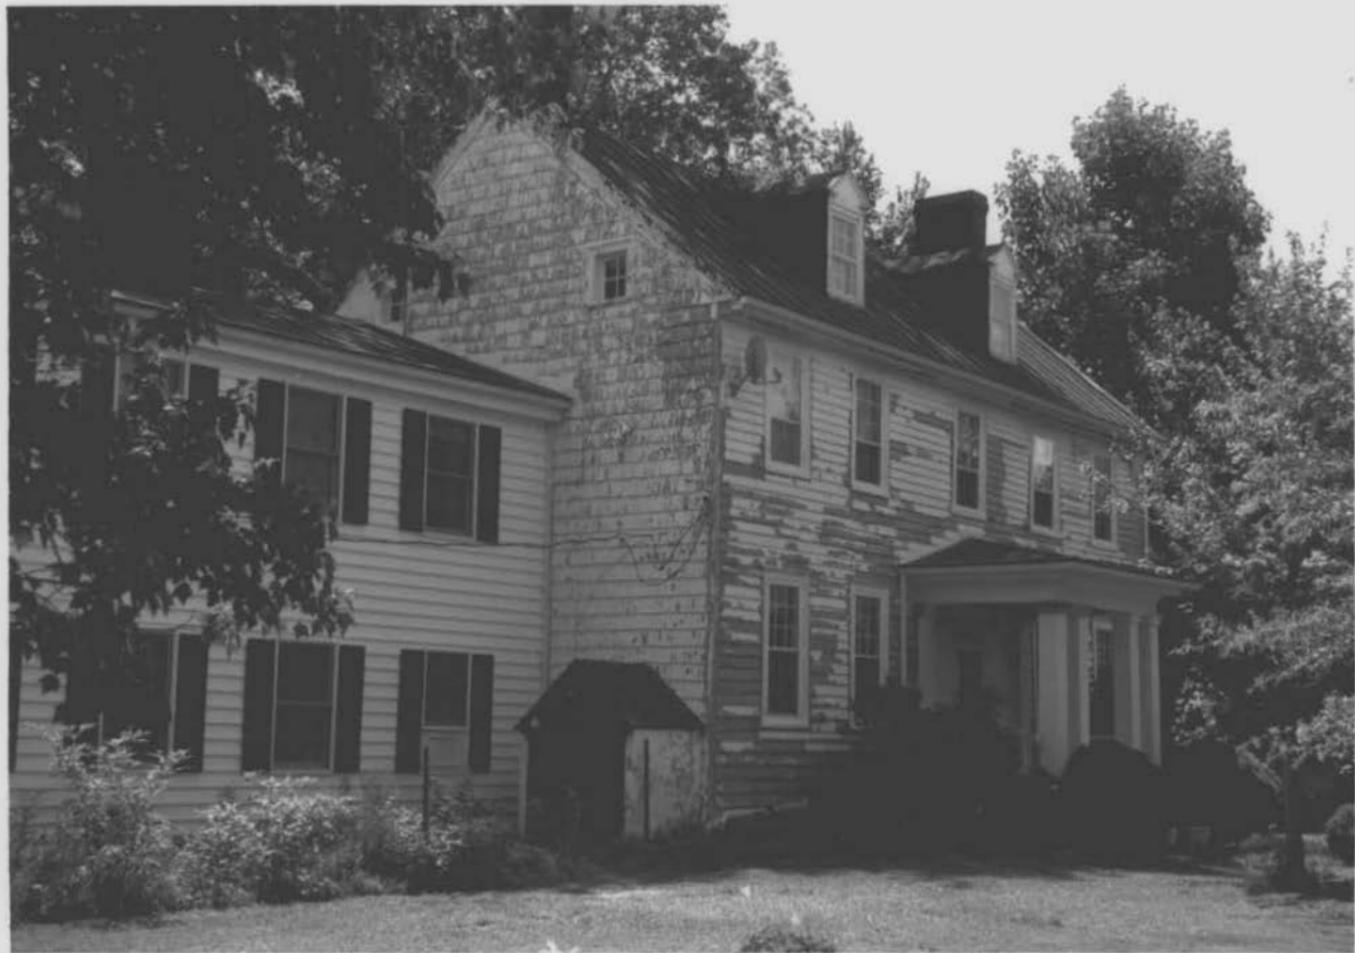
QA-230 Loust Hill

Main house + wing from Northwest
during preparations to paint exterior

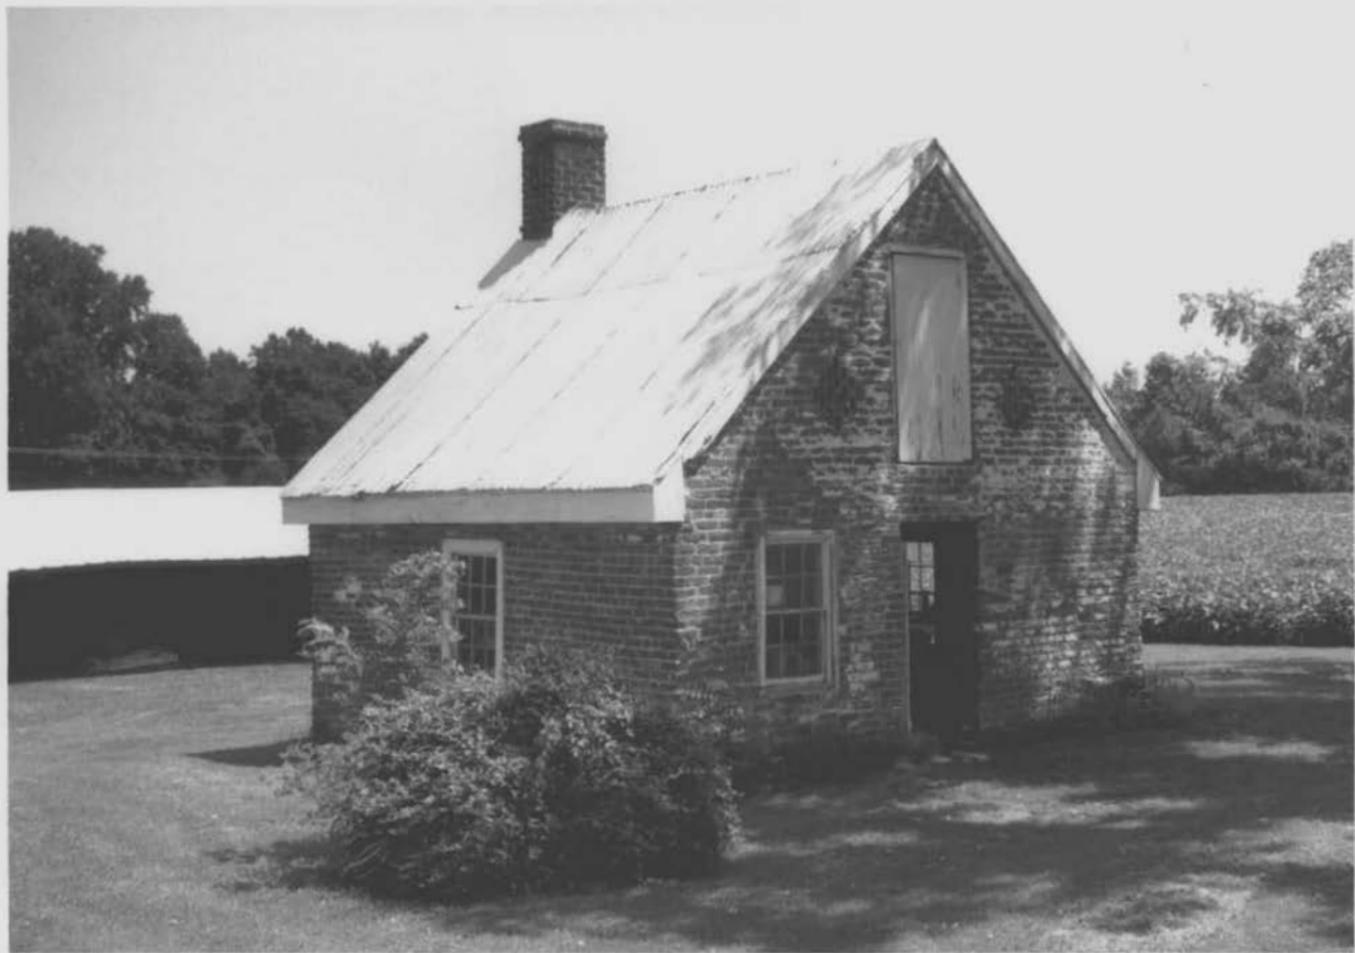
QA-230 Lonest Hill

Brick kitchen + quarter from Southwest

The principal entrance is centered in the south gable wall, with one 6/6 to the left and a second door centered in the upper gable, flanked by diamond pattern ventilators in the brickwork. The first floor door opening has been heavily repaired but is presumably original. The window to the left of the first floor door appears to be cut in, while the second floor door opening appears to be original. The rakeboards have been replaced.

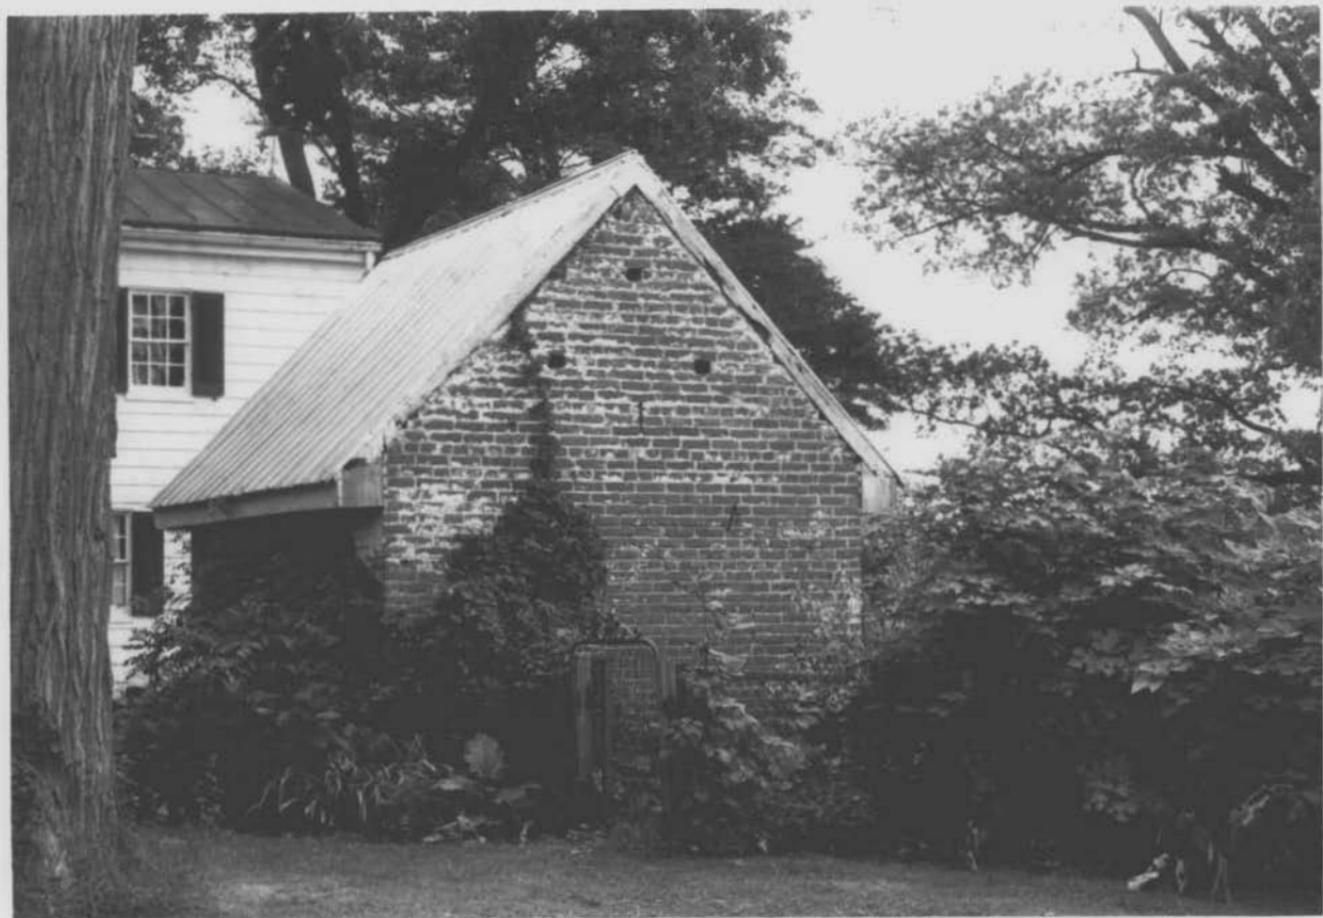
QA-230 Locust Grove
Centreville, Maryland
Orlando Ridout V 1981
Brick meat house

Located approximately 25 feet to the east of the wing is a brick meat house, 12 feet wide and 16 feet long. It has a pitched gable roof oriented on an east-west axis with a beaded batten door centered on the west gable wall. The brickwork is three course bond; the eaves are boxed in; the roof is covered with standing seam metal. One early beaded rakeboard has survived intact, the rest are badly weathered or replaced. There are three small vent holes in the upper gable of the east wall; similar holes in the west gable have been filled with bricks.

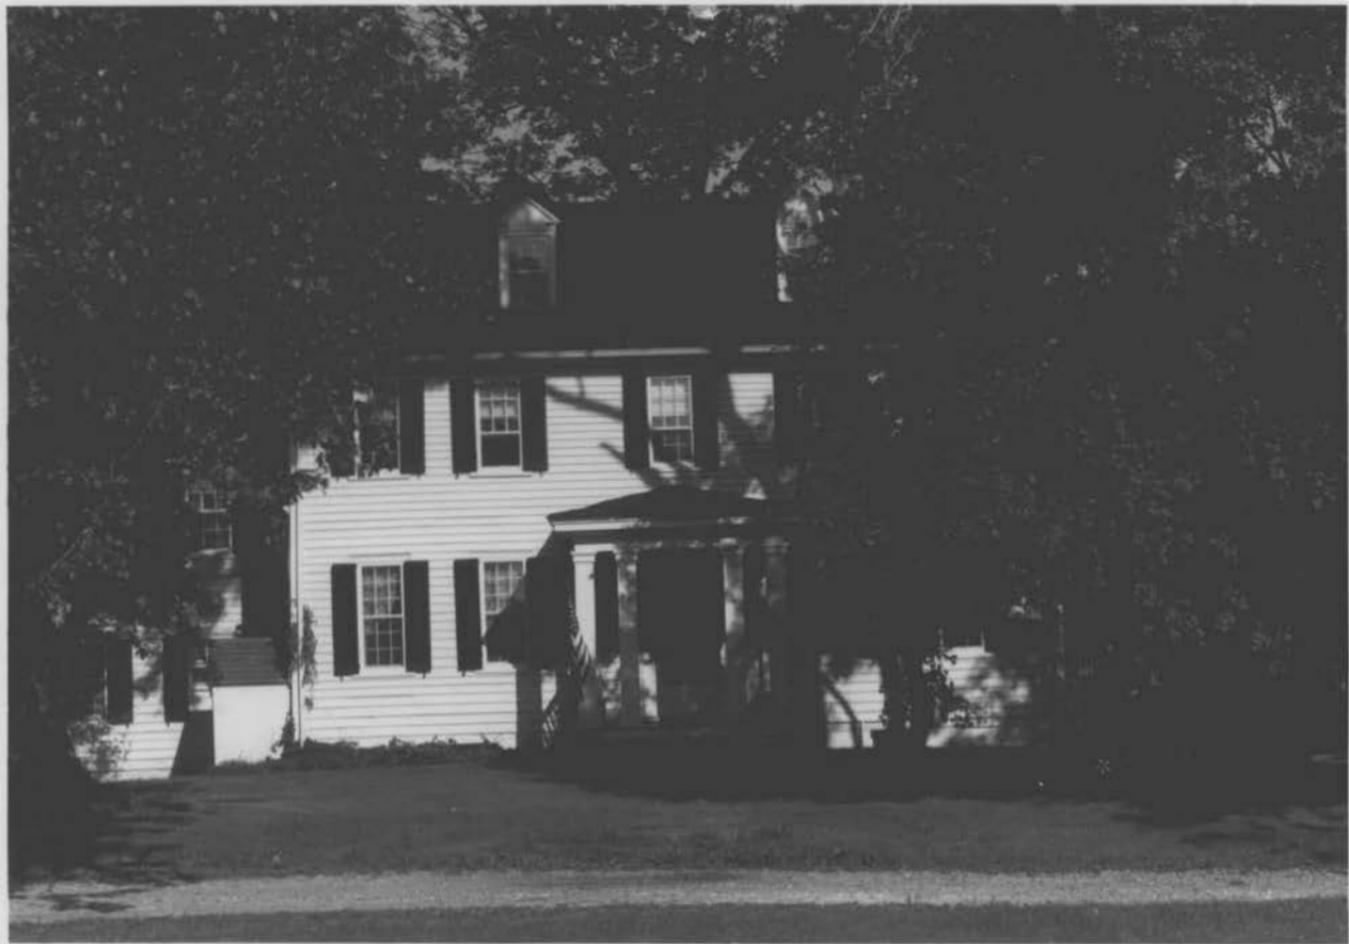
QA-230

Locust Hill
Centreville, Maryland
Orlando Ridout V 1980
Front facade from Northwest

The front facade of the main house faces west, toward Centreville. The entrance is in the center bay, flanked by two 9/9 windows on each side. There are five 9/6 windows on the second floor and two 6/6 pitched roof dormers on the third floor. Two three-light cellar windows pierce the stuccoed brick foundation. The siding

consists of 20th century beaded weatherboards with beaded cornerboards; the eaves are finished with a simple box cornice. The existing standing-seam metal roof replaces earlier wood shingles. A small, one story entrance porch protects the door in the center bay, which has a four-light transom, but no sidelights.

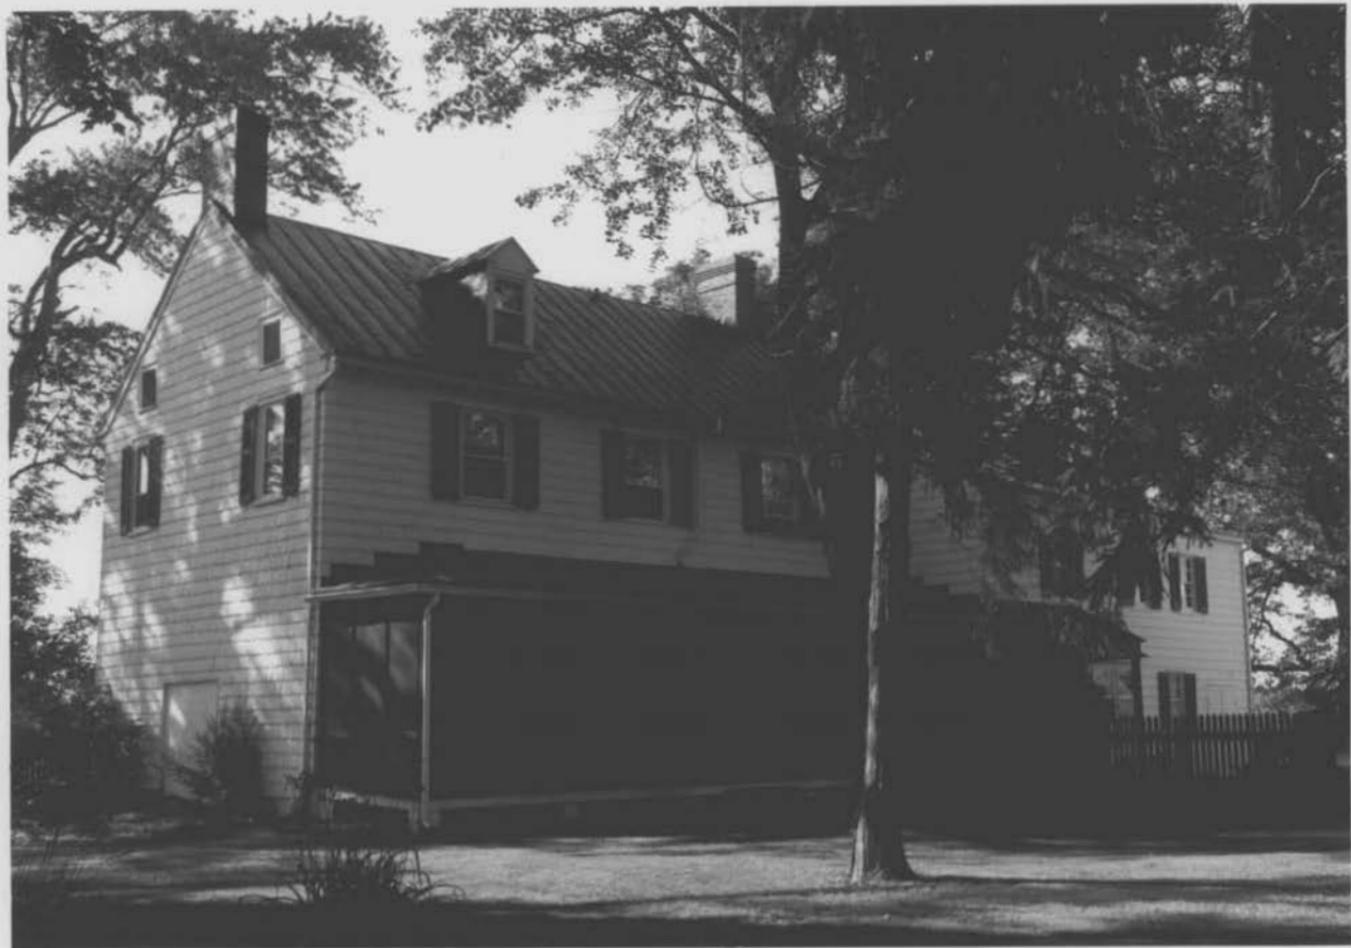
QA-230

Locust Hill
Centreville, Maryland
Orlando Ridout V 1980
Rear facade from Southeast

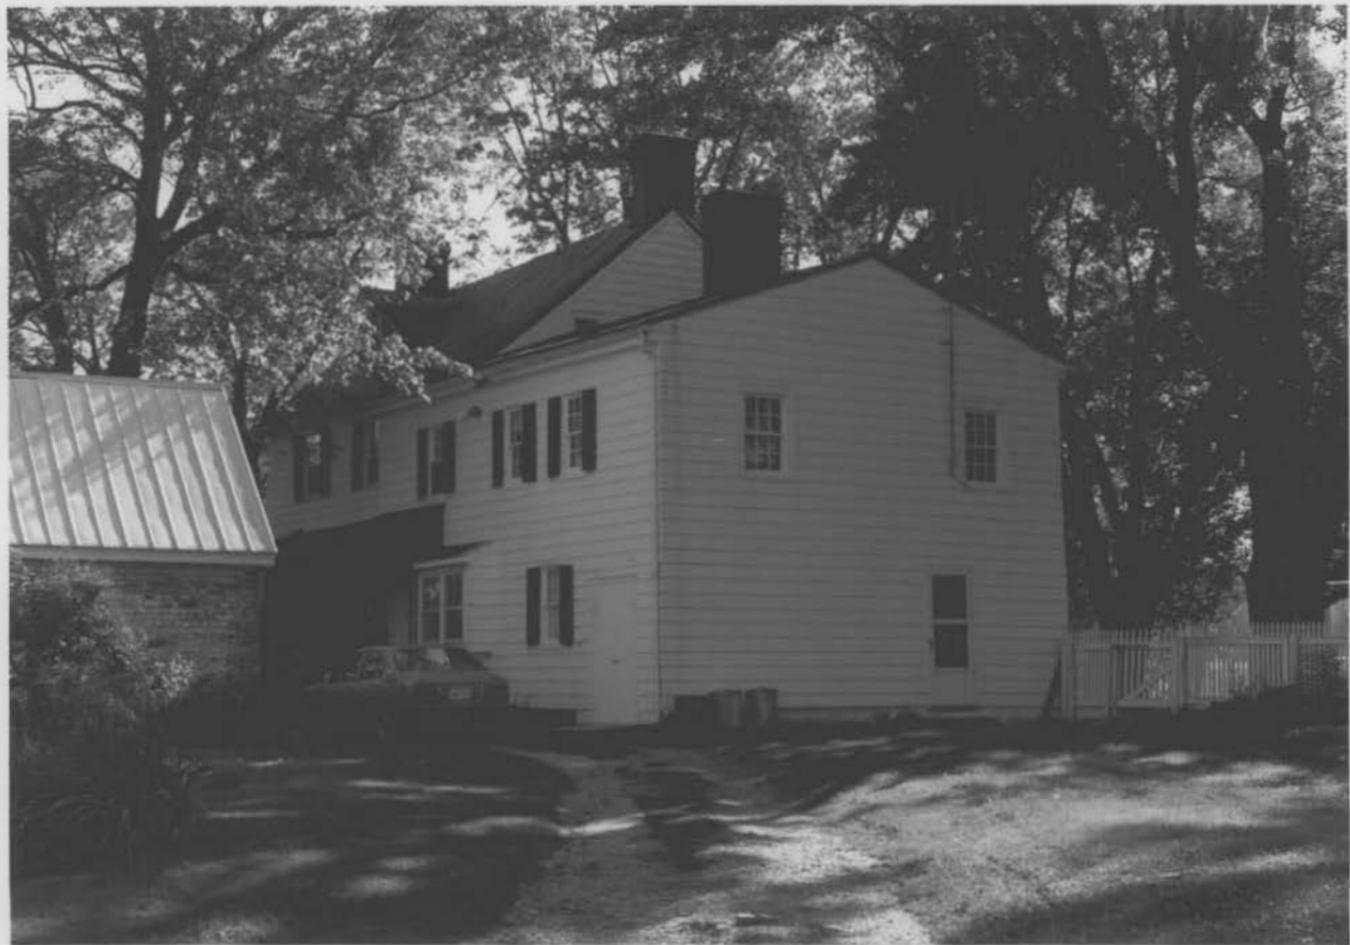
QA-230

Locust Hill
Centreville, Maryland
Orlando Ridout V 1980
House and wing from Northeast

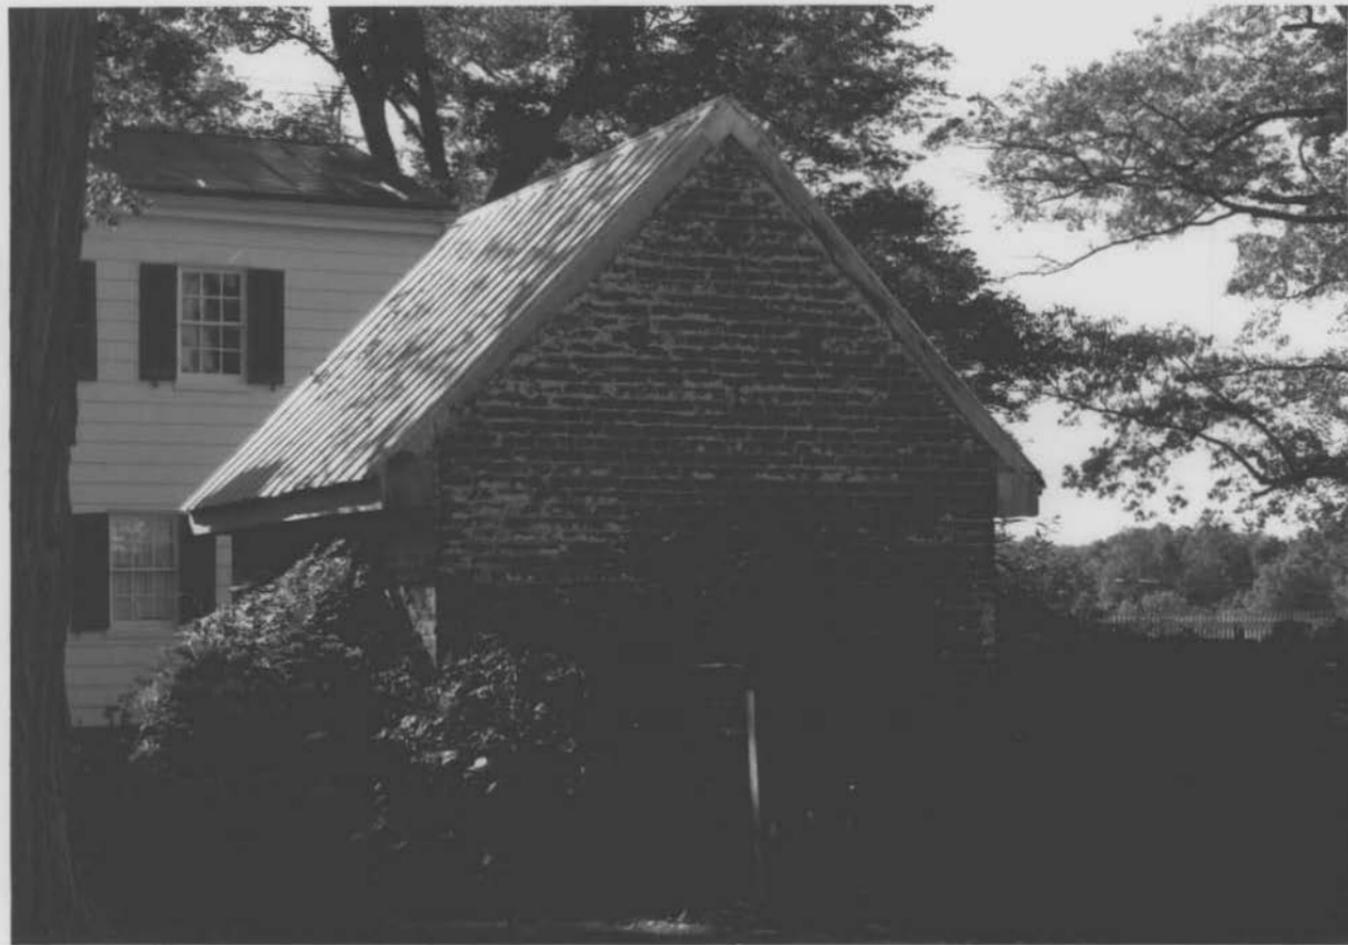
QA-230

Locust Hill
Centreville, Maryland
Orlando Ridout V 1980
Meat House
