INVENTORY FORM FOR STATE HISTORIC SITES SURVEY

AND/OR COMMON
 Gunther Farm

2 LOCATION
 STREET & NUMBER
 North side Back Starr Road
 CITY, TOWN
 Starr VICINITY OF
 CONGRESSIONAL DISTRICT
 1st
 STATE
 Maryland COUNTY
 Queen Anne's

QA-423

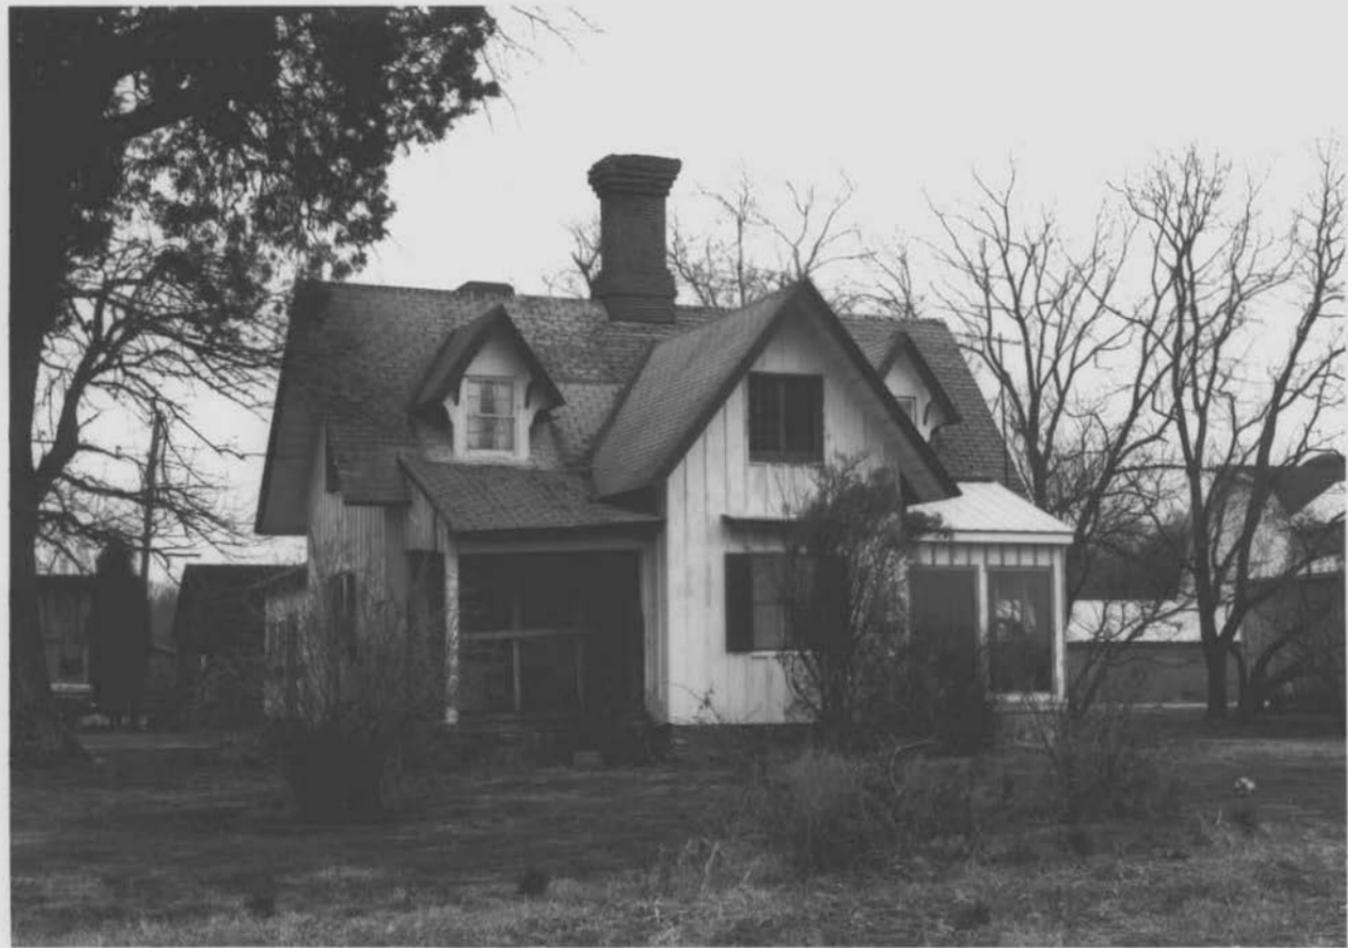
QA-423 Gunther Farm
Back Starr Road
Starr vicinity
Orlando Ridout V Dec. 1980
View from southwest

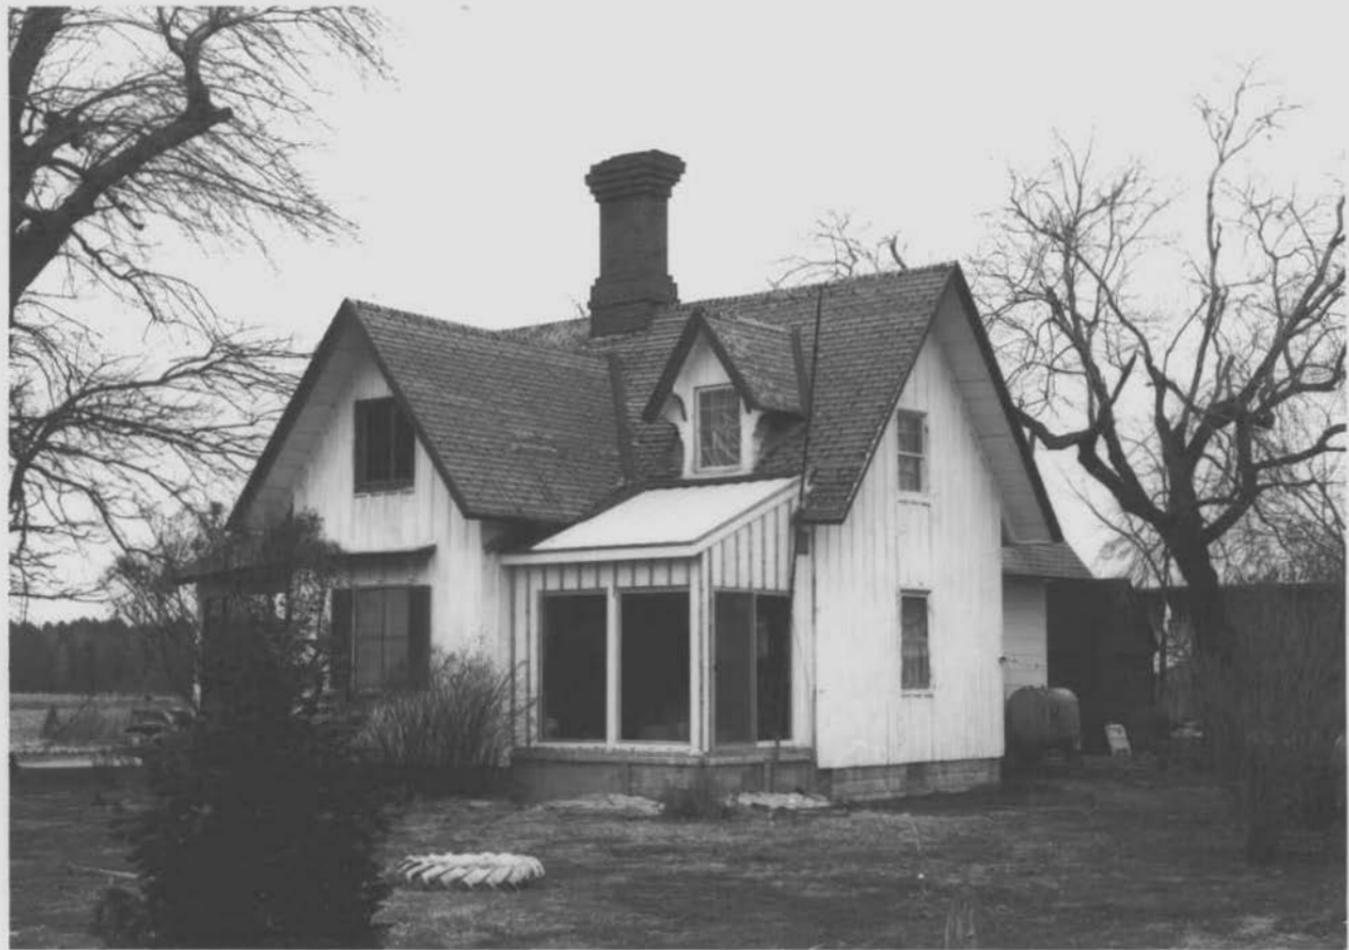
QA-423 Gunther Farm
Back Starr Road
Starr vicinity
Orlando Ridout V Dec. 1980
View from south

The front projecting wing rests on a continuous brick foundation. A pair of original 18-light wood casement windows is centered on the first floor, protected by a projecting window hood or pent supported by three scrolled and chamfered brackets. Paired original 15-light casement windows are centered in the upper gable. The board-and-batten siding consists of machine sawn vertical sheathing with wide, beveled battens. The roof oversails at the gable eaves and is left exposed underneath, with a simple molded three-piece verge board. As previously noted, the door on the west wall of the front wing survives, the door on the east wall has been blocked.

as the eaves of the house. To the east of the projecting wing, the first floor window has been replaced with sliding glass doors opening onto the enclosed porch. The original dormer survives on the second floor. The large front chimney rises from the center of the house. It corbels in about one foot above the ridge and then corbels out again above a straight shaft.
