QA-48

James Clements Farm
Sudlersville
Private

circa 1760-1790

INVENTORY FORM FOR STATE HISTORIC SITES SURVEY

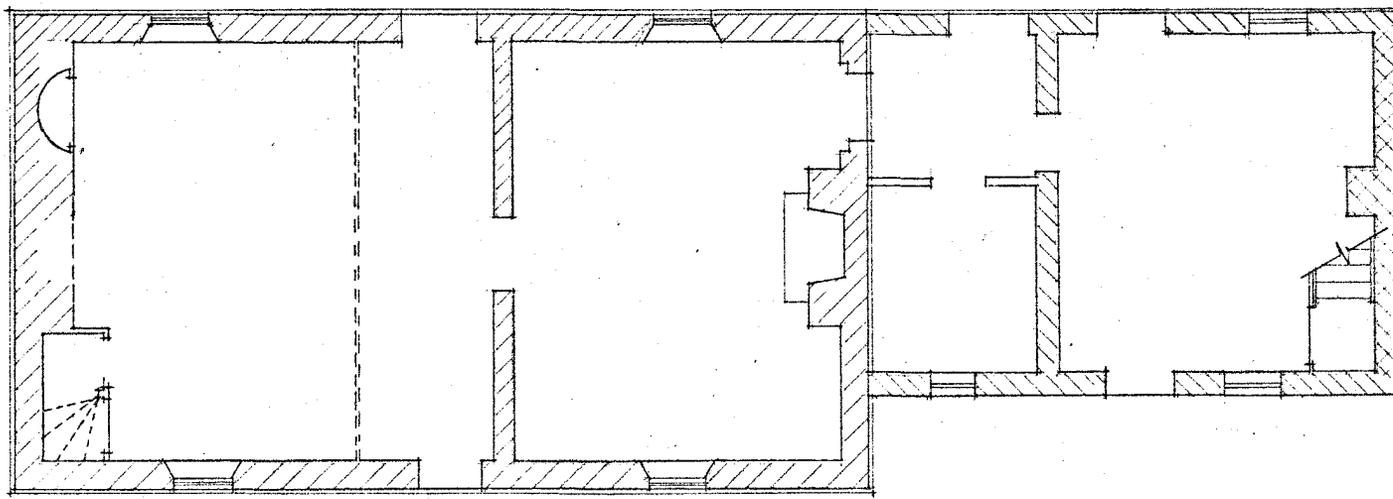
JAMES CLEMENTS FARM
SUDLERSVILLE, MARYLAND

- ▨ PERIOD I: C. 1780
- ▩ PERIOD II: C. 1800
- ▧ PERIOD III: 20th C. REPAIR

Evidence found concealed below the modern stairway suggests that the present hall-parlour plan is a modification of an earlier, though not necessarily original center hall plan. A scar remains in the plaster below the stair from a one-inch board partition which formed a hallway approximately 5½ feet wide. The early baseboard and chairrail remain on this section of wall, and the outline of the board partition is clearly outlined on the trim. Although the trim does cross the line of the wall, there is no paint where the partition and the corresponding trim butted against it, and a pair of carefully cut notches in the baseboard show where the partition baseboard was mitred into place. The seam in the plaster also indicates that the partition was put in before the wall was plastered, and not as an afterthought.
