QA-59

Franklin Prickett Farm
Church Hill vicinity
Private

INVENTORY FORM FOR STATE HISTORIC SITES SURVEY

Franklin Prickett Farm

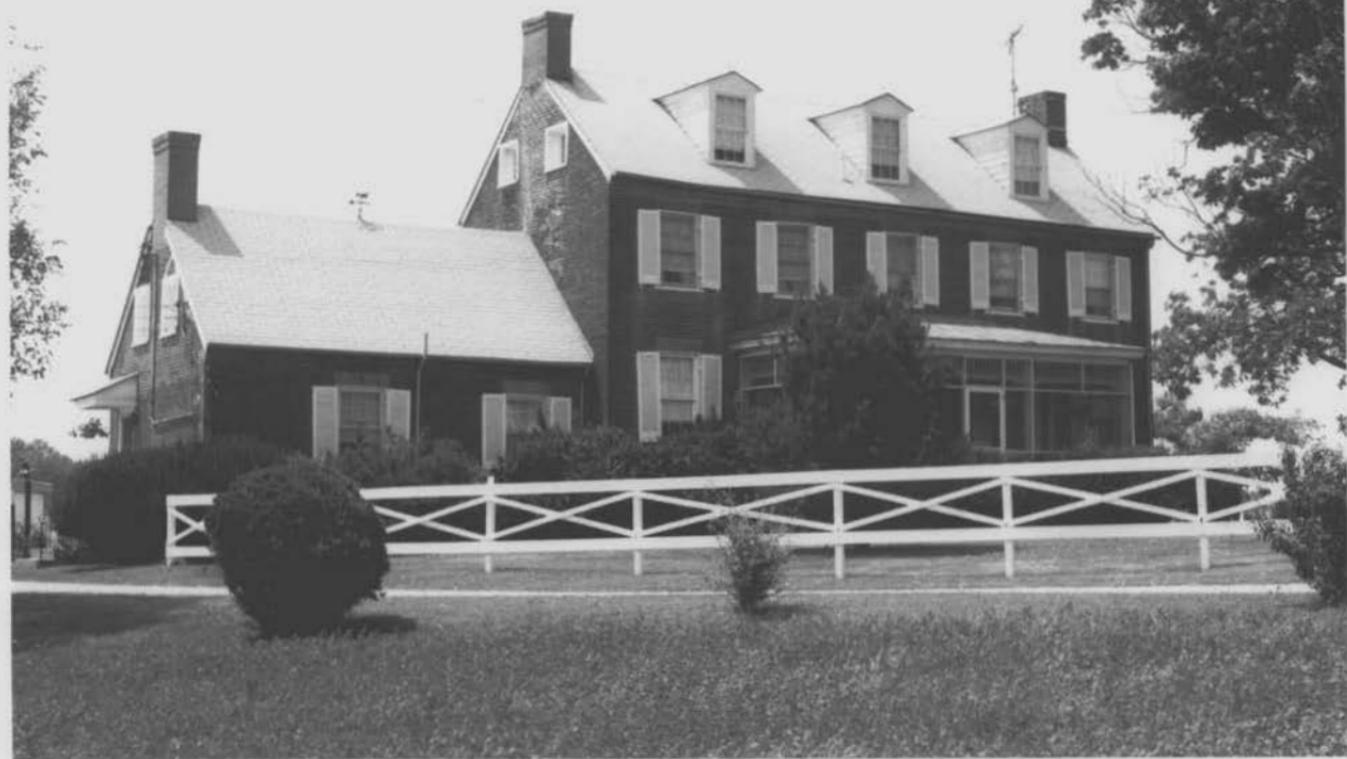
QA-59 Franklin Prickett Farm
Flat Iron Square
Church Hill vicinity
Orlando Ridout V 1980
View from SE

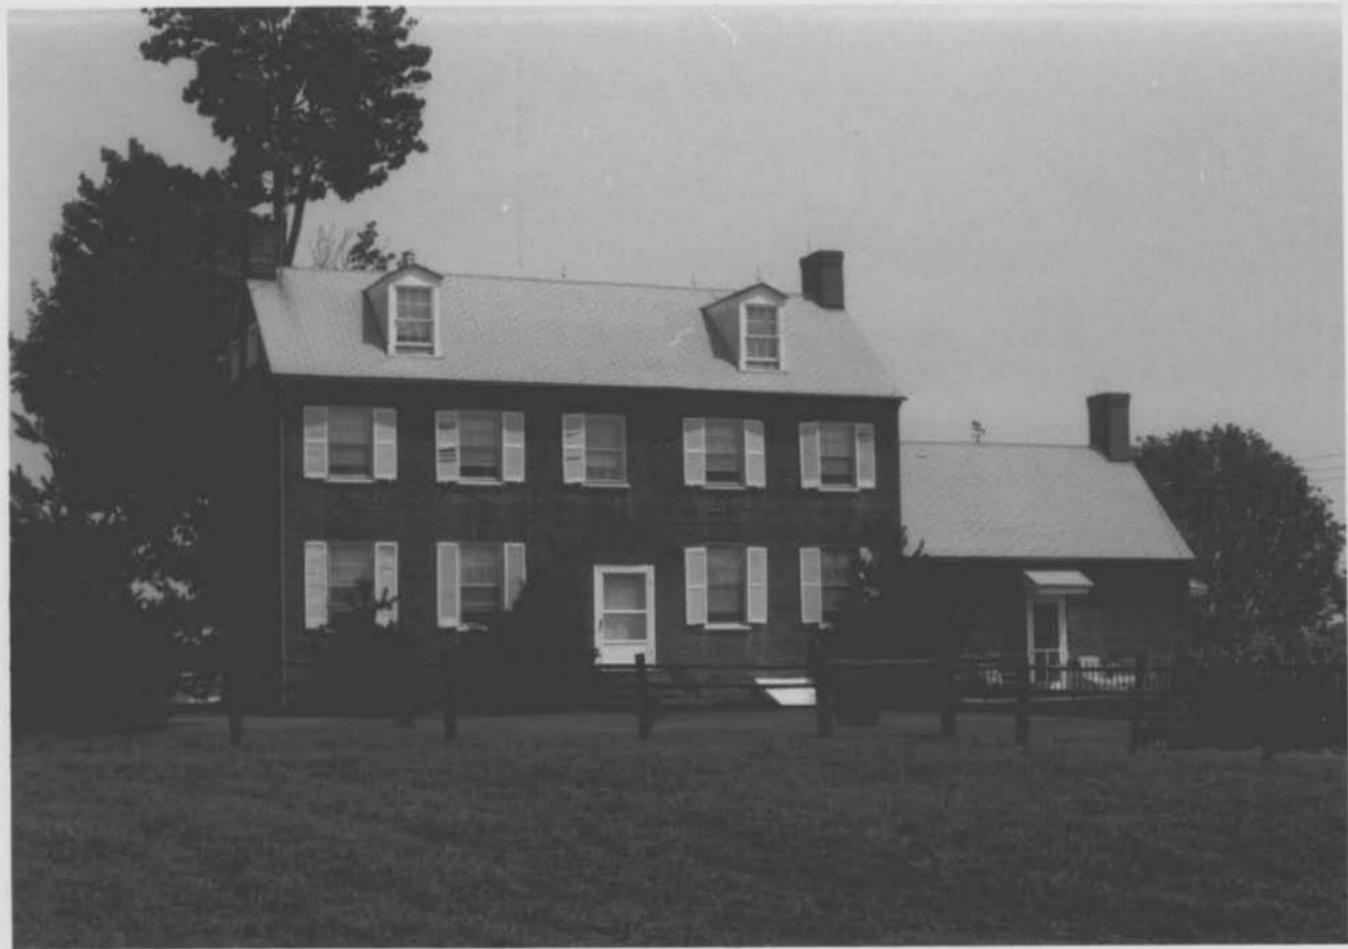
QA-59 Franklin Prickett Farm
Flat Iron Square
Church Hill vicinity
Orlando Ridout V 1980
View from west
