QA-79

Upper Heathworth  
Burrisville vicinity  
Private

INVENTORY FORM FOR STATE HISTORIC SITES SURVEY

HISTORIC  
Upper Heathworth  
AND/OR COMMON

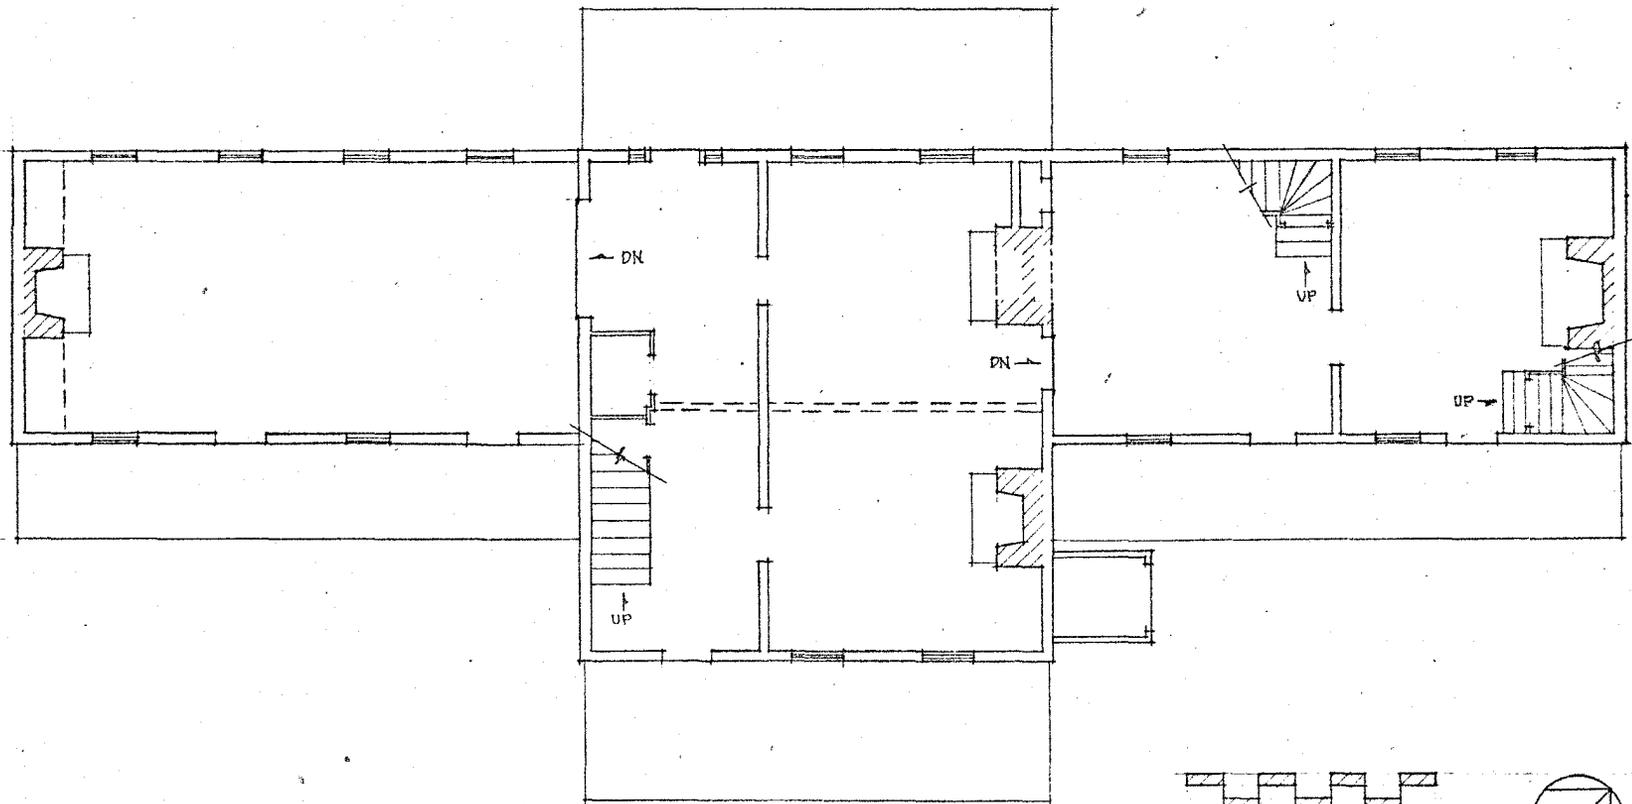
0 2 4 6 8 10 12 14  
SCALE: 3/32" = 1'-0"

UPPER HEATHWORTH  
BURRISVILLE, MARYLAND

JUNE 23, 1978.

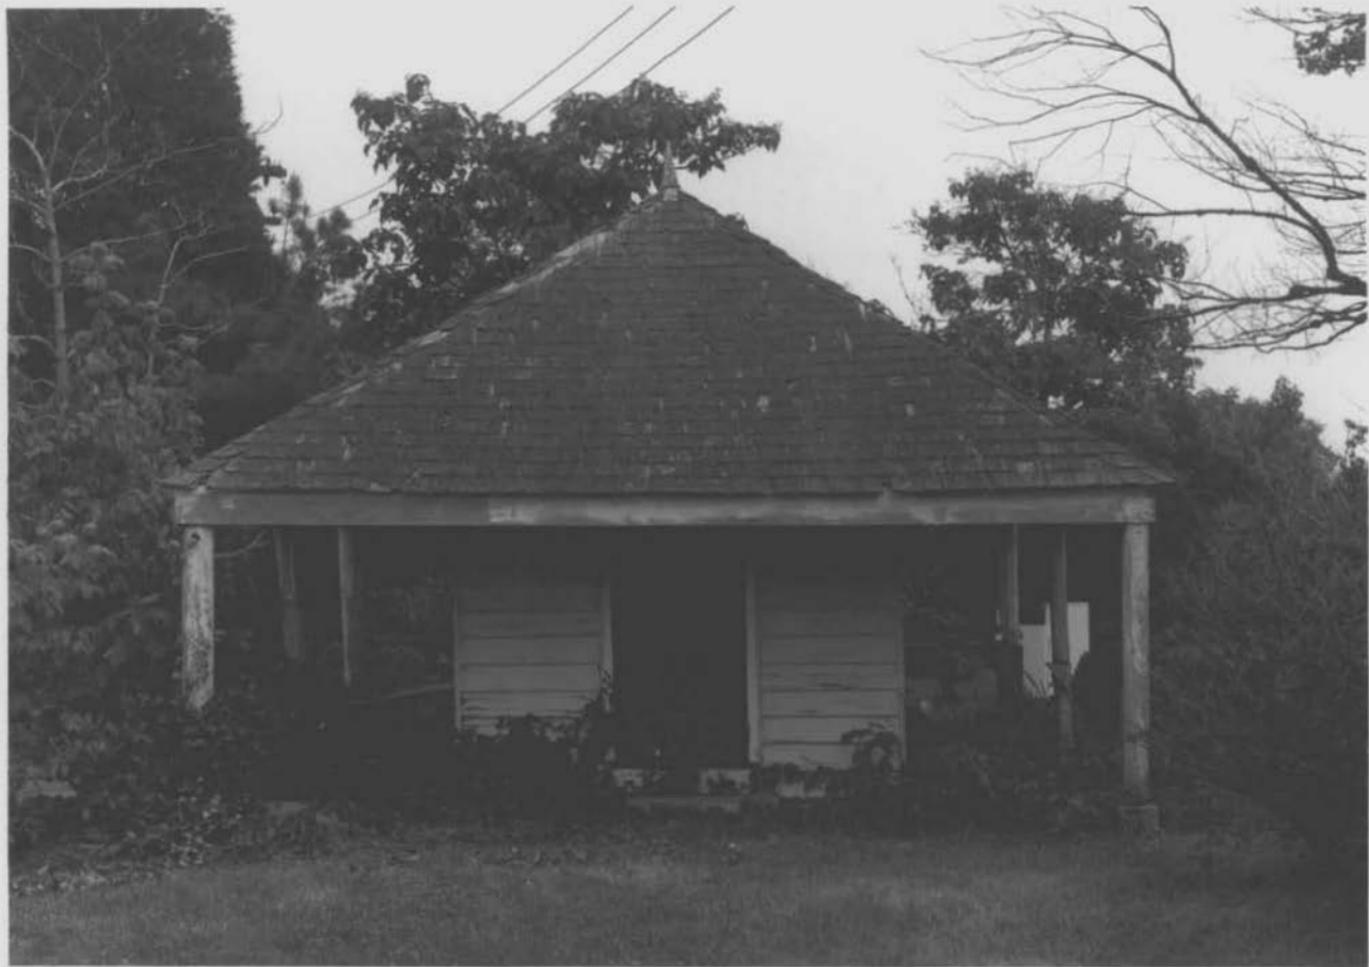
QA-79 Upper Heatworth Dairy  
Burrisville vicinity, Md.  
Orlando Ridout V, 1978 (MHT)  
NW facade, camera facing SE

To the east of the main house, directly behind the northeast wing, there is a small frame dairy with a large overhanging pyramidal roof. The dairy building is approximately eight feet square, with a beaded batten door centered on the northwest facade, toward the house, and a single six-over-six window centered on each side wall. It sits on a brick foundation that encloses a springhouse or ice-house, with access through a hinged trap door in the floor.

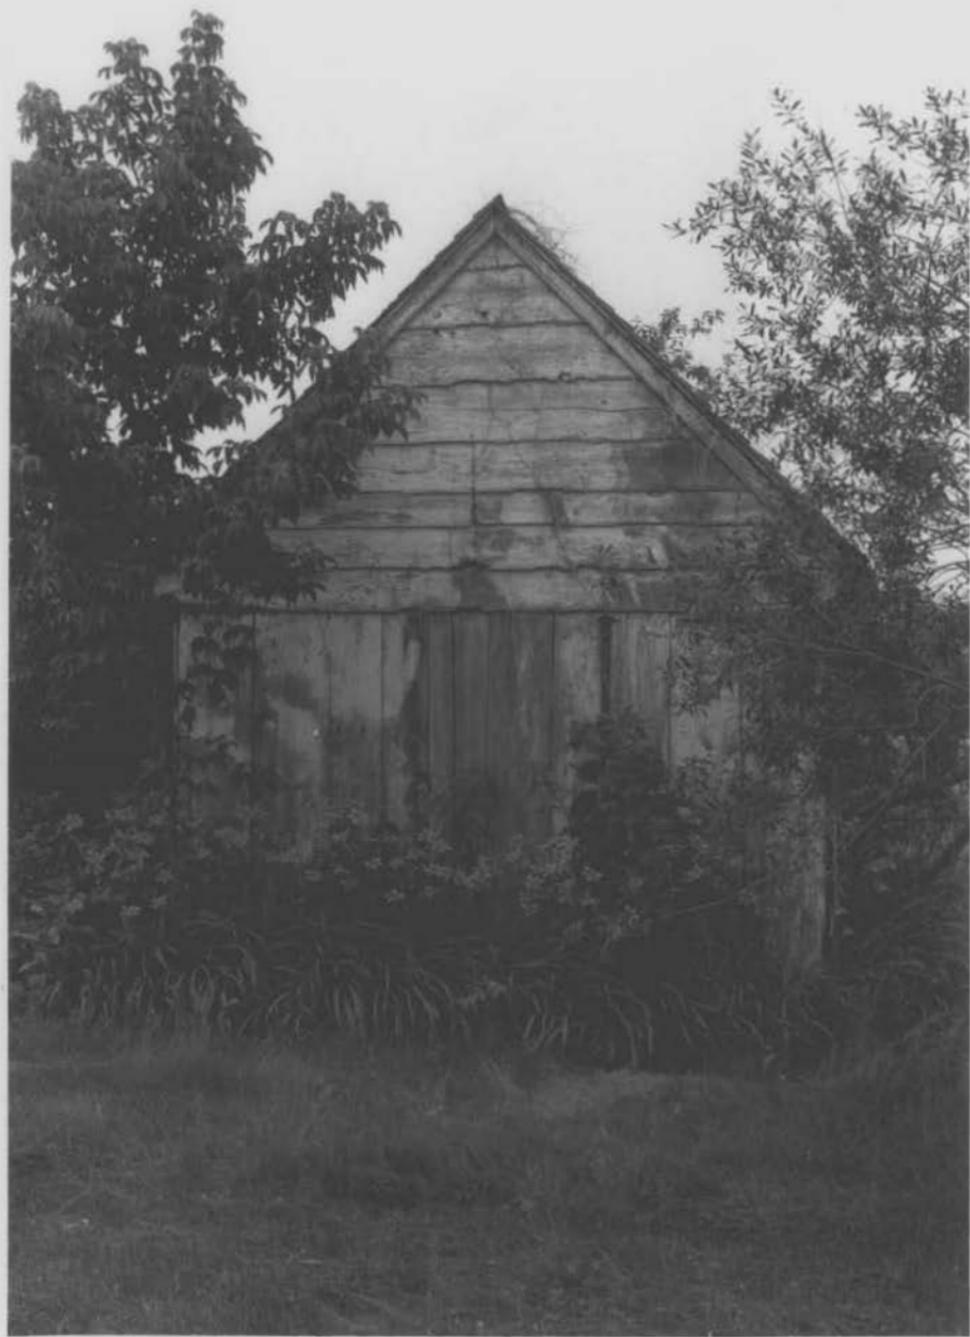
QA-79 Upper Heatworth: Meathouse  
Burrisvile vicinity, Md  
Orlando Ridout V, 1978 (MHT)  
SW Gable, camera facing NE

Two outbuildings of particular note have also survived. A small frame dairy with an overhanging pyramidal roof is located to the east of the main house, and a post-and-plank meat house is located at the eastern edge of the yard, adjoining the more recent farm buildings.
