QA-89
Pearle Walls Farm
Ingleside vicinity
Private

INVENTORY FORM FOR STATE HISTORIC SITES SURVEY

Pearle Walls Farm

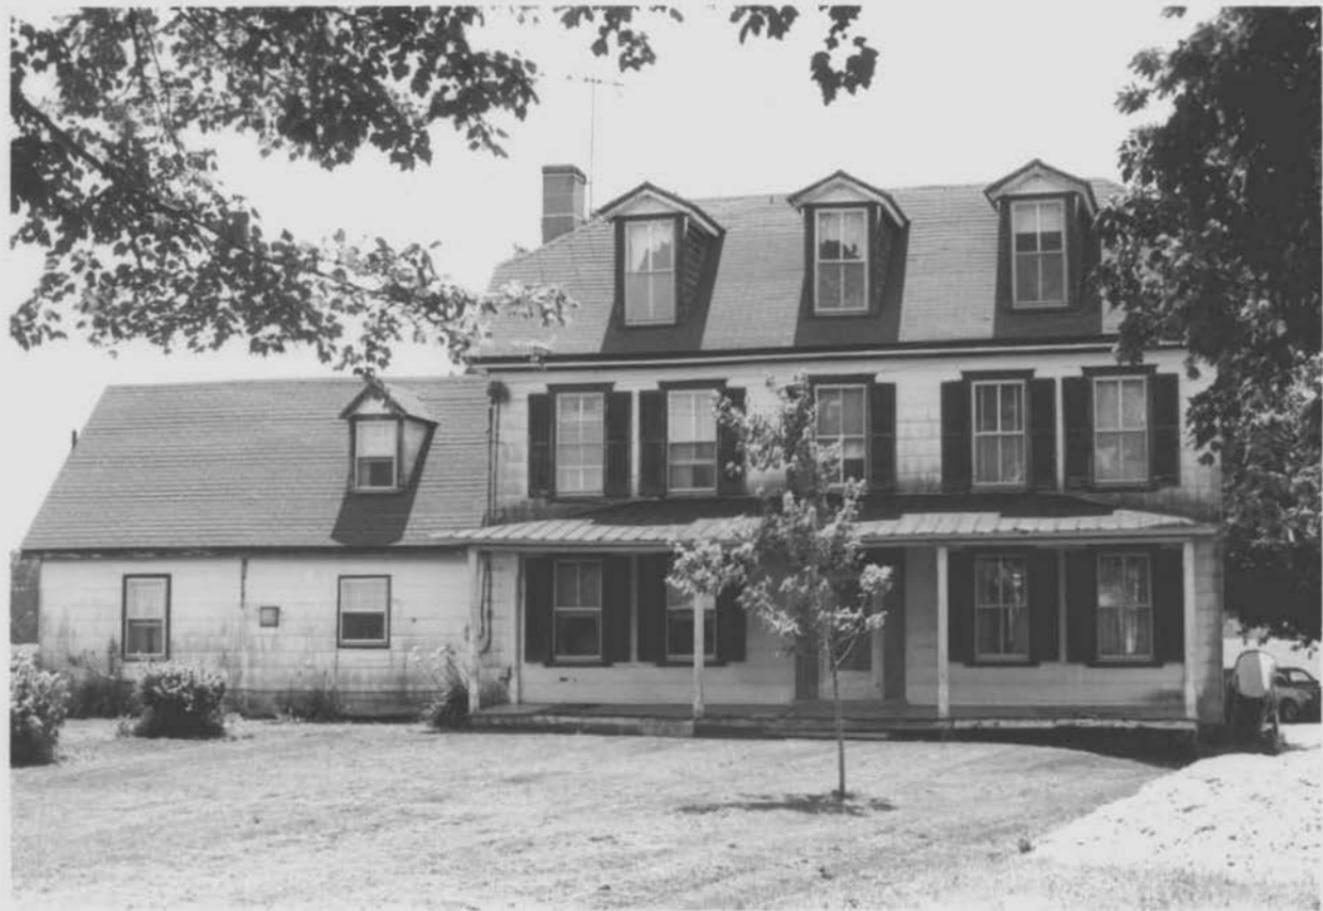
QA-89

Pearl Walls Farm
Ingleside vicinity
Orlando Ridout V 1981
Front facade from south

The principal facade faces north toward Ingleside. The door is in the center bay framed with sidelights and transom and flanked by two 2/2 windows on each side. Five 2/2 windows are ranged across the second story; there are three pitched roof 2/2 windows on the third story. The house rests on a continuous brick foundation and is covered with asbestos shingles over earlier beveled horizontal weatherboards. The eaves are boxed in and trimmed with a bold Victorian crown mold; the roof is asphalt shingle. A one story Victorian porch with chamfered posts stretches across the first story on this facade.
