QA-98
Sterling Price Farm
Centreville vicinity
Private

early 19th century, 1893

INVENTORY FORM FOR STATE HISTORIC SITES SURVEY

Sterling Price, Jr. Farm, Seegar Farm

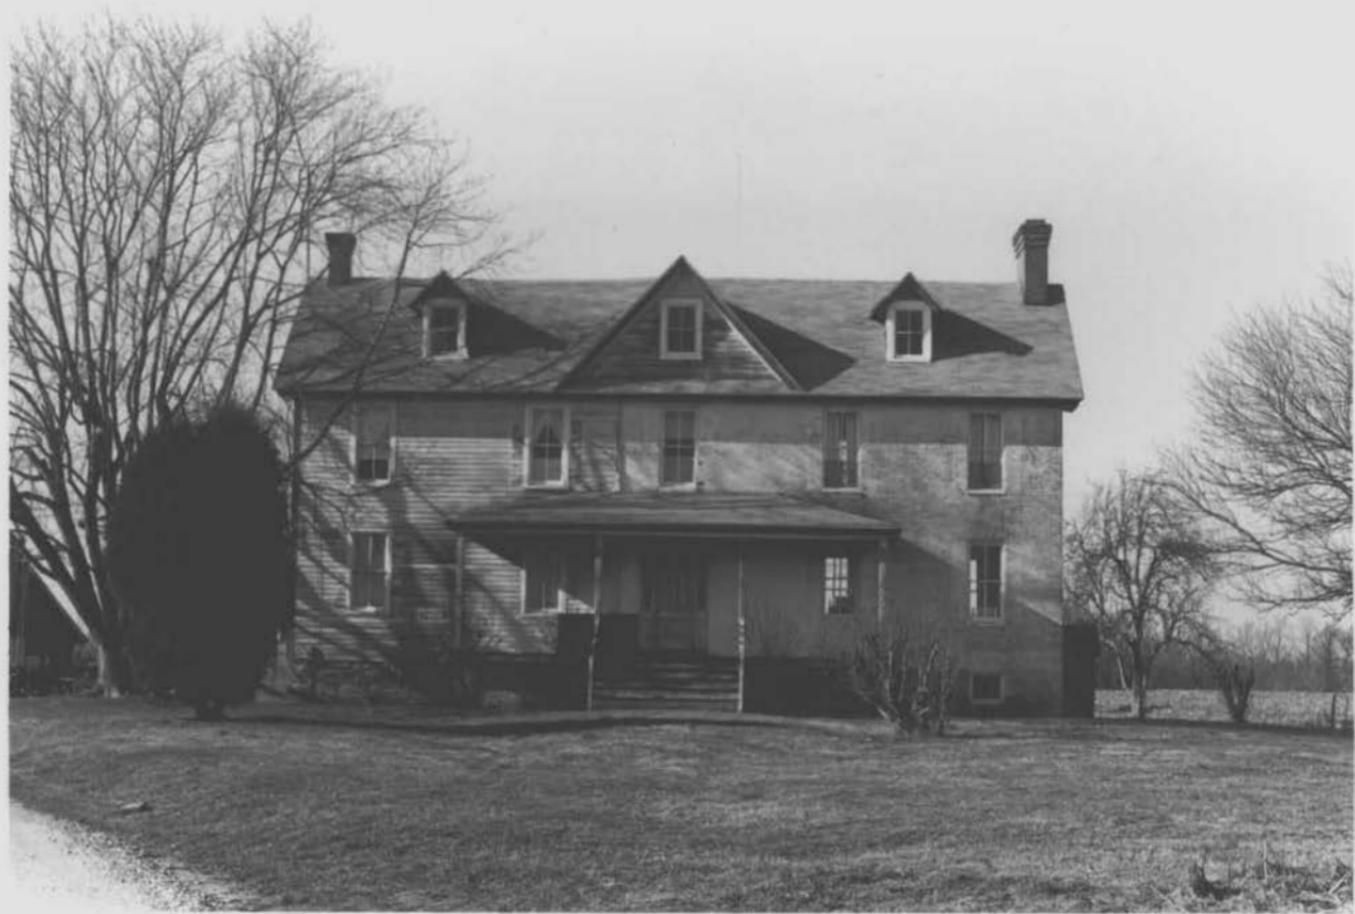
QA-98 Sterling Price, Jr. Farm
Centreville vicinity
Orlando Ridout V 1981
East (front) facade

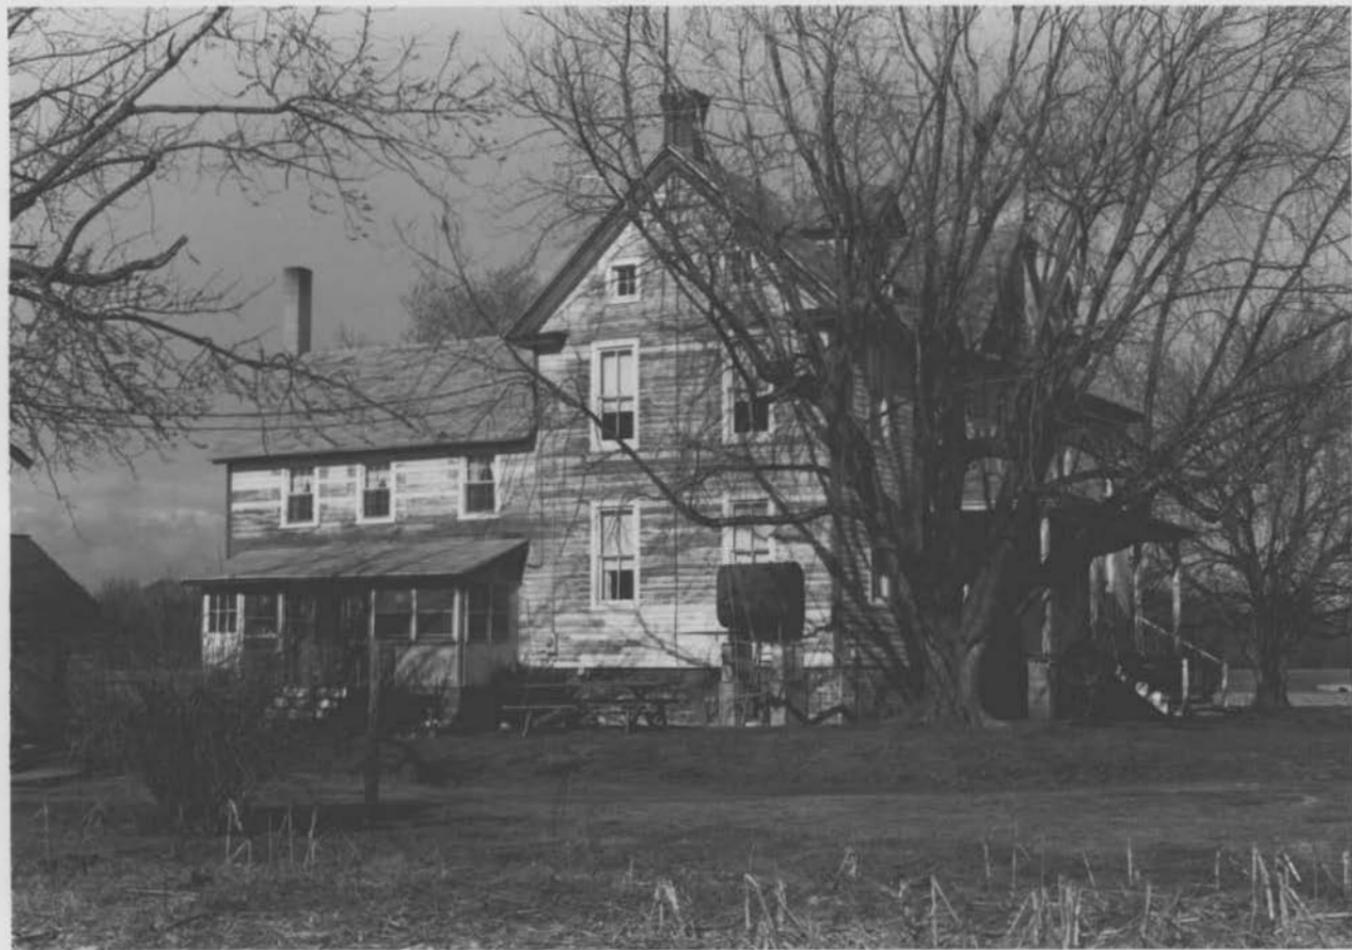
QA-98

Sterling Price, Jr. Farm
Centreville vicinity
Orlando Ridout V 1981
View from Southeast

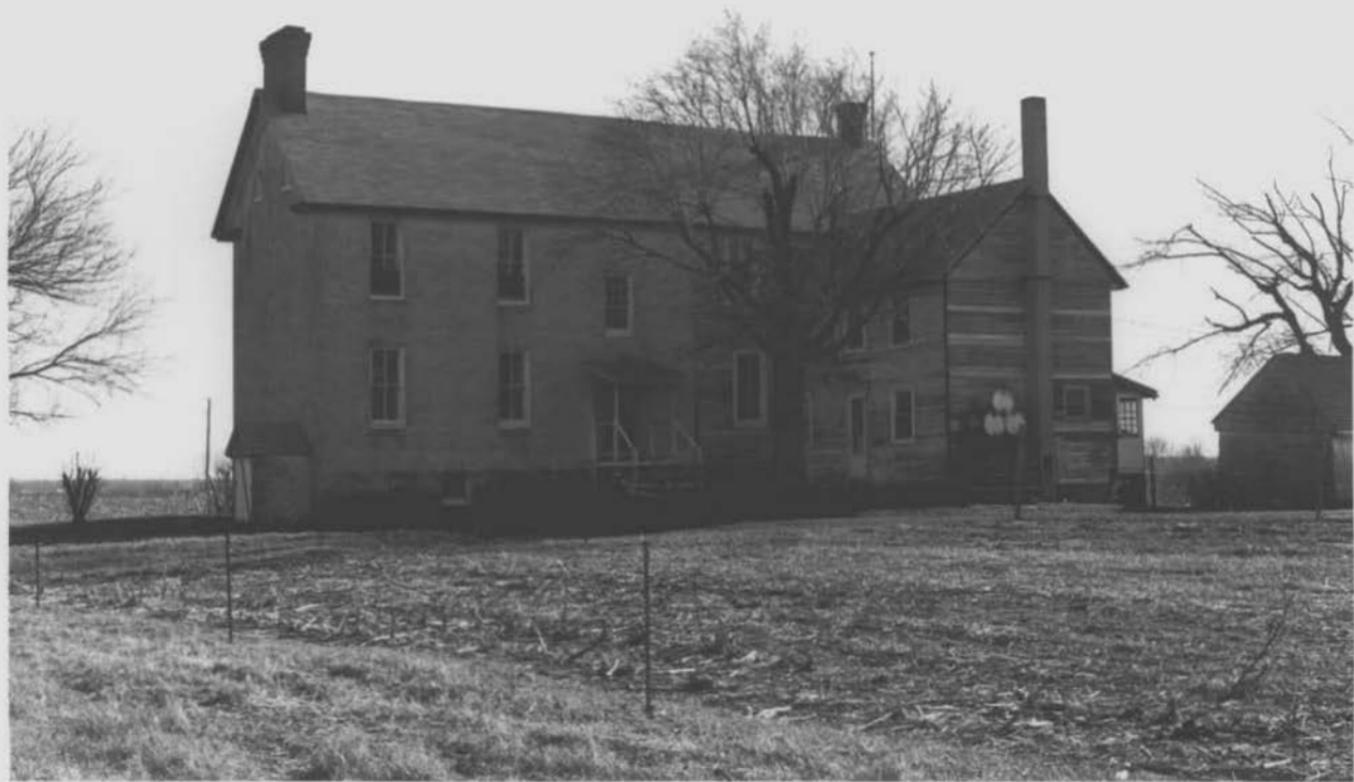
QA-98

Sterling Price, Jr. Farm
Centreville vicinity
Orlando Ridout V 1981
Rear (west) facade

There is no seam in the brick foundation between the frame addition and the rear ell, but the drop in the interior floor level is reflected in the height of the foundation, which is seven courses lower under the wing. There are doors in the center and west bays on the first floor of the wing, and a 6/6 window in the east bay. Three 6/6 windows are ranged across the second story. The siding is plain horizontal weatherboards with beaded cornerboards; the cornice is boxed. A modern exterior stove chimney rises at the center of the west gable of the rear wing. The only opening is a modern window to the right of the chimney on the first floor. On the north wall of the wing, there is a door in the center bay on the first floor, flanked by 6/6

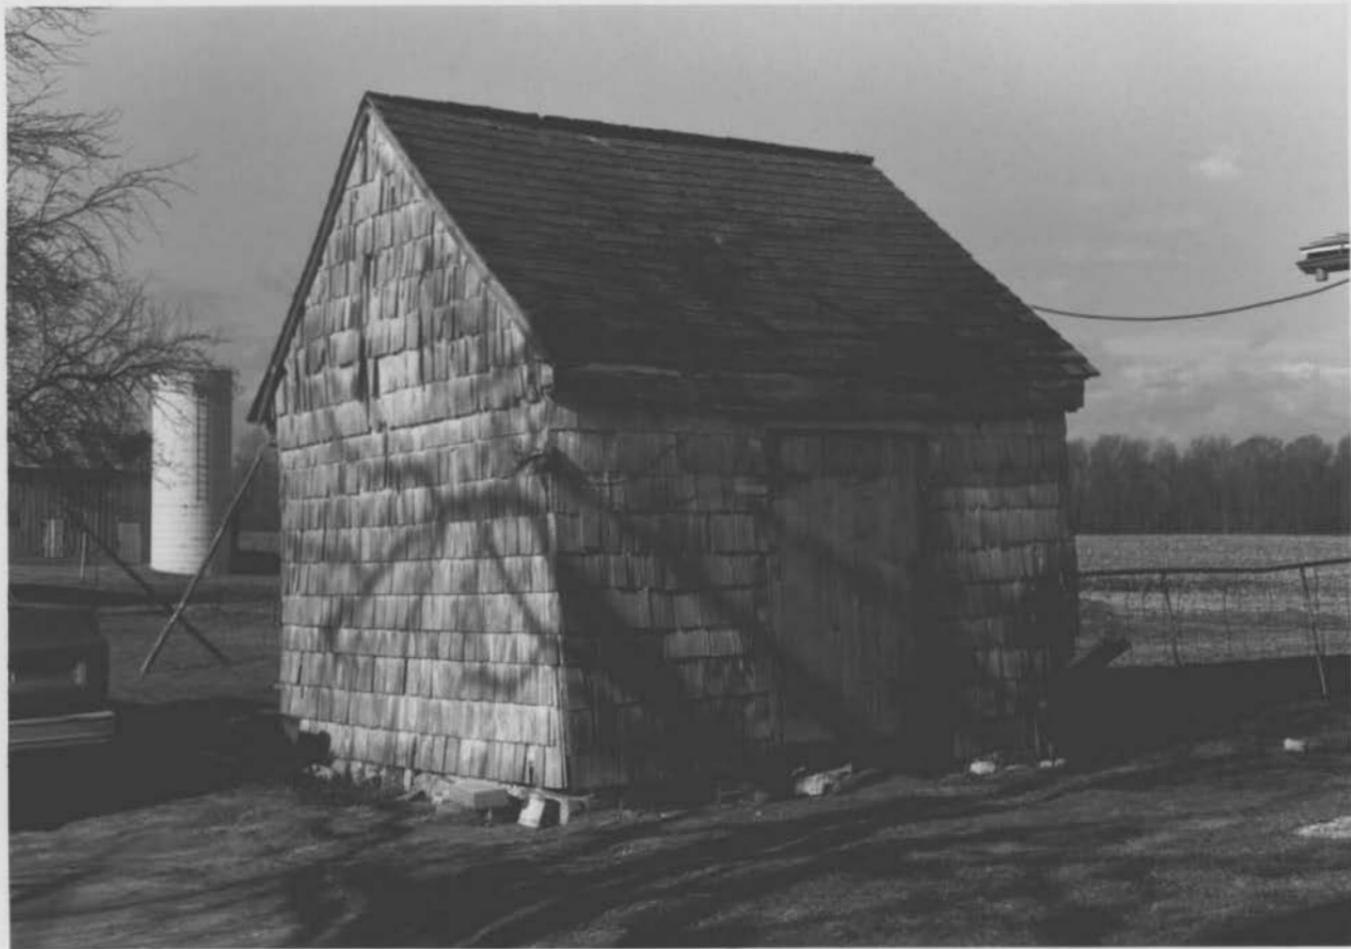
QA-98

Sterling Price, Jr. Farm
Centreville vicinity
Orlando Ridout V 1981
Post-and-Plank Meat House

Of equal interest to the house is the post-and-plank meat house in the side yard. This is one of the finest and most carefully preserved examples of this construction technique surviving in the county. The wrought and double-struck nails used in the roof framing suggest a date of circa 1800-20, making it one of the earliest surviving examples in the county. The original interior down braces in this type of construction are unusual; the solid raftered roof is unique.
