INVENTORY FORM FOR STATE HISTORIC SITES SURVEY

1 NAME
 HISTORIC
 Peace and Plenty
 AND/OR COMMON

2 LOCATION
 STREET & NUMBER
 Southeast corner U.S. 301 and Maryland 213
 CITY, TOWN
 Centreville VICINITY OF
 CONGRESSIONAL DISTRICT
 1st
 STATE
 Maryland
 COUNTY
 Queen Anne's

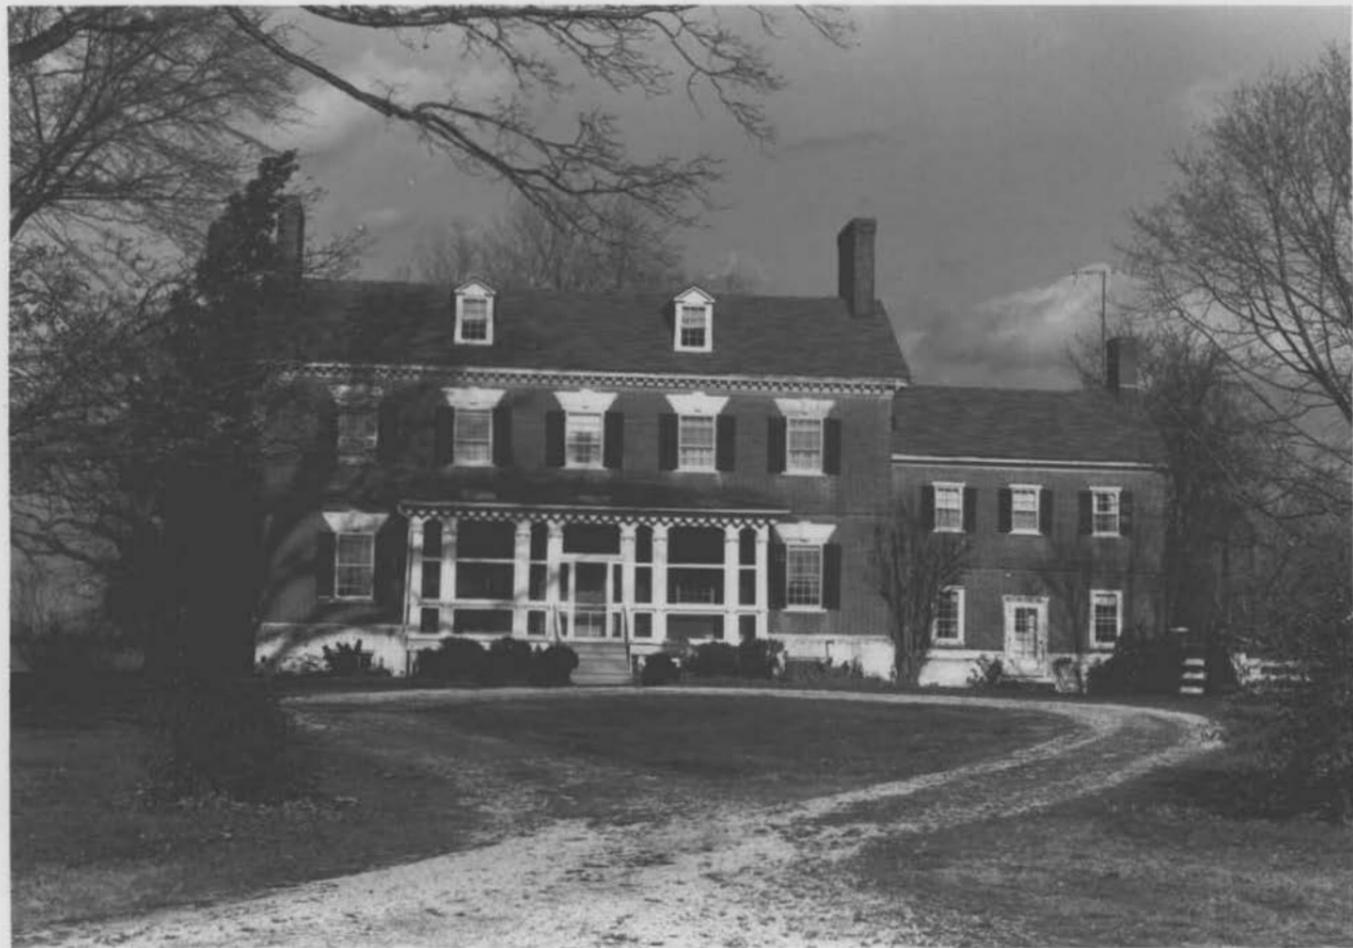
QA-99 Peace and Plenty
 Centreville vicinity
 Orlando Ridout V 1981
 South (front) facade

crown mold is quite plain and is presumably a replacement. The cornice returns at each end against the gable wall. The roof is covered with asphalt shingles. A one story 19th century porch with a hip roof protects the center three bays, replacing an earlier (presumably original) entrance porch in the center bay. One brick pier survives from the earlier porch, concealed by the existing porch.

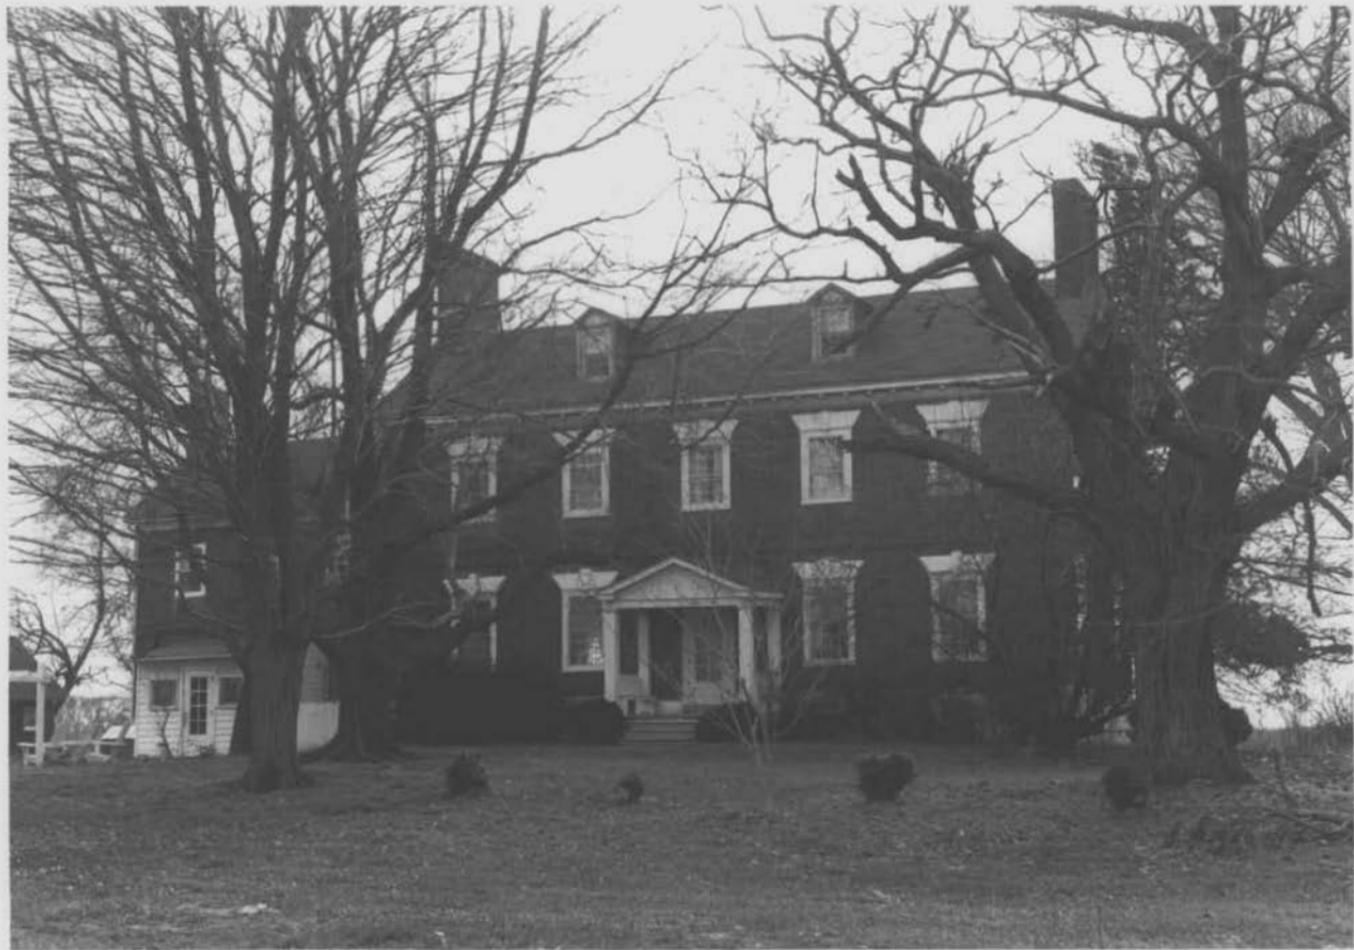
Peace and Plenty
Centreville vicinity
Orlando Ridout V 1981
North facade

all date to the second quarter of the 19th century. The west cellar window has been bricked up and the bulkhead cellar entrance has been shifted from the right of the door to the left of the door. The brickwork matches the front facade as well. The rusticated lintels have been replaced in the east and west bays on the first story. A one story entrance porch in the center bay probably dates to the early 20th century.

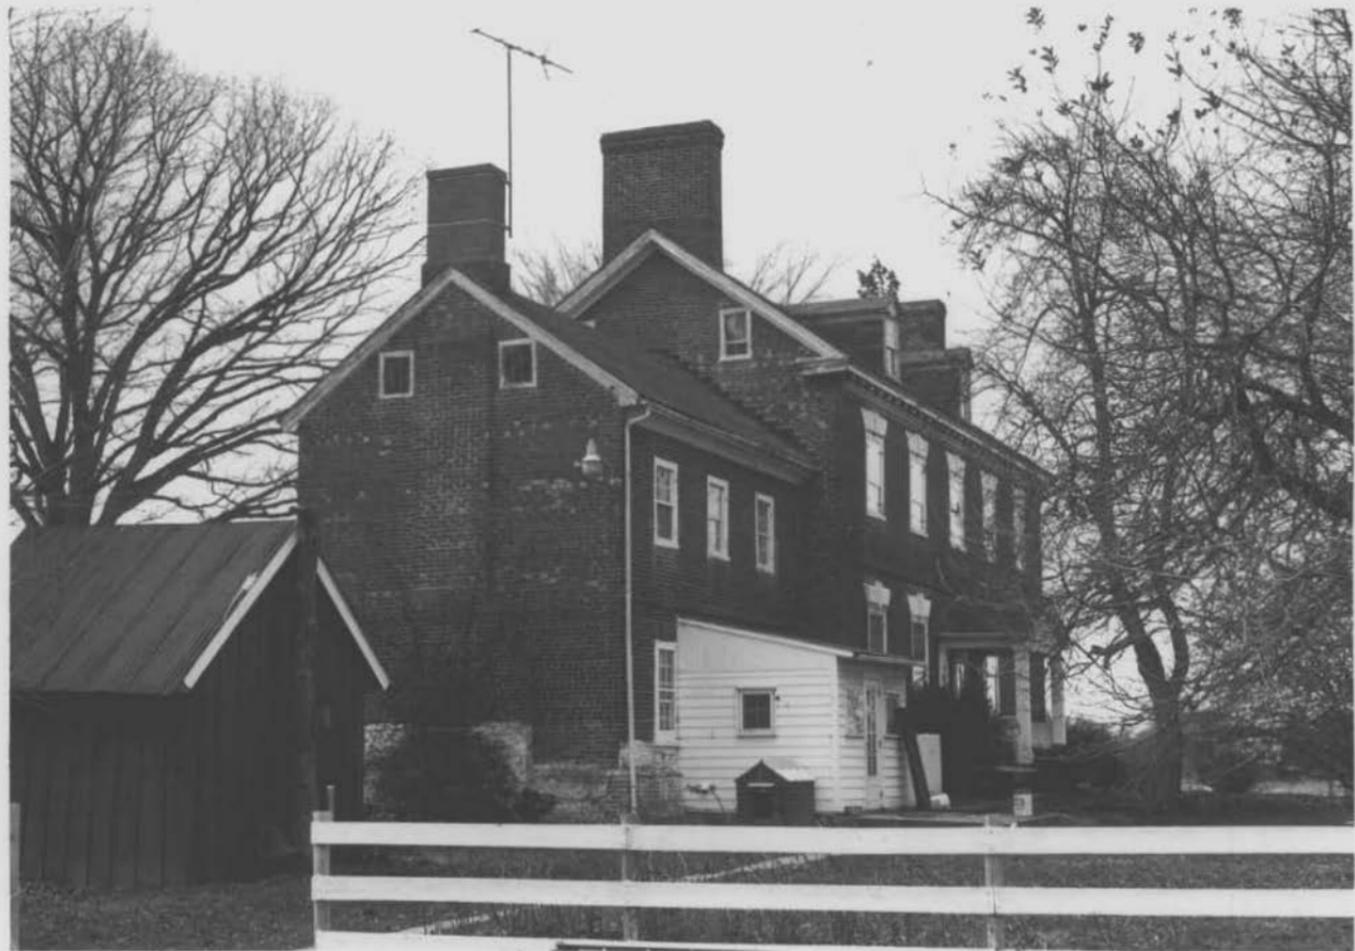
Peace and Plenty
Centreville vicinity
Orlando Ridout V 1981
View from Northeast

On the east gable wall of the wing, the chimney projects out approximately nine inches from the wall surface. It shoulders in above the first story fireplace and corbels back in flush with the upper gable. The only openings in this wall are a pair of small, boarded-up windows flanking the chimney in the upper gable. The brickwork is laid in three-course bond above a molded water table and three-course bond foundation. The eaves are trimmed with wide rakeboards and plain crownmold. The chimney shaft has been rebuilt above the ridge.

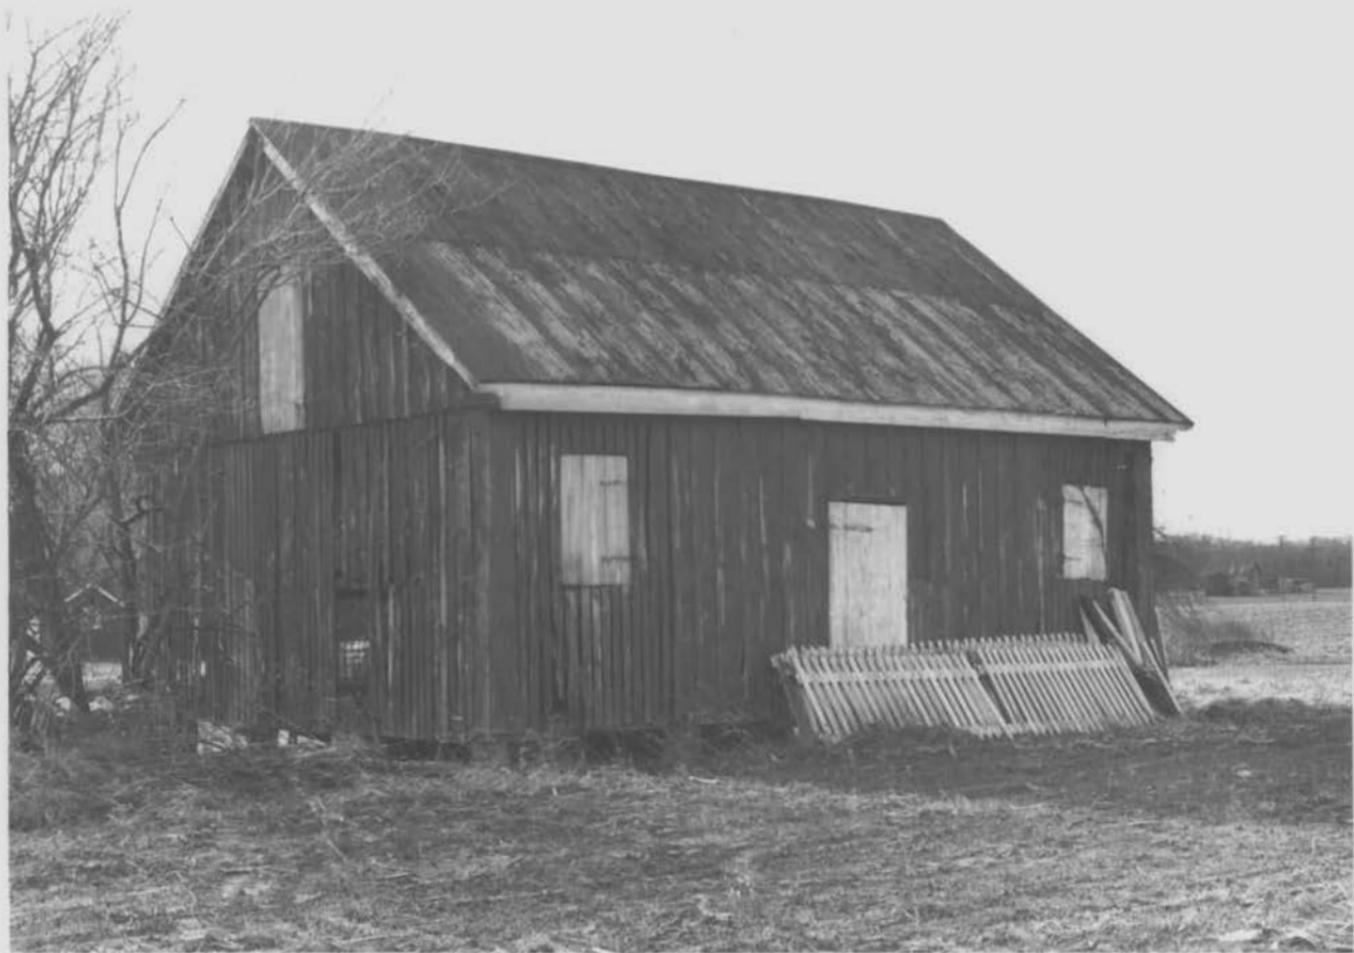
QA-99 Peace and Plenty
 Centreville vicinity
 Orlando Ridout V 1981
 Granary, from northeast

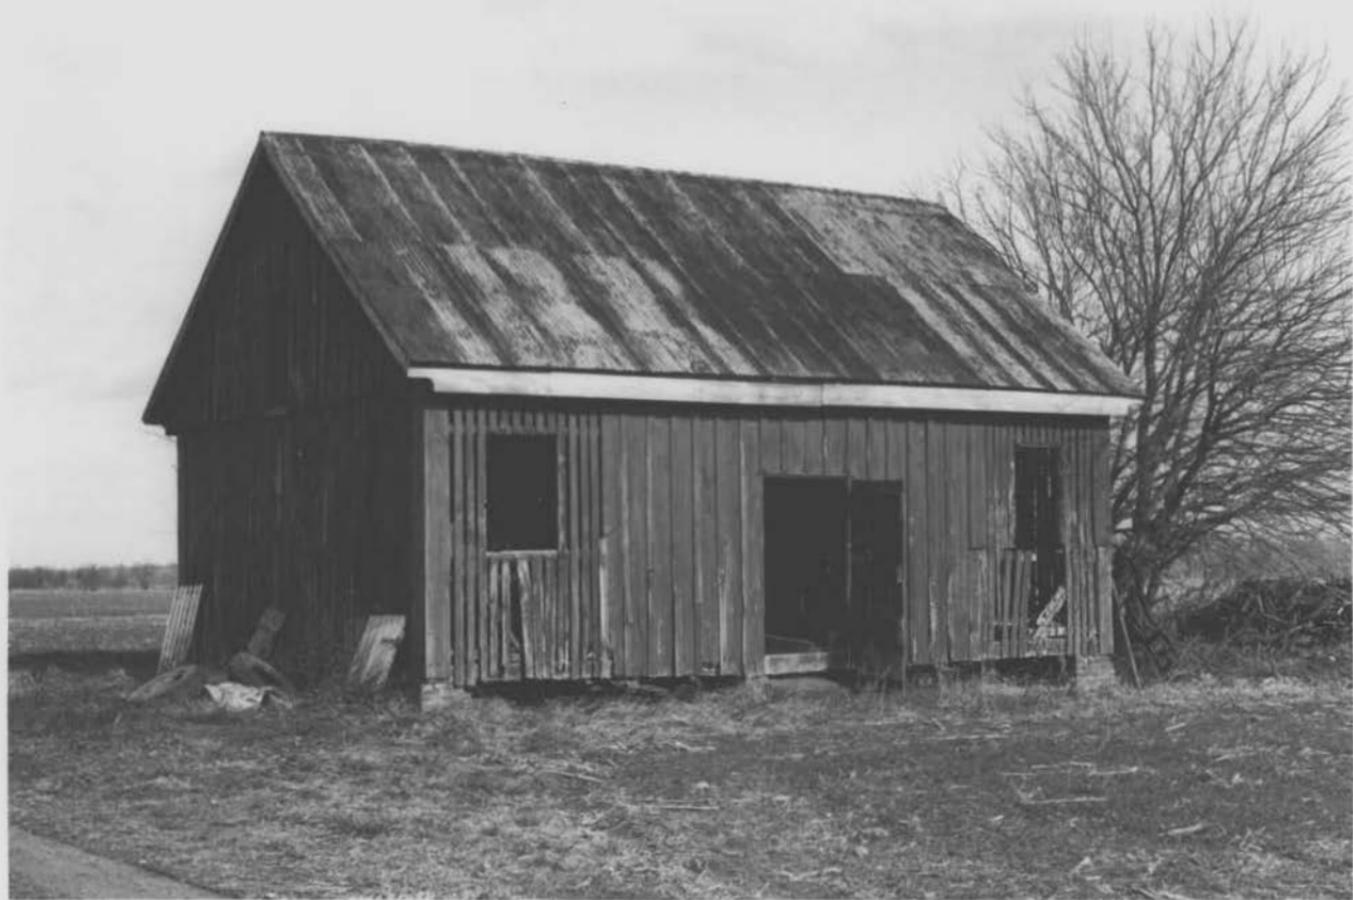
QA-99 Peace and Plenty
 Centreville vicinity
 Orlando Ridout V 1981
 Granary, from southwest
