MASON DAVIS DAIRY FARM
Route 51, South east of Cumberland
Late 19th Century

INVENTORY FORM FOR STATE HISTORIC SITES SURVEY

Mason Davis Dairy Farm

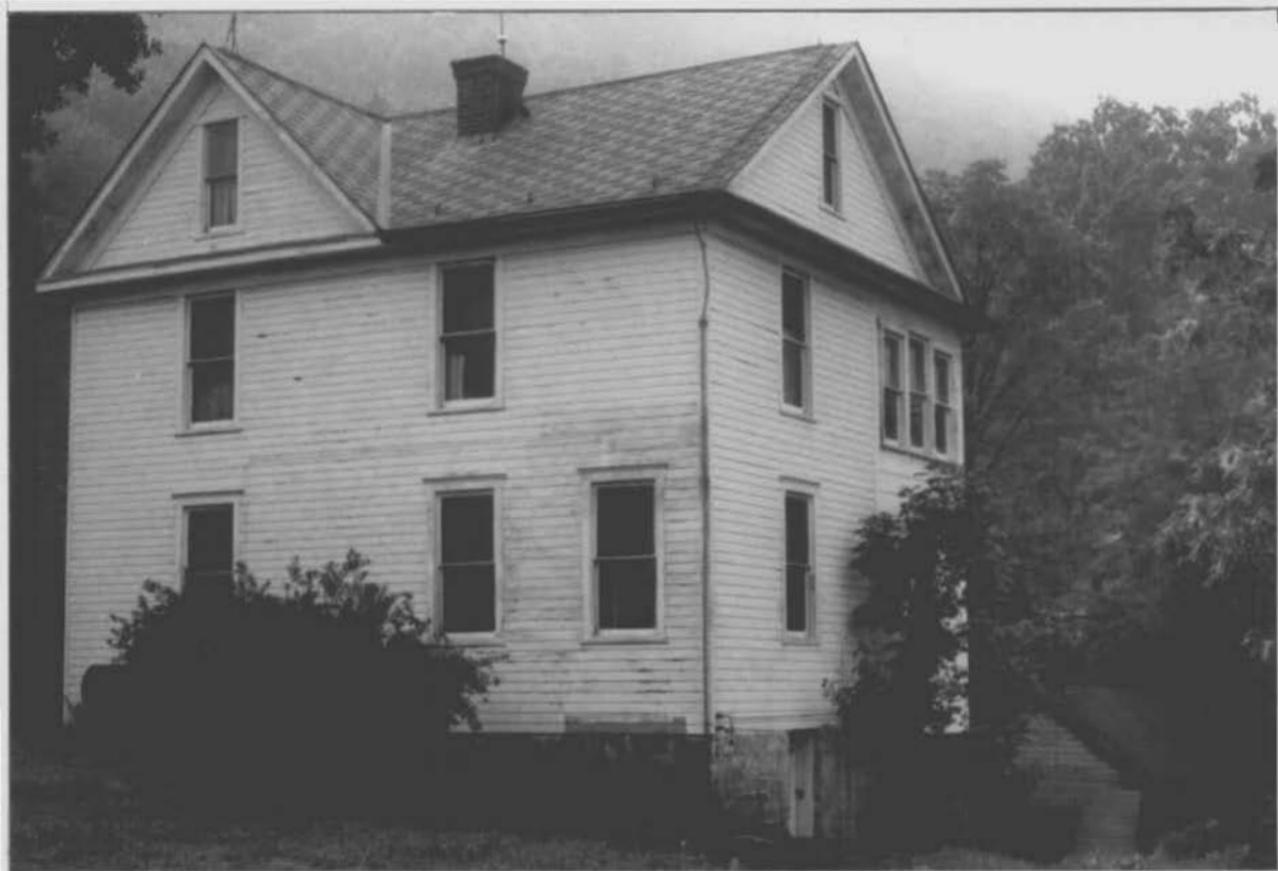
The Mason Davis Dairy Farm is a large rectangular structure that is two and a half stories high and four bays wide. The building is frame and is covered with novelty siding. The entire structure is supported by a high cut stone foundation with a plain water table. The roof of the structure is gabled and is covered by replaced asphalt shingles. A single dormer is placed along the front of the roof line directly above the second story windows. The windows are all double hung, pegged wooden sash frames with cornices and one over one lights with the exception of the two windows which are set into the foundation which are six over six lights with plain trim. The main facade is interrupted on its western end by a bay window which extends two stories from the roof line to the porch. The main entrance is located on the northern facade and consists of a paneled door with a transom light. This entrance is covered by a 4 bay porch supported by brackets and turned supports and is surrounded by a railing composed of turned ballisturs. One corbeled brick chimney is located within the facade.

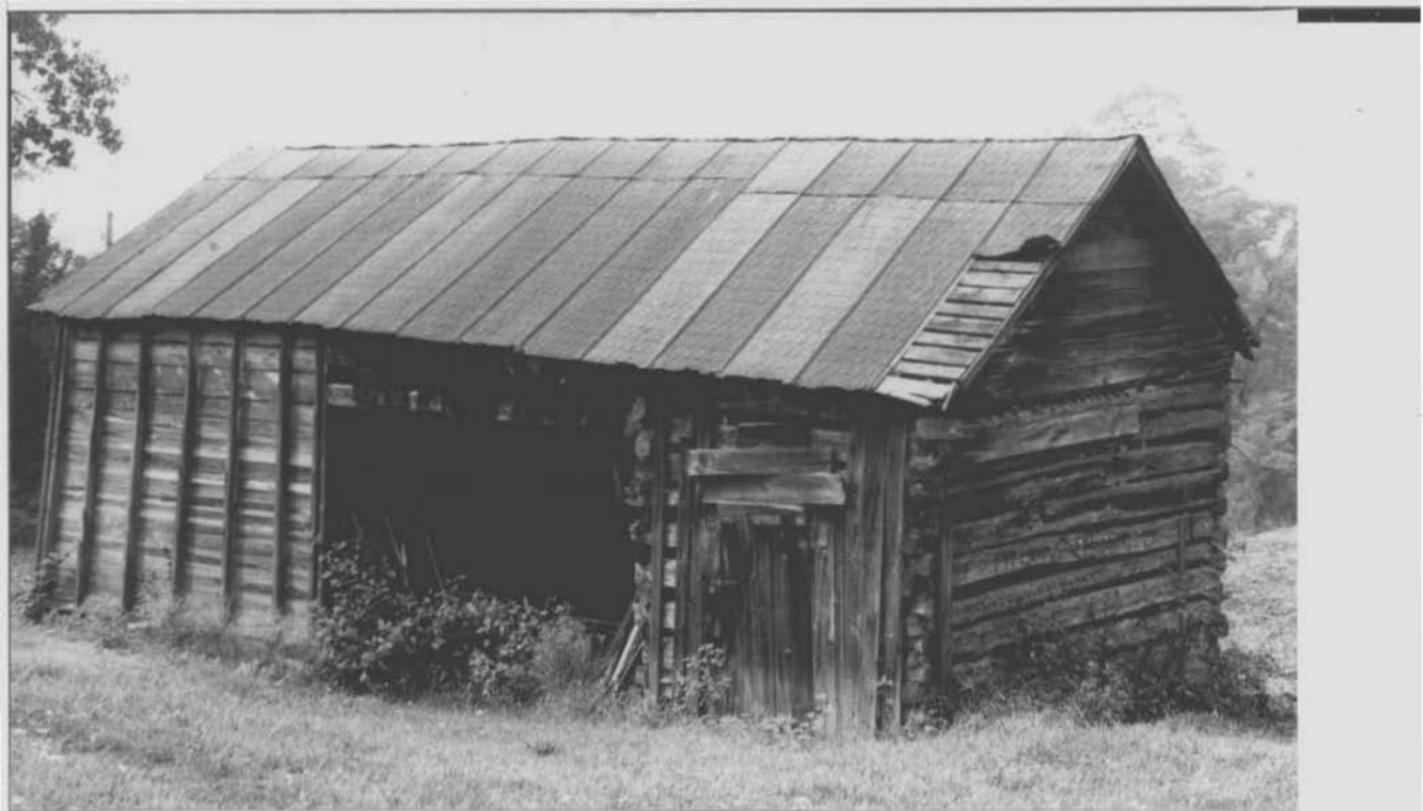
Mason Davis Dairy Farm
Wagon Shed and Corn Crib

The Davis Dairy Farm also includes numerous out-buildings including a log wagon shed and corn crib- which was, at the time, covered with weatherboard. The house and out-buildings are in fair condition but as the farm is no longer occupied, the buildings are deteriorating somewhat more rapidly than normal.
