Name: #10711/MDS/OVER MILL RUN.

MARYLAND INVENTORY OF HISTORIC BRIDGES
HISTORIC BRIDGE INVENTORY
MARYLAND STATE HIGHWAY ADMINISTRATION/
MARYLAND HISTORICAL TRUST

SHA Bridge No. 1071 Bridge name MD 51 over Mill Run

Bridge No. 1071 is a 1-span, 2-lane, concrete slab bridge. The bridge was originally built in 1932 and has not been significantly altered. The structure is 26 feet, 7 inches long and has a clear roadway width of 31 feet, 5 inches; there are no sidewalks. The out-to-out width is 34 feet, 9 inches. The bridge was built on a 42° skew. The concrete slab is 2 feet, 6 inches thick, and it has a bituminous wearing surface. The structure has pierced concrete parapets and the roadway approaches have narrow shoulders and steel guard rails. The substructure consists of two (2) concrete abutments and flared concrete wing walls. The bridge is not posted, and has a sufficiency rating of 5.

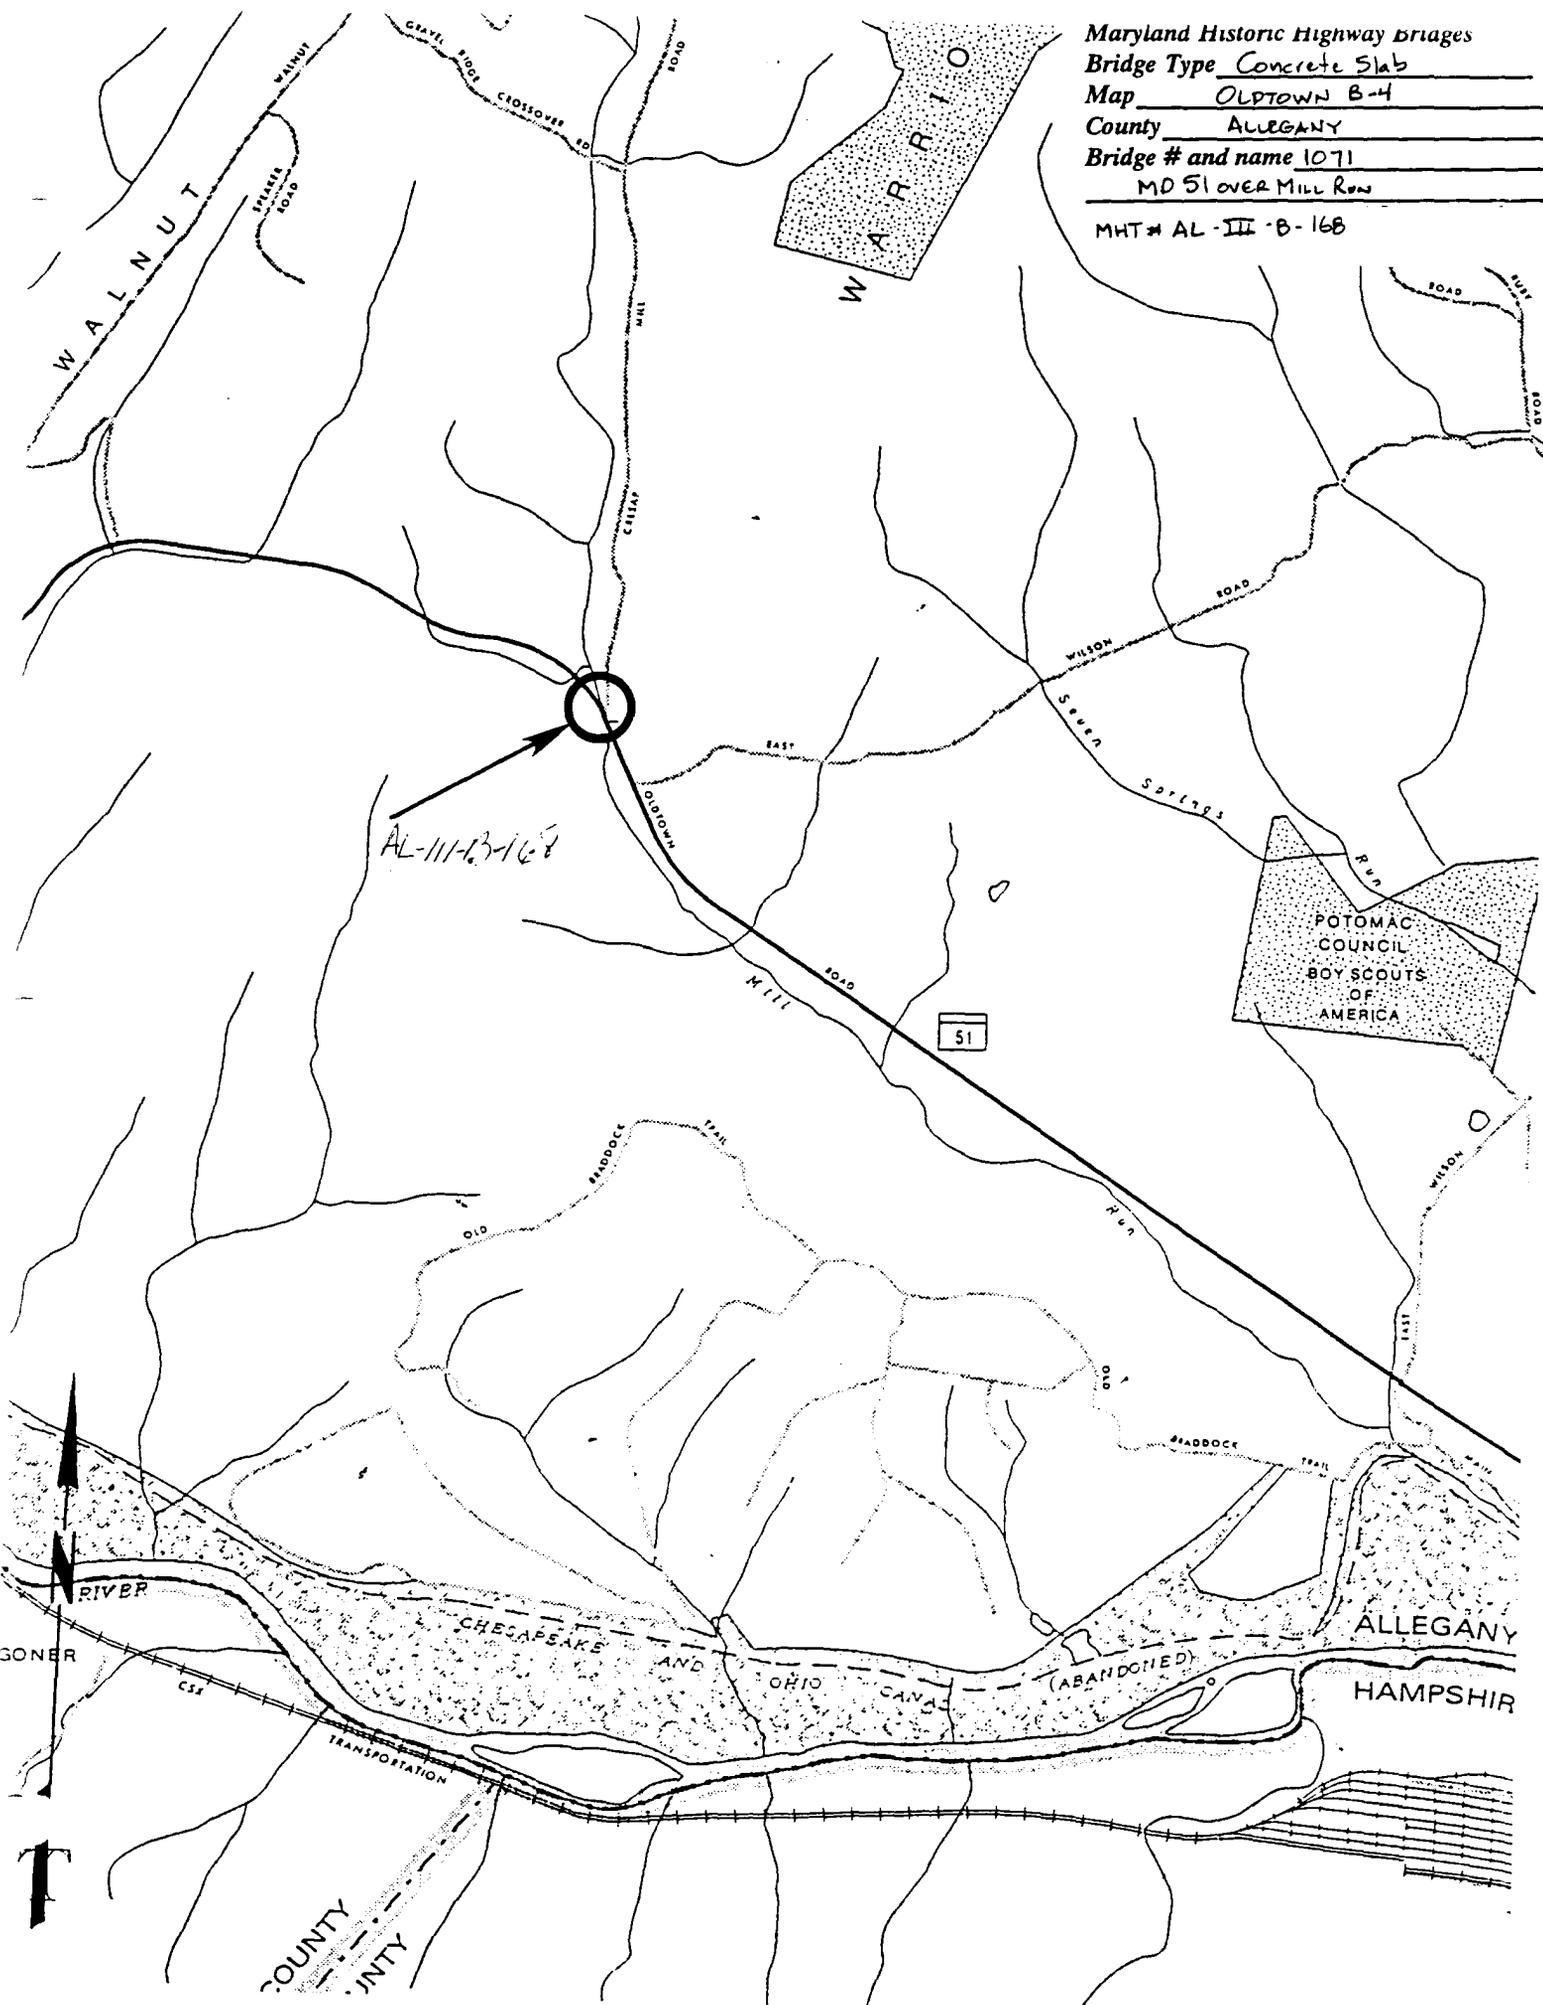
MHT # AL-III-B-168

1. AL-III - B-168
2. MD 51 over Mill Run
3. Allegany Co, MD
4. Ryan McKay
5. 3/97
6. MD SHPD
7. Downstream elevation
8. 1 of 4

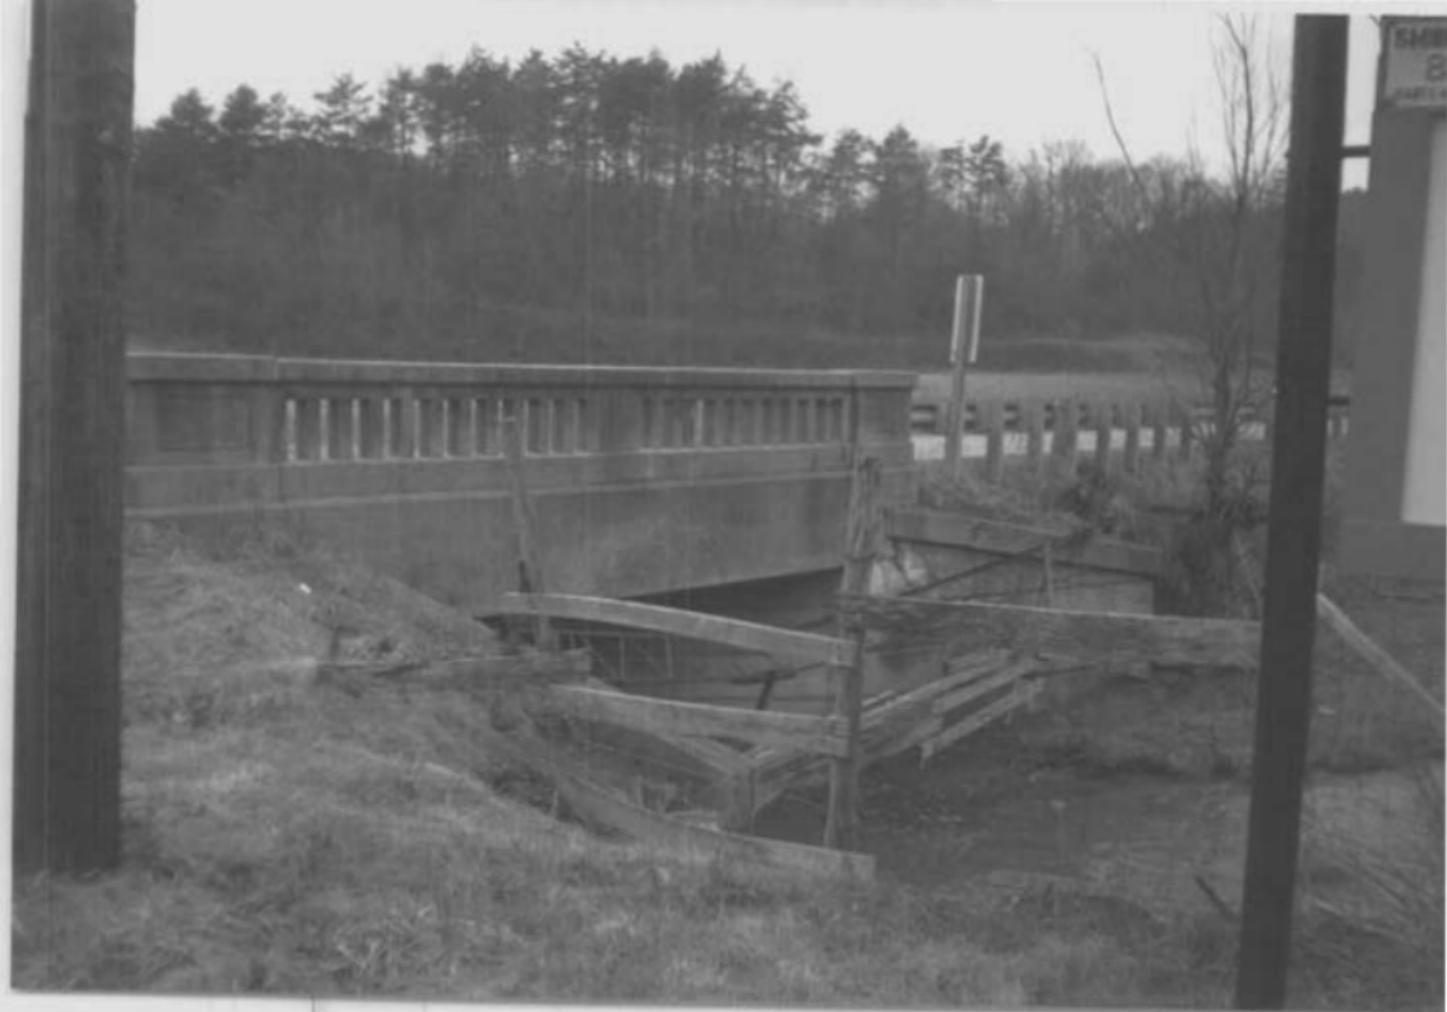
1. AL-III - B-168
2. MA 51 over Mill Run
3. Allegany Co, MO
4. Ryan McKay
5. 3/97
6. MO SHPO
7. Upstream elevation
8. 2 of 4

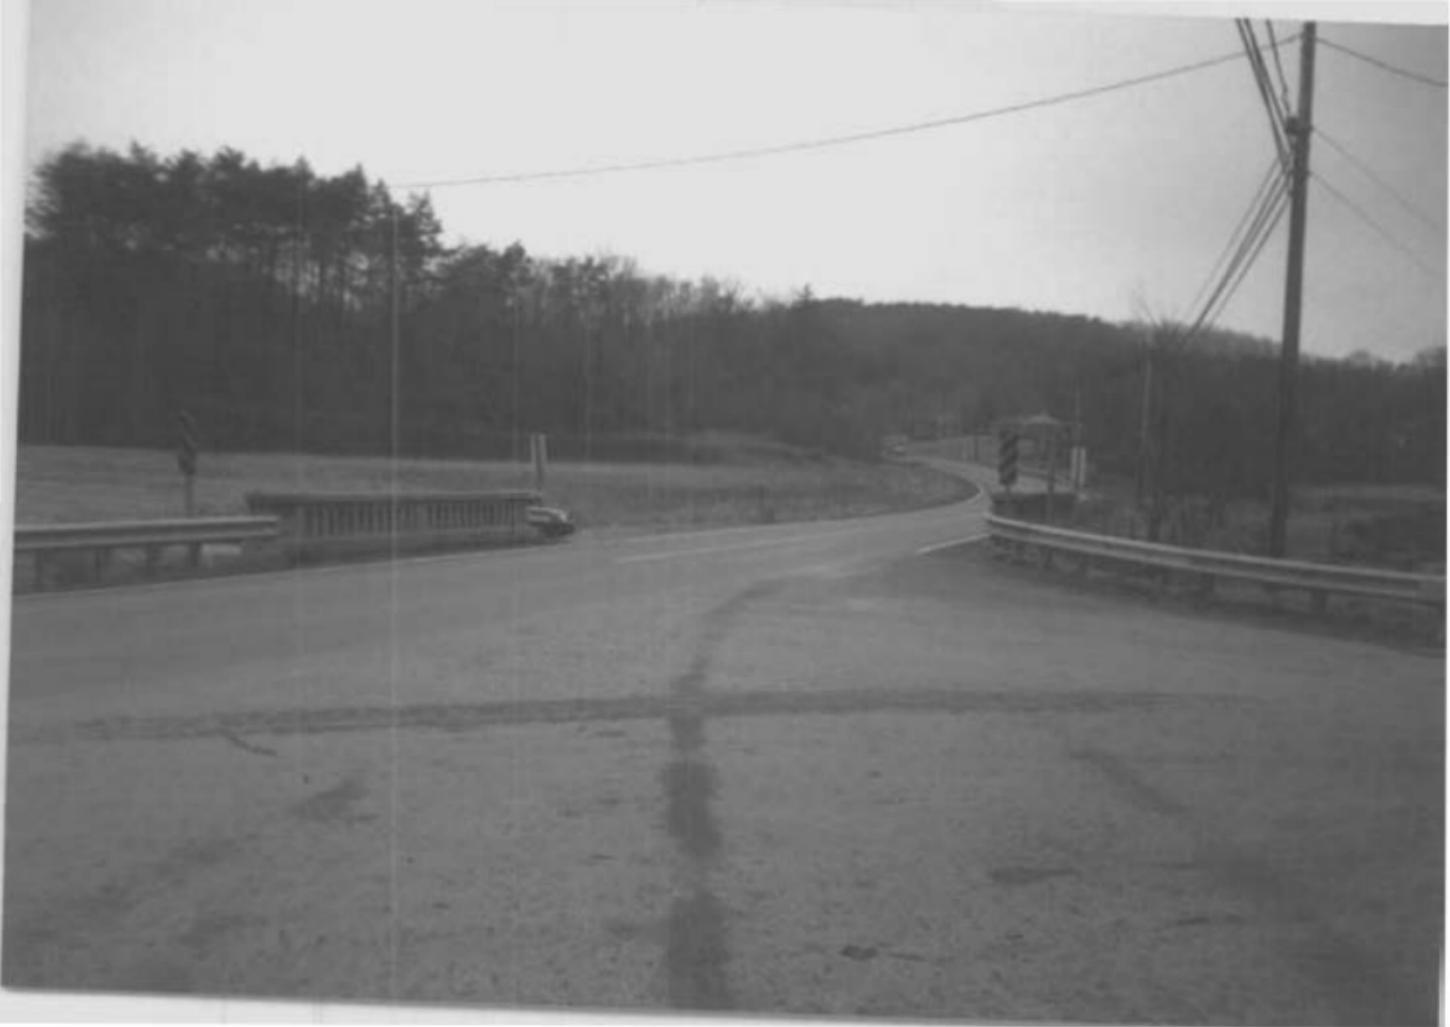
8. 3 of 4

7. East approach

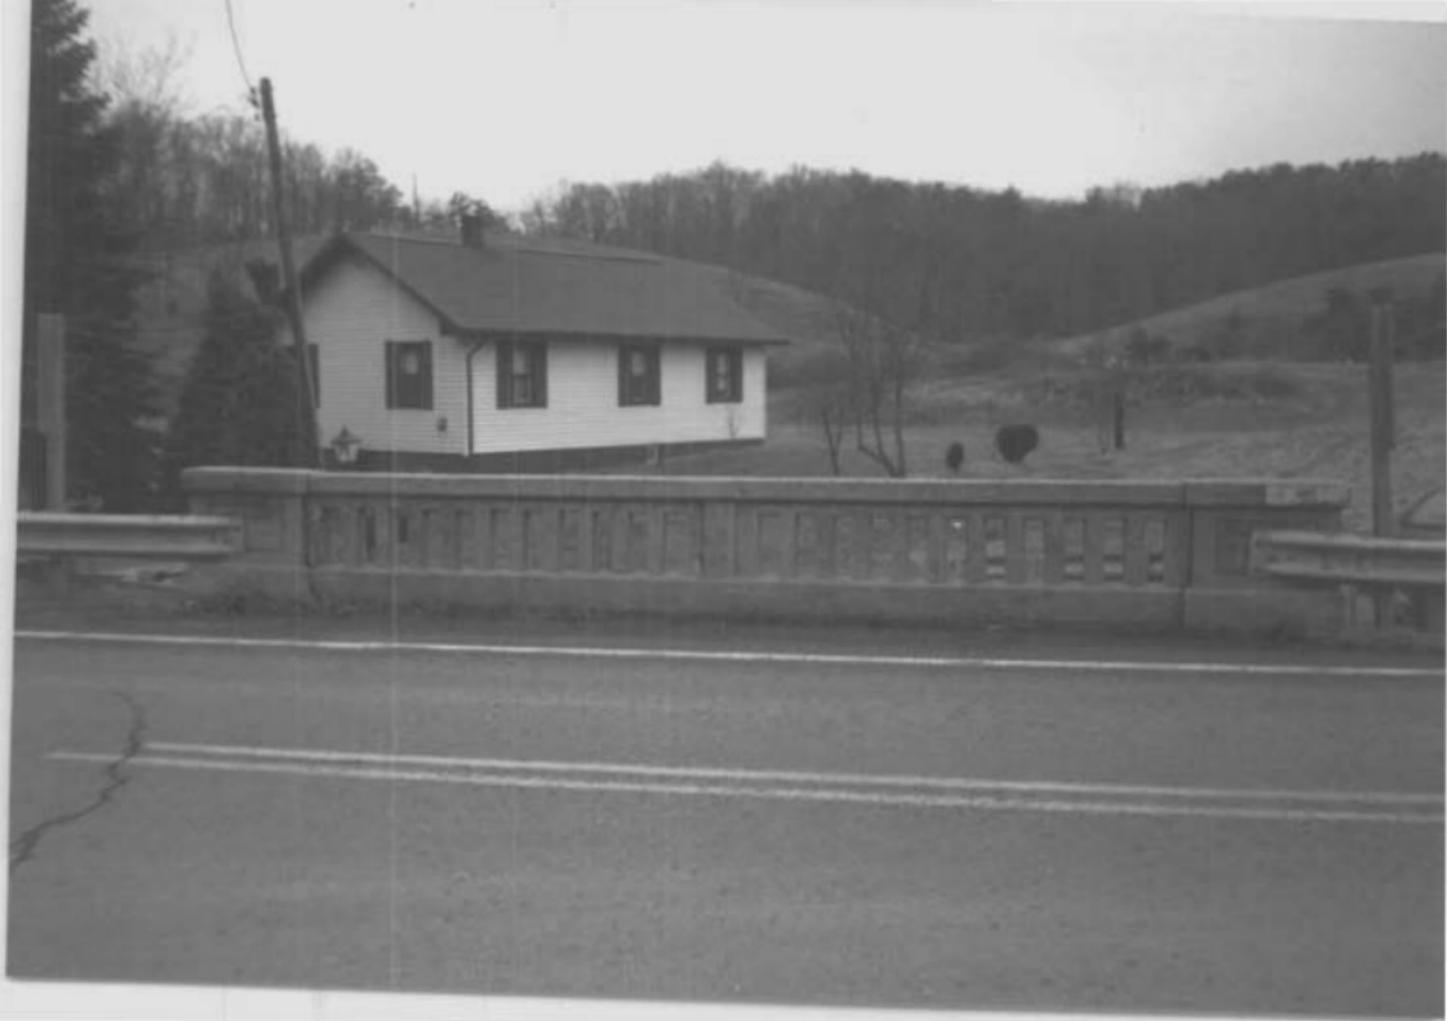
According to the 1996 inspection report, this structure was in good condition with numerous cracks, scaling, and spalling on the substructure and superstructure. The asphalt wearing surface has large cracks across the road surface. The concrete is scaling in places, and has areas of spalling on the concrete slab and at the base of the south abutment. The abutments have been repaired in the past, and the southwest and northeast wing walls have areas where the repairs have failed. There are numerous deposits of efflorescence. Also, the concrete parapet is scaling on the top.

1. AL-III-B-168
2. MD SI over Mill Run
3. Allegany Co, MD
4. Ryan McKay
5. 3/97
6. MD SHPO
7. South parapet
8. 4 of 4
