# National Register of Historic Places Inventory—Nomination Form

historic Big Bottom Farm (preferred)

and/or common Clauson Farm

AL-III-C-044

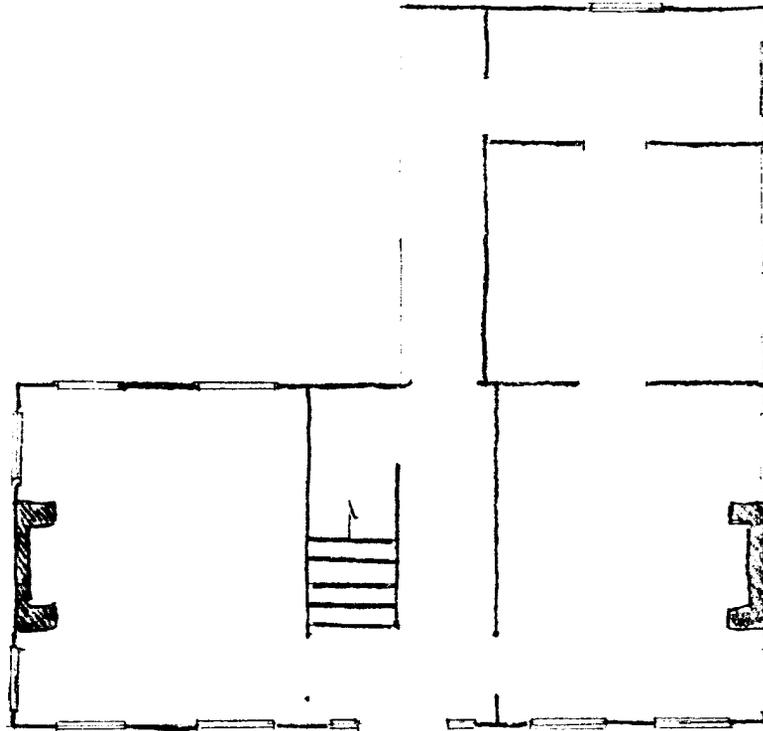
BIG BOTTOM FARM

APPROXIMATE 1ST FLOOR PLAN - NOT TO SCALE

The interior plan has a central stair hall with one large room on either side. The main staircase is a simple structure. It has a turned newel post and a plain handrail which curves upward at the top with a "gooseneck." To the north of the stair hall is the parlor. Approximately centered in its north wall is a fireplace with a Greek Revival mantel consisting of a shelf and symmetrically molded pilasters. Door and window architraves are also decorated with symmetrical molding similar to that used on the mantel. Corner blocks are decorated with a square or Greek Key pattern. No other woodwork in the house is as elaborate as that found in the parlor and first floor hall.

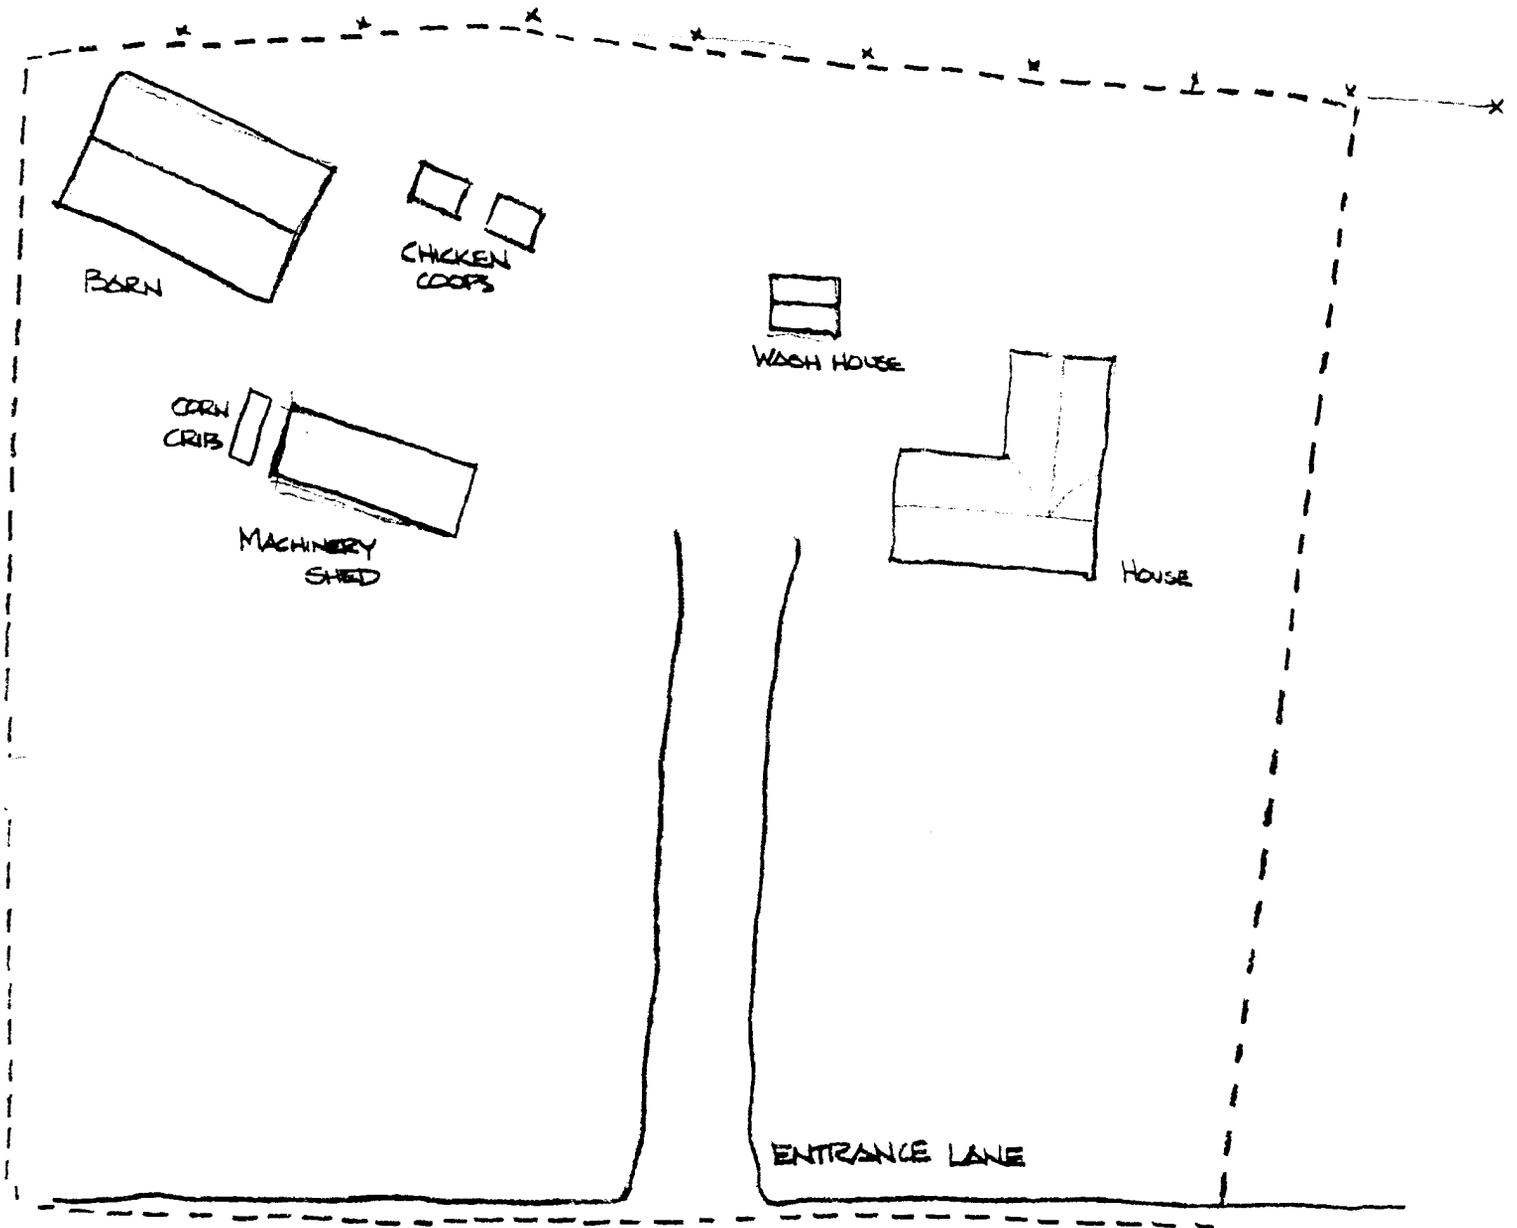
BIG BOTTOM FARM, ALLEGANY CO. MD

APPROXIMATE SITE PLAN

----- NOMINATION BOUNDARY

The nominated property consists of approximately 5 acres to include the house, barn, outbuildings and immediate surroundings. The boundaries are described as follows: beginning at a point on the east side of Hazen Road, 100 feet south of the entrance lane to the property and leading in a straight line in a southeasterly direction to a fence located at the bottom of a slope a short distance southeast of the house; then turning 90 degrees and proceeding in a straight line to the northeast, along said fence to a point opposite the northeast corner of the barn; then turning 90 degrees to the northwest and proceeding in a straight line to the east edge of Hazen Road; then following the east edge of Hazen Road in a south-westerly direction to the place of beginning (see attached sketch plan).

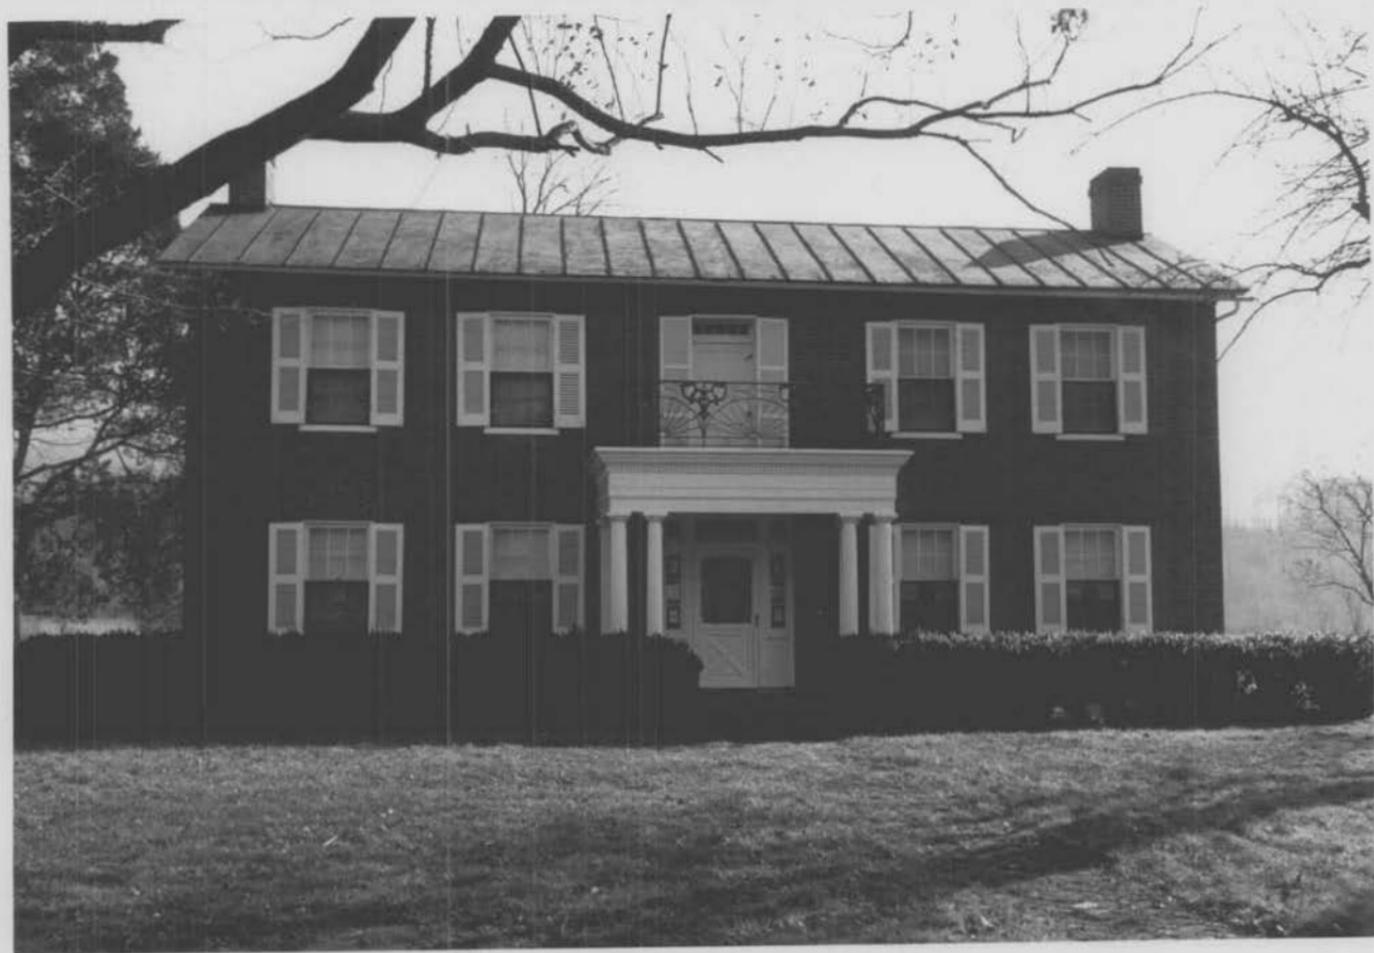
Clauson farm (BIG BOTTOM FARM) AL-111-C-044

West facade

This two and one-half story brick house is five bays wide, one room deep, and has a two-story, three bay ell to the rear. The principal (west) facade is laid in Flemish bond, with jack arches over all openings. On the first floor, the entrance occupies the central bay, and features a paneled surround with a five-pane transom and three-pane sidelights. Two 6/6 sash windows are arrayed on either side of the doorway. On the second story, 6/6 windows are aligned above those on the first floor; the central bay holds a transomed doorway - probably a recent enlargement of a window opening - affording access to an iron-railed balcony atop a portico apparently of recent date. The shallow-pitched gable roof is covered with standing-seam metal, with interior chimneys at each end. Corbeling appears at the cornice.

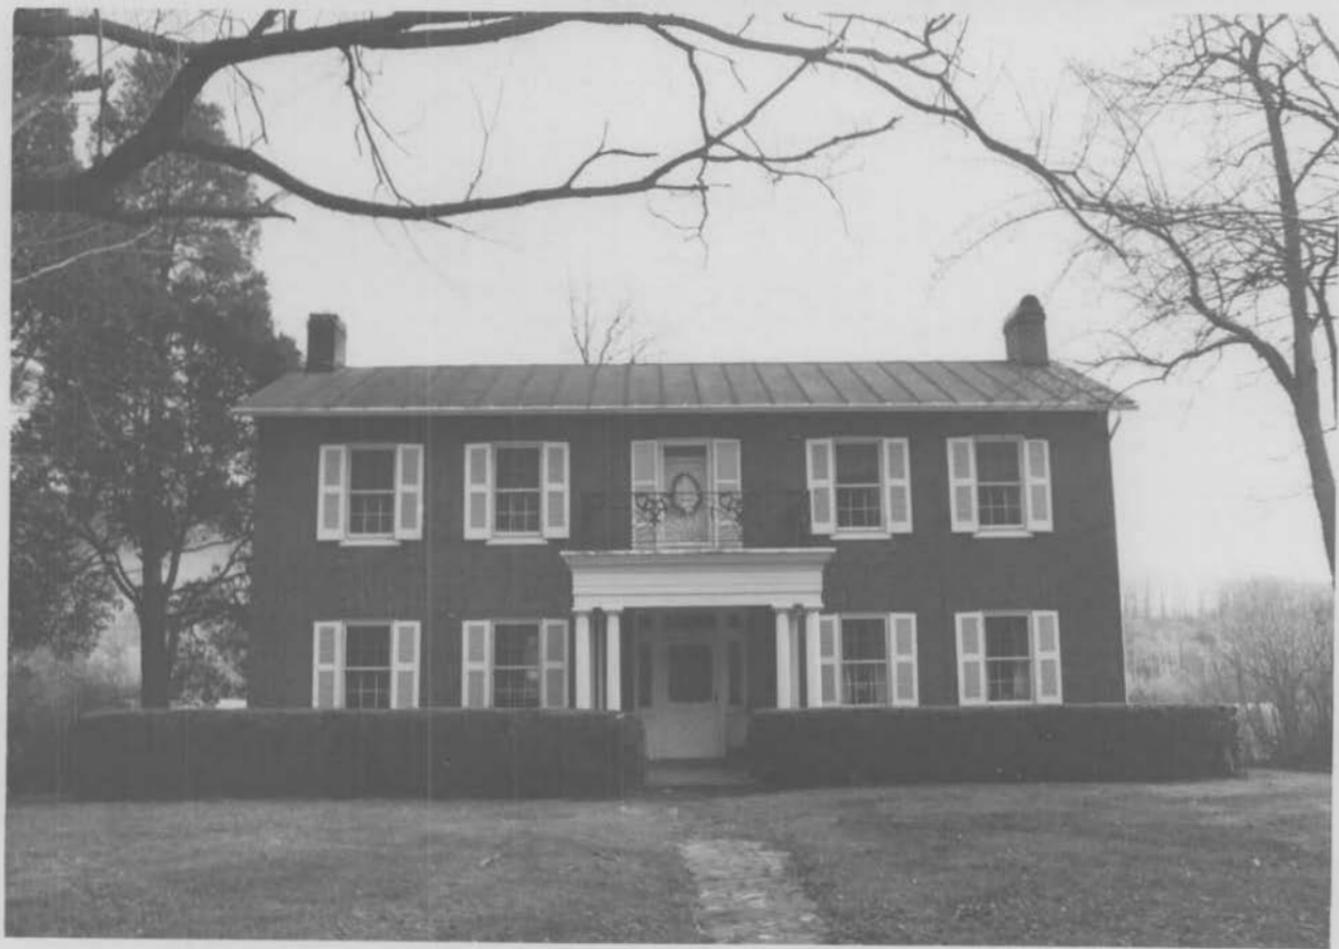
(1)

1. Big Bottom Farm
2. Cumberland vic., Allegany Co., MD
3. Photo Date: Dec. 1983
4. Photo by Paula S. Reed
5. Neg. Location: Preservation Associates, Inc., Hagerstown, MD
6. View: E.
7. Photo # 1

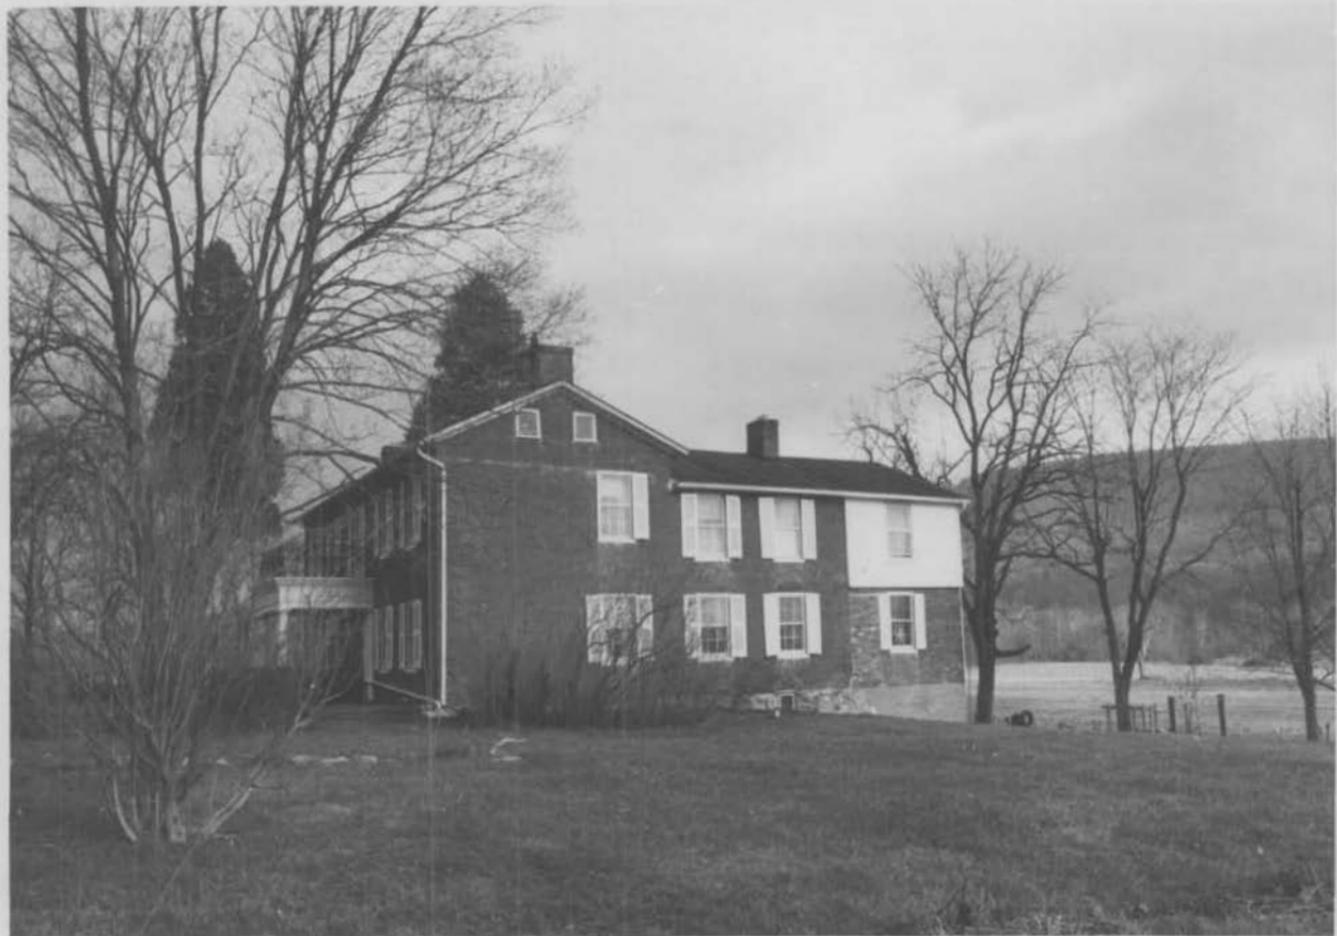
1. Big Bottom Farm
2. Cumberland vic., Allegany Co., MD
3. Photo Date: Dec. 1983
4. Photo by Paula S. Reed
5. Neg. Location: Preservation Associates, Inc., Hagerstown, MD
6. View: NE
7. Photo # 2

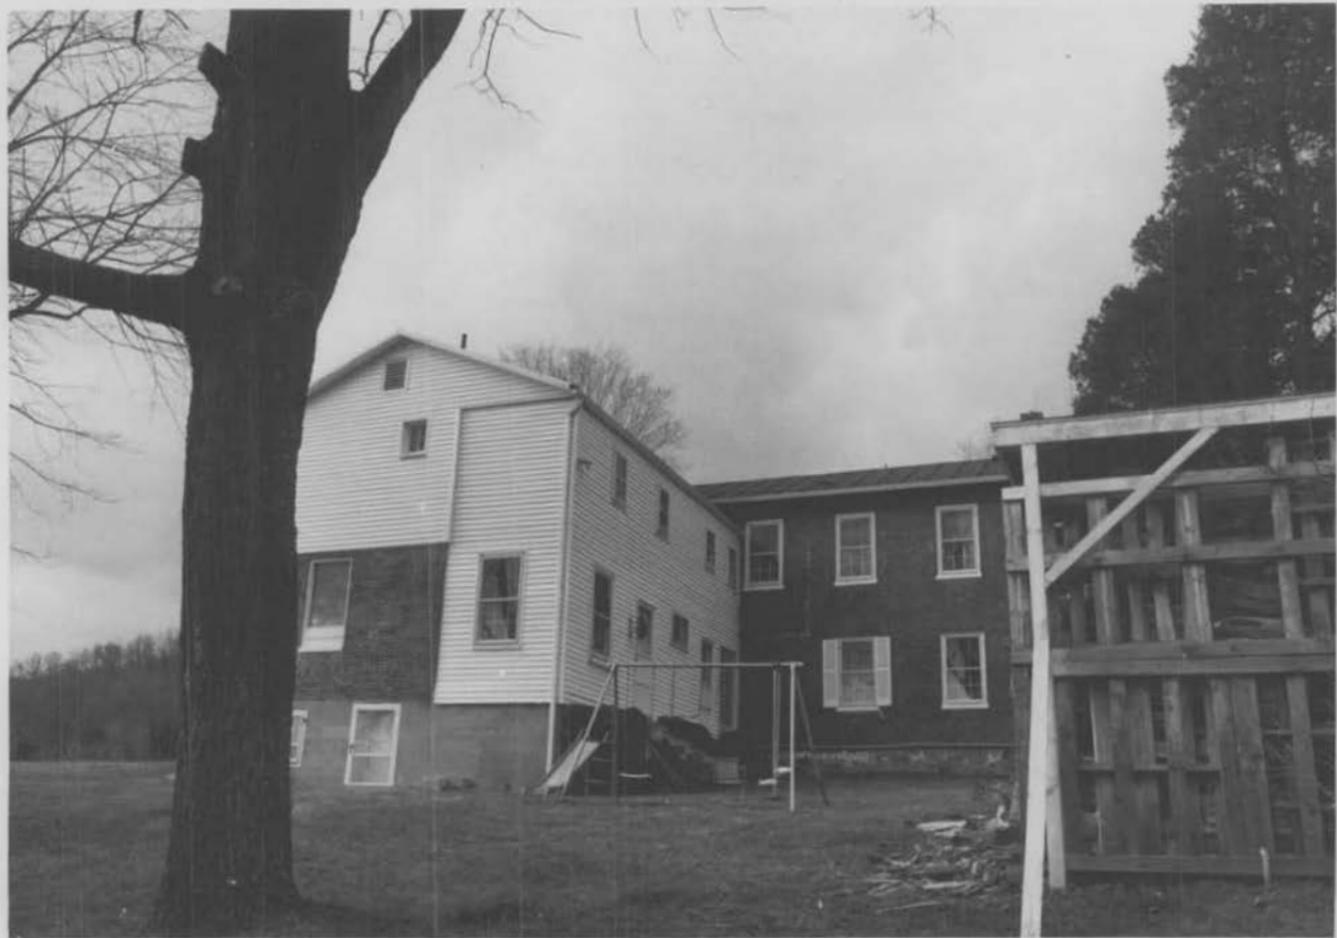
(3)

1. Big Bottom Farm
2. Cumberland vic., Allegany Co., MD
3. Photo Date: Dec. 1983
4. Photo by Paula S. Reed
5. Neg. Location: Preservation Associates, Inc., Hagerstown, MD
6. View: SW
7. Photo # 3

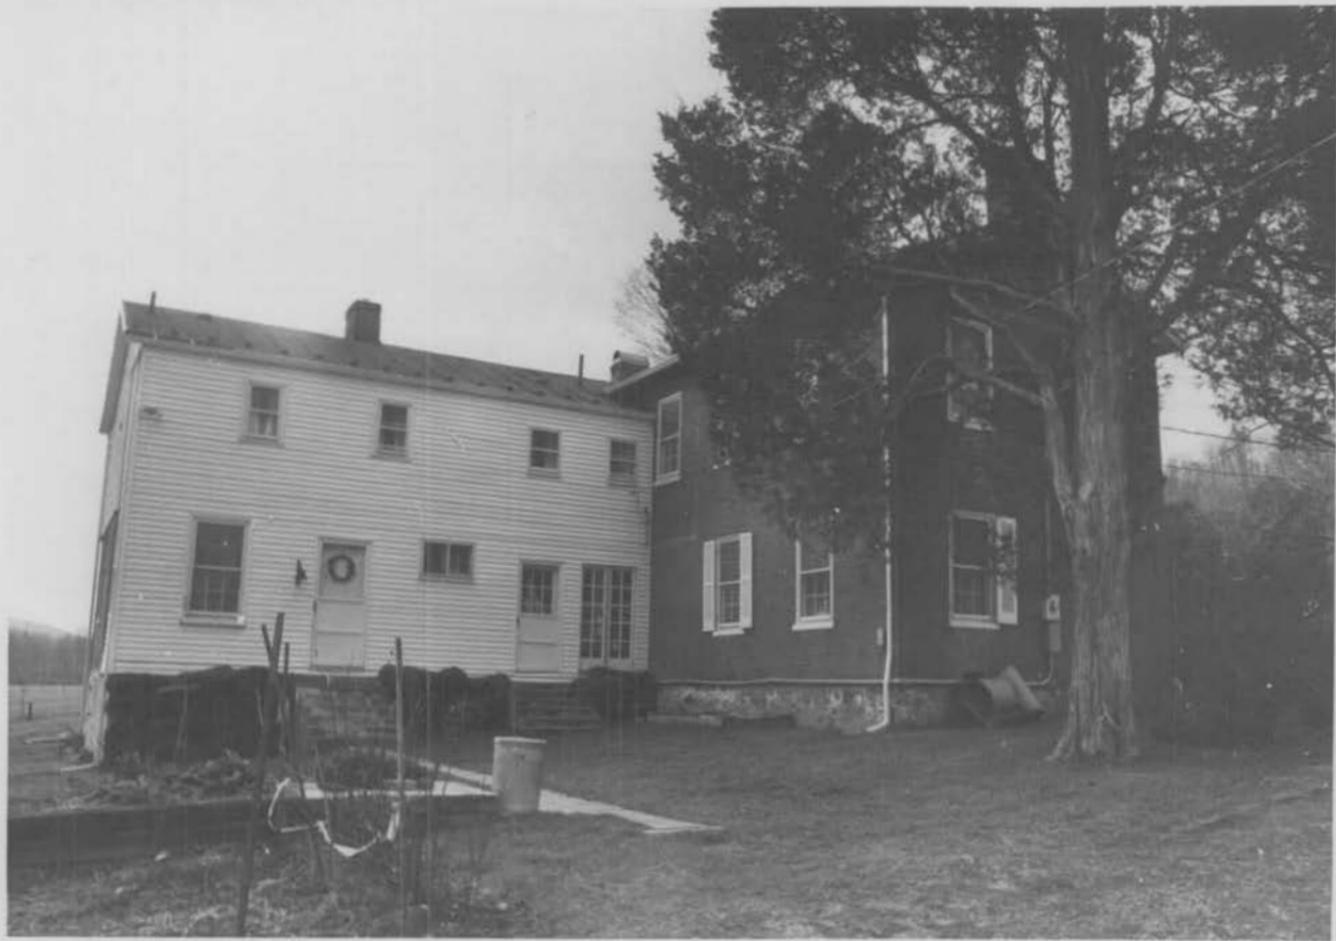
④

1. Big Bottom Farm
2. Cumberland vic., Allegany Co., MD
3. Photo Date: Dec. 1983
4. Photo by Paula S. Reed
5. Neg. Location: Preservation Associates, Inc., Hagerstown, MD
6. View: SW
7. Photo # 4

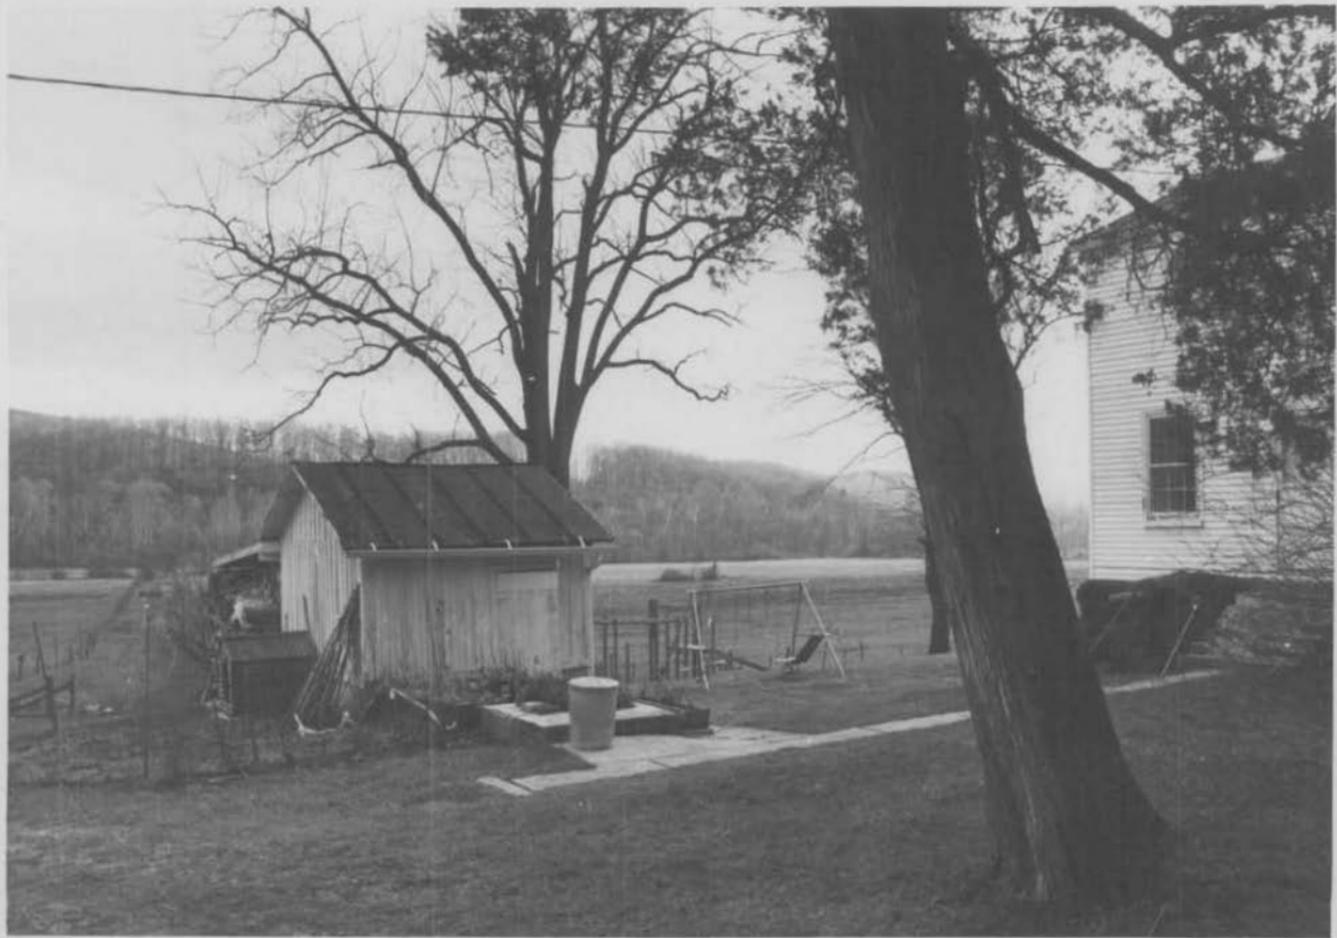
1. Big Bottom Farm
2. Cumberland vic., Allegany Co., MD
3. Photo Date: Dec. 1983
4. Photo by Paula S. Reed
5. Neg. Location: Preservation Associates, Inc., Hagerstown, MD
6. View: SE - WASH HOUSE
7. Photo # 5

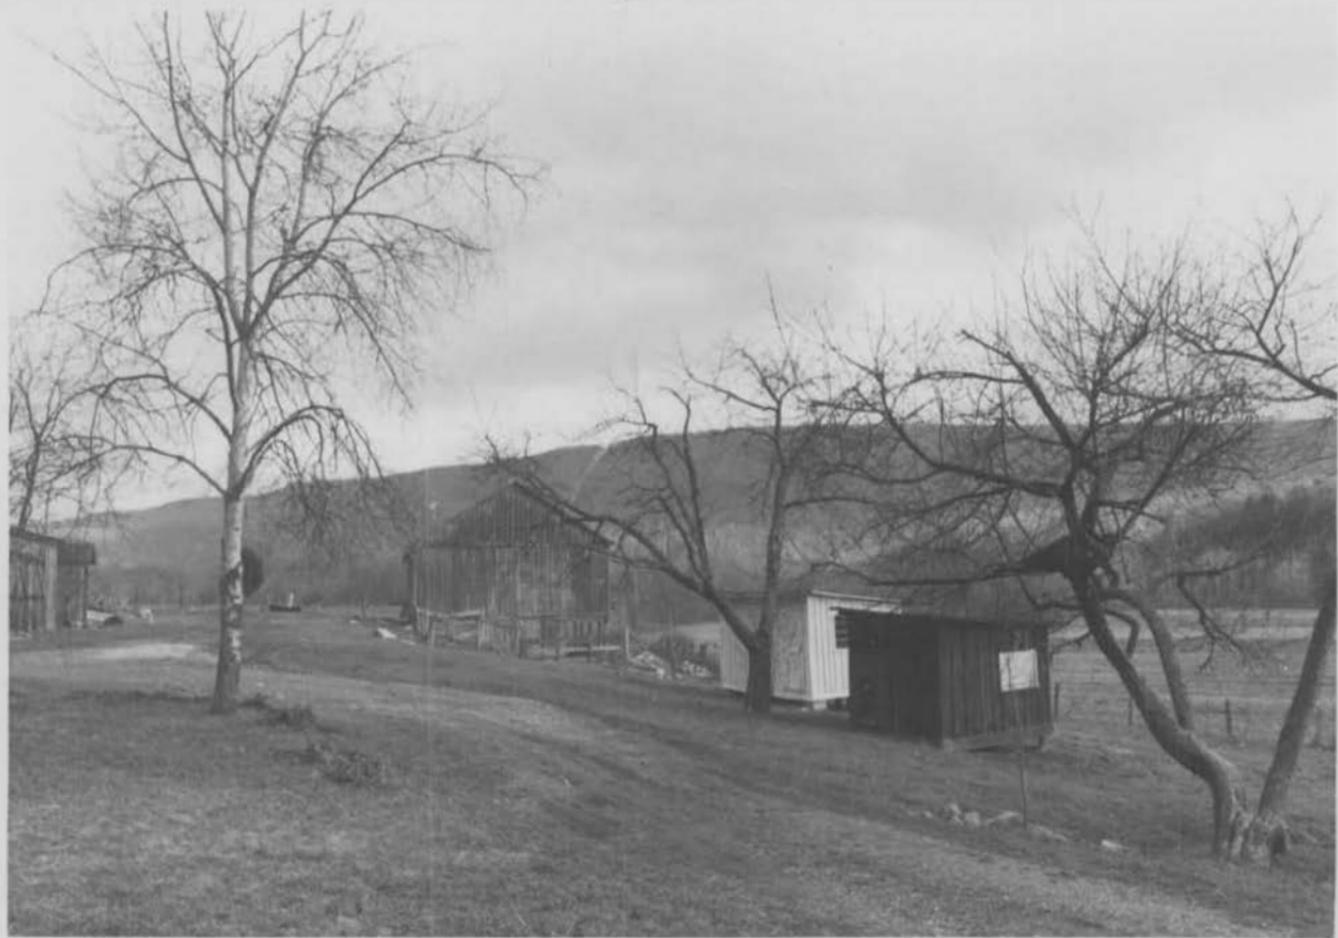
Several outbuildings are associated with the house, including a frame bank barn of moderate size with board-and-batten siding resting on a stone foundation.

1. Big Bottom Farm
2. Cumberland vic., Allegany Co., MD
3. Photo Date: Dec. 1983
4. Photo by Paula S. Reed
5. Neg. Location: Preservation Associates, Inc., Hagerstown, MD
6. View: NE - BARN & OUTBUILDINGS
7. Photo # 6

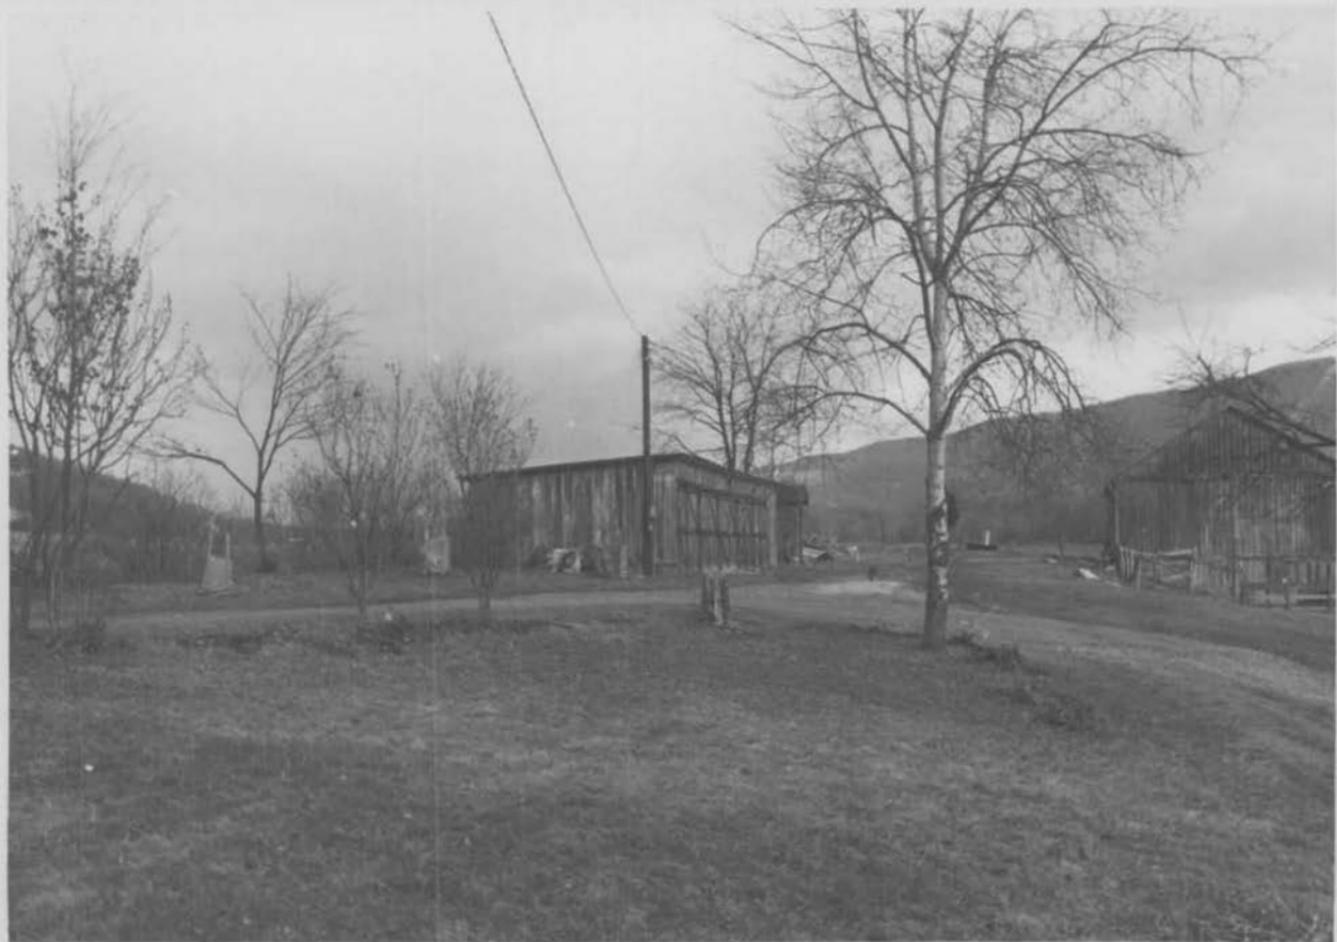
1. Big Bottom Farm
2. Cumberland vic., Allegany Co., MD
3. Photo Date: Dec. 1983
4. Photo by Paula S. Reed
5. Neg. Location: Preservation Associates, Inc., Hagerstown, MD
6. View: N. BARN & OUTBLDG'S
7. Photo # 7

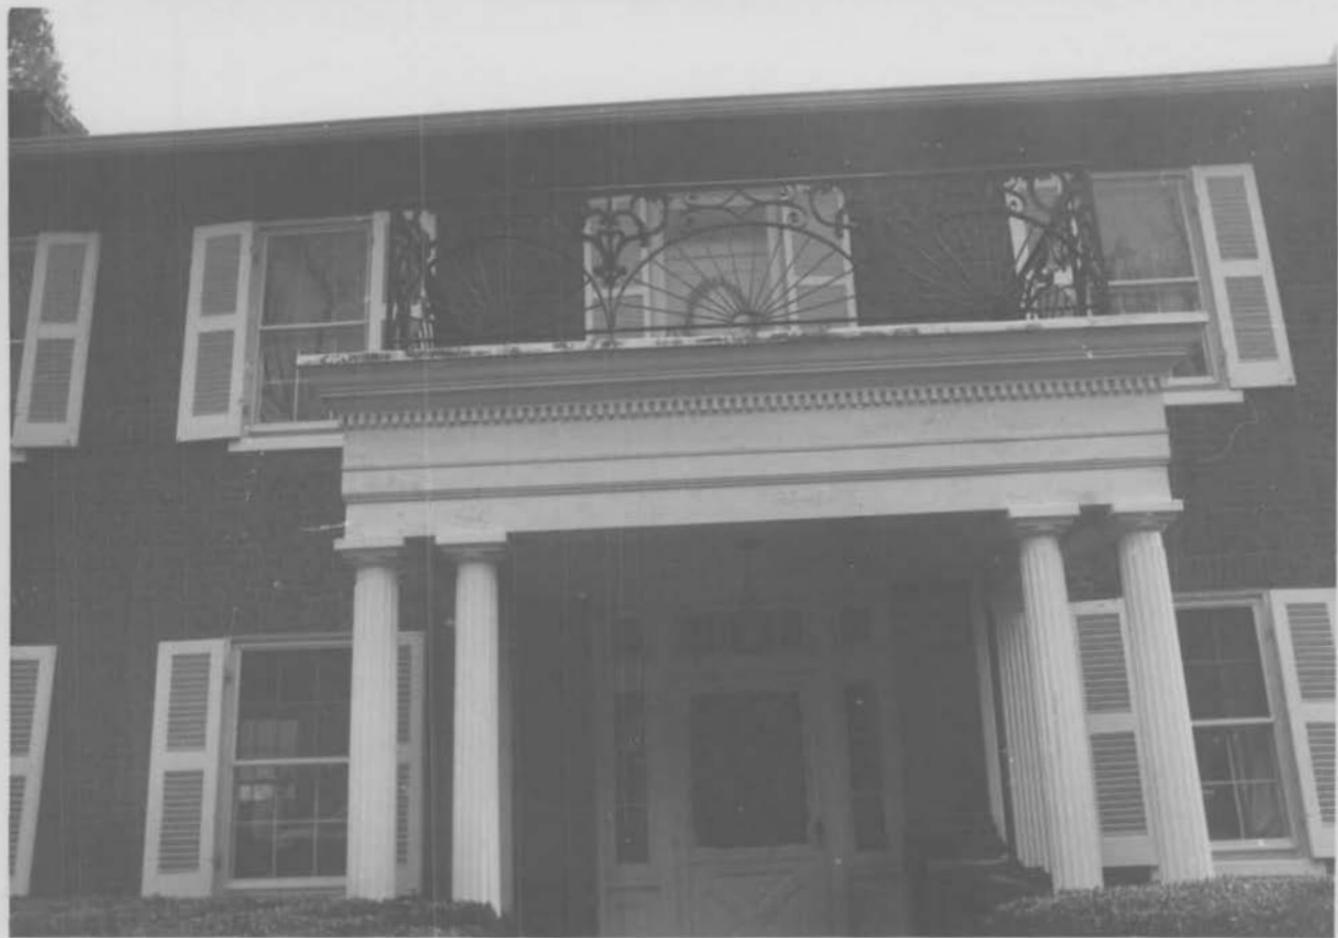
1. Big Bottom Farm
2. Cumberland vic., Allegany Co., MD
3. Photo Date: Dec. 1983
4. Photo by Paula S. Reed
5. Neg. Location: Preservation Associates, Inc., Hagerstown, MD
6. View: *DETAIL, FRONT ELEVATION*
7. Photo # *8*

The main entrance features a four-panel door flanked by sidelights and surmounted by a transom. Among the more notable features of the house is the front porch, which appears to be part of the original construction, although it has been reworked, noticeably at the column bases. The porch is clearly reminiscent of the Greek Revival style and is in keeping with the rest of the stylistic motifs used in the house. The porch is supported by pairs of fluted doric columns, upon which rests a full entablature. It is flat roofed, with roof area enclosed by a cast iron railing and balustrade, which may be original, but is more likely an early 20th century addition. The ironwork is elaborate with mixed motifs including semi-elliptical fans and curved and scrolled designs forming the infill. Some of the patterns suggest art nouveau designs. The second-story door which opens onto the porch is original; it has four panels and is hung beneath a five-light transom.

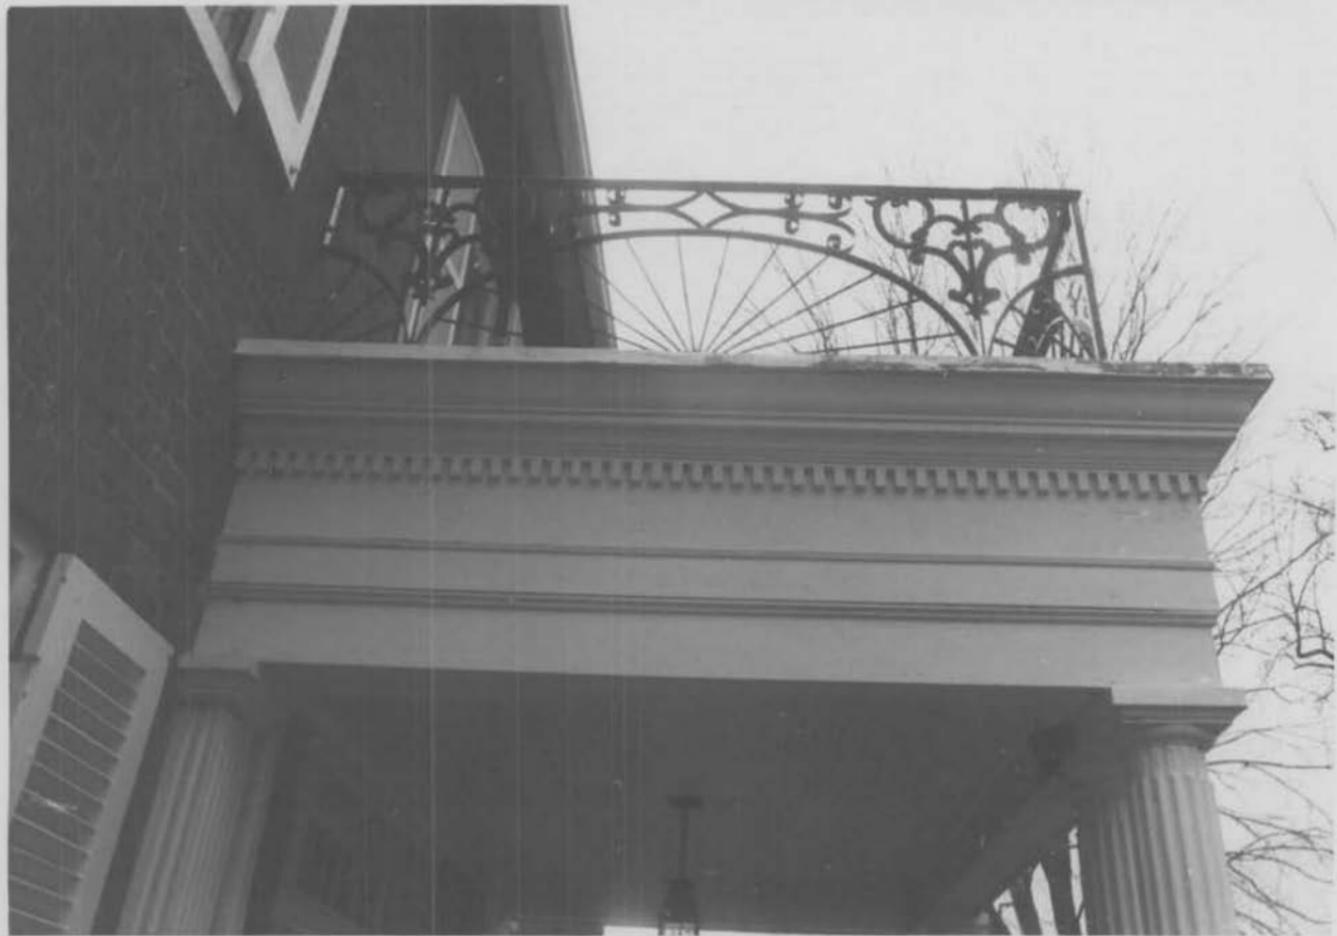
1. Big Bottom Farm
2. Cumberland vic., Allegany Co., MD
3. Photo Date: Dec. 1983
4. Photo by Paula S. Reed
5. Neg. Location: Preservation Associates, Inc., Hagerstown, MD
6. View: DETAIL - PORCH
7. Photo # 9

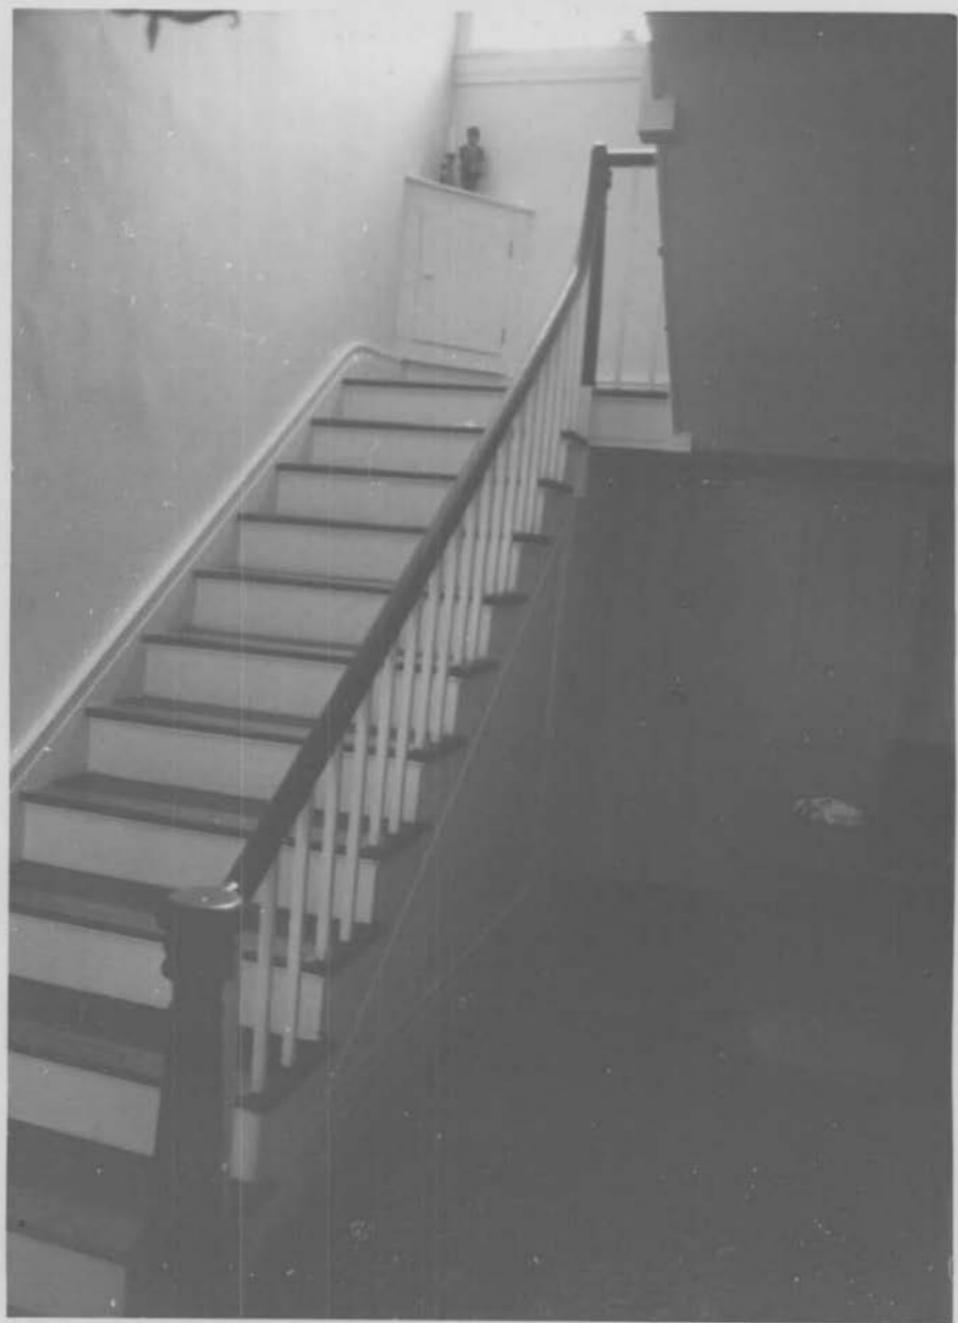
10

1. Big Bottom Farm
2. Cumberland vic., Allegany Co., MD
3. Photo Date: Dec. 1983
4. Photo by Paula S. Reed
5. Neg. Location: Preservation Associates, Inc., Hagerstown, MD
6. View: MAIN STAIR
7. Photo #10

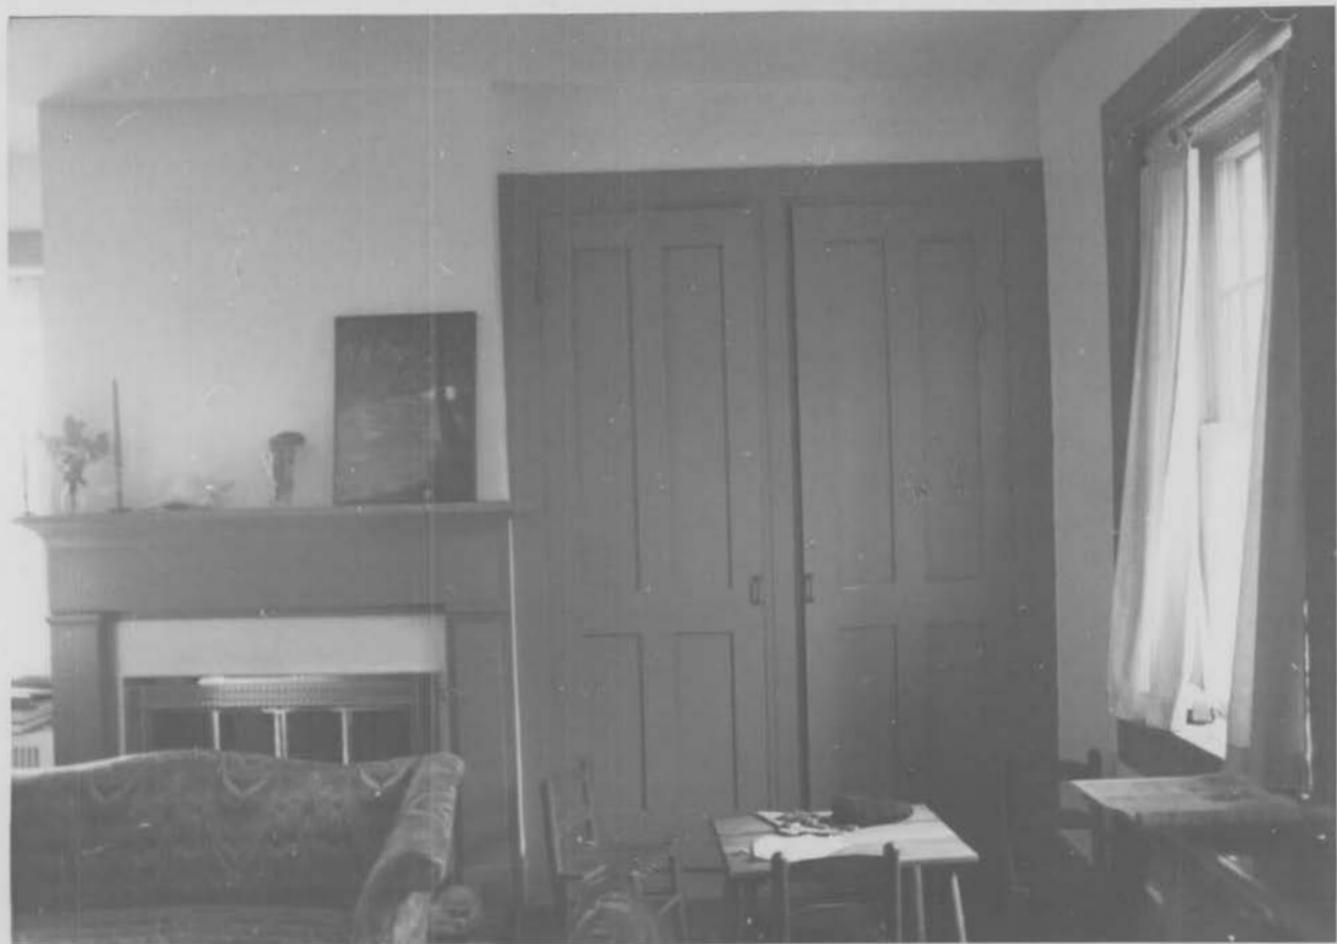
6. View: S. ROOM, 1<sup>st</sup> FL.
7. Photo # 14

South of the hallway is a less formal room containing a fireplace with a very simple mantelpiece with the merest suggestion of pilasters at its sides. Adjacent to the fireplace is a built-in cupboard behind a pair of plain four panel doors.

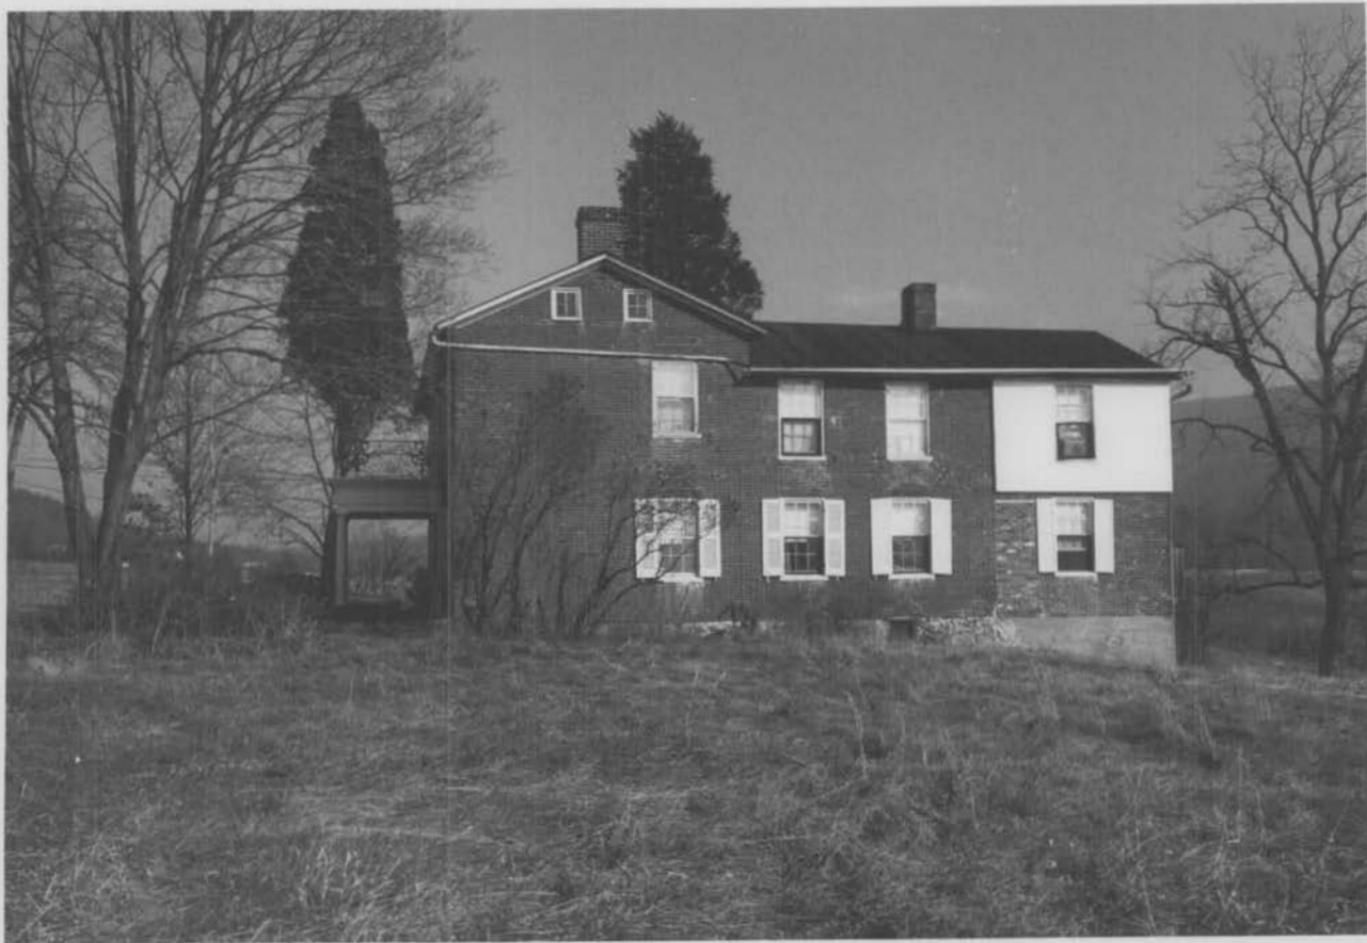
AZ-III-C-044

Claason farm  
South facade

The south facade is laid in five-course bond. Two small square four-pane casement windows light the attic, and each story of the main section has a single 6/6 sash window placed to the right (east) of center. An ell three bays wide, two stories high, with a trio of 6/6 windows on each, extends to the east; the brickwork of the south wall is continuous with that of the main section. The masonry at the east end of the ell shows evidence of alterations, including the blocking of a doorway. The north facade of the ell, now enclosed in modern framing, may have incorporated a porch or gallery at one time. The rear (east) facade of the main section has openings corresponding to the front fenestration.

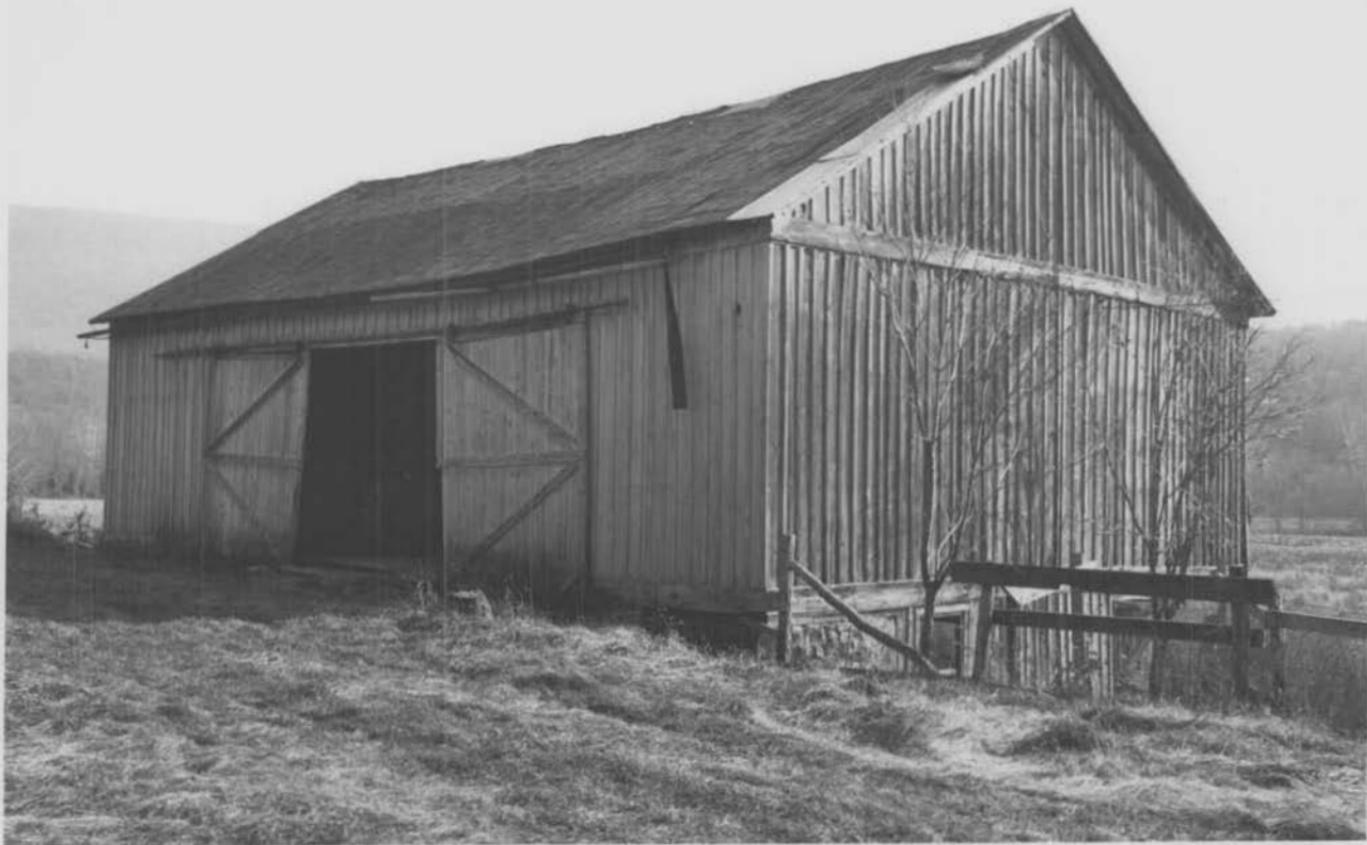
AL-III-C-044

Clauson barn  
view from southwest
