**NATIONAL REGISTER OF HISTORIC PLACES
REGISTRATION FORM**

historic name Cumberland YMCA

other names/site number AL-IV-A-151

street 205 Baltimore Ave.

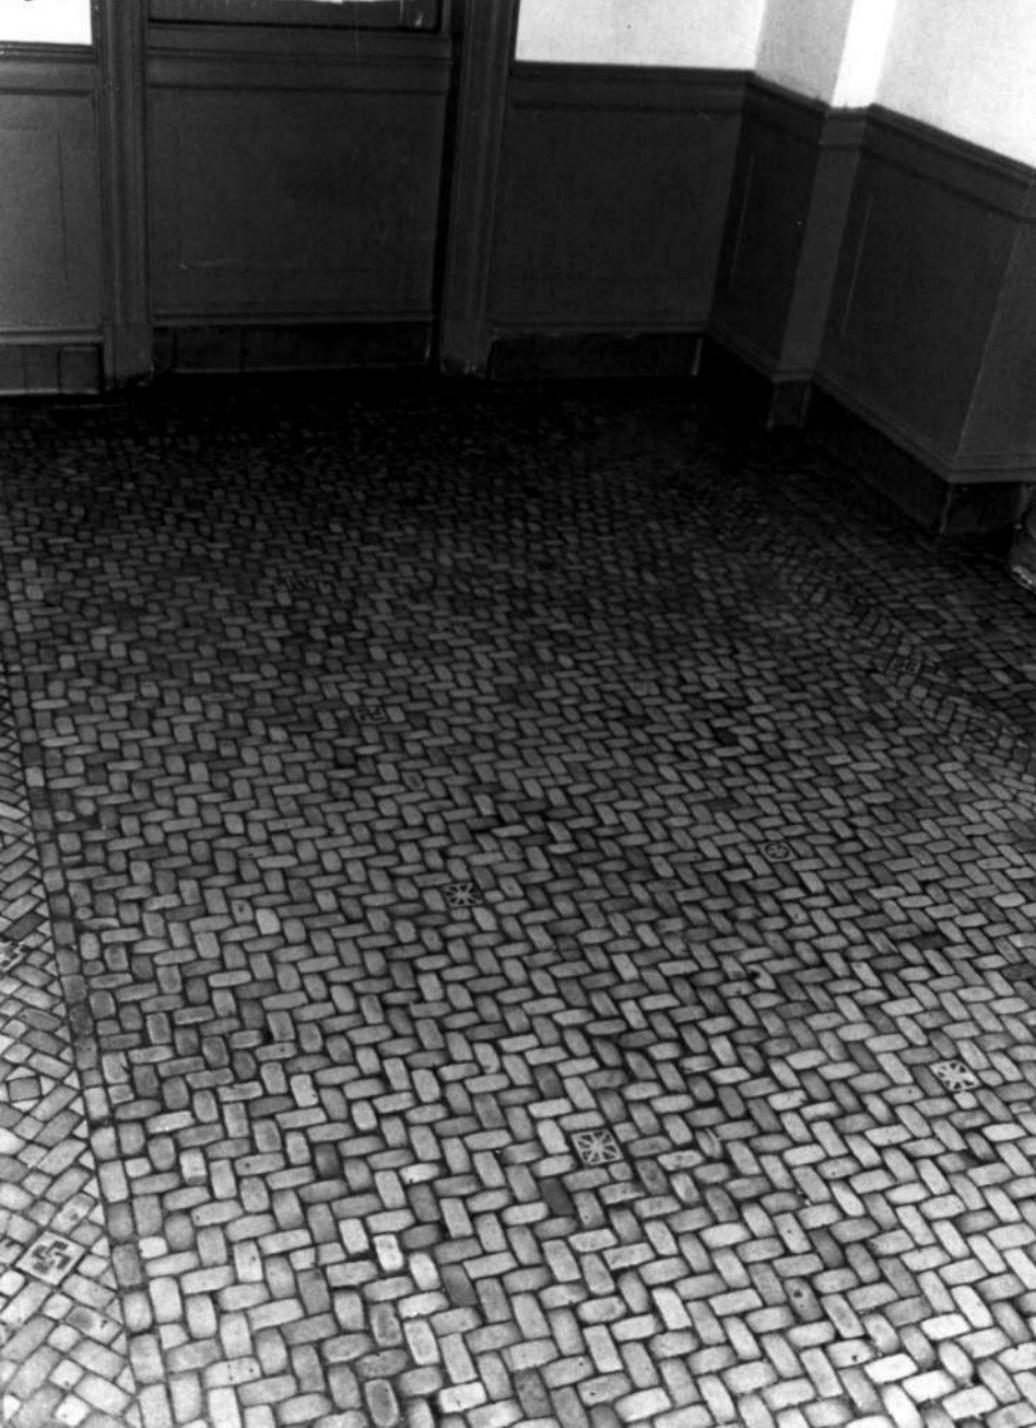
#7

mercator tile floor, lobby, 1st floor

The entrance areas, lobby, "board" room and main floor corridors are finished with Mercer tile with decorative borders. In most rooms on the main floor, wood paneled wainscoting extends approximately five feet up the wall. In the board room, a meeting room in the south end of the building, a projecting bay with french windows, follows the exterior elliptical projecting bay. The entrance to the projecting area is enframed by a dark-stained paneled and molded lintel supported at each side by a fluted column. An ample molded cornice defines the perimeter of the room.

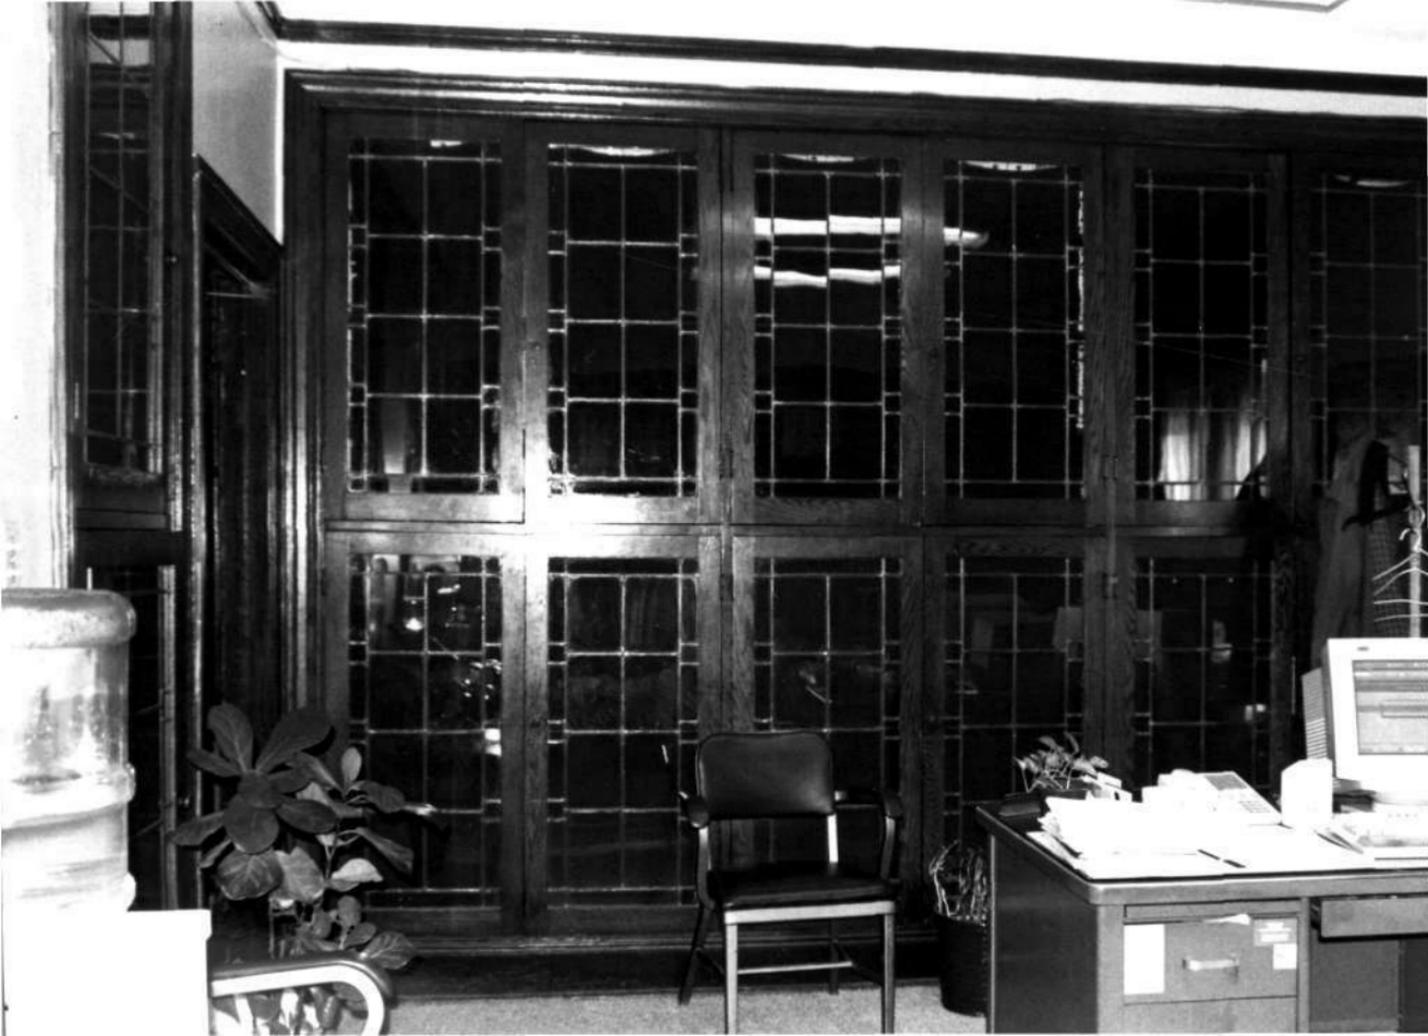
#10

library/office, first floor

Another notable space is the former library now serving as executive offices for the YMCA. Book shelves are located behind leaded glass doors and trimmed with naturally finished wooded architraves. A fireplace is located in an alcove at the south end of the room. The front of the fireplace is covered with square tiles and a naturally finished wooden architrave and mantel shelf.

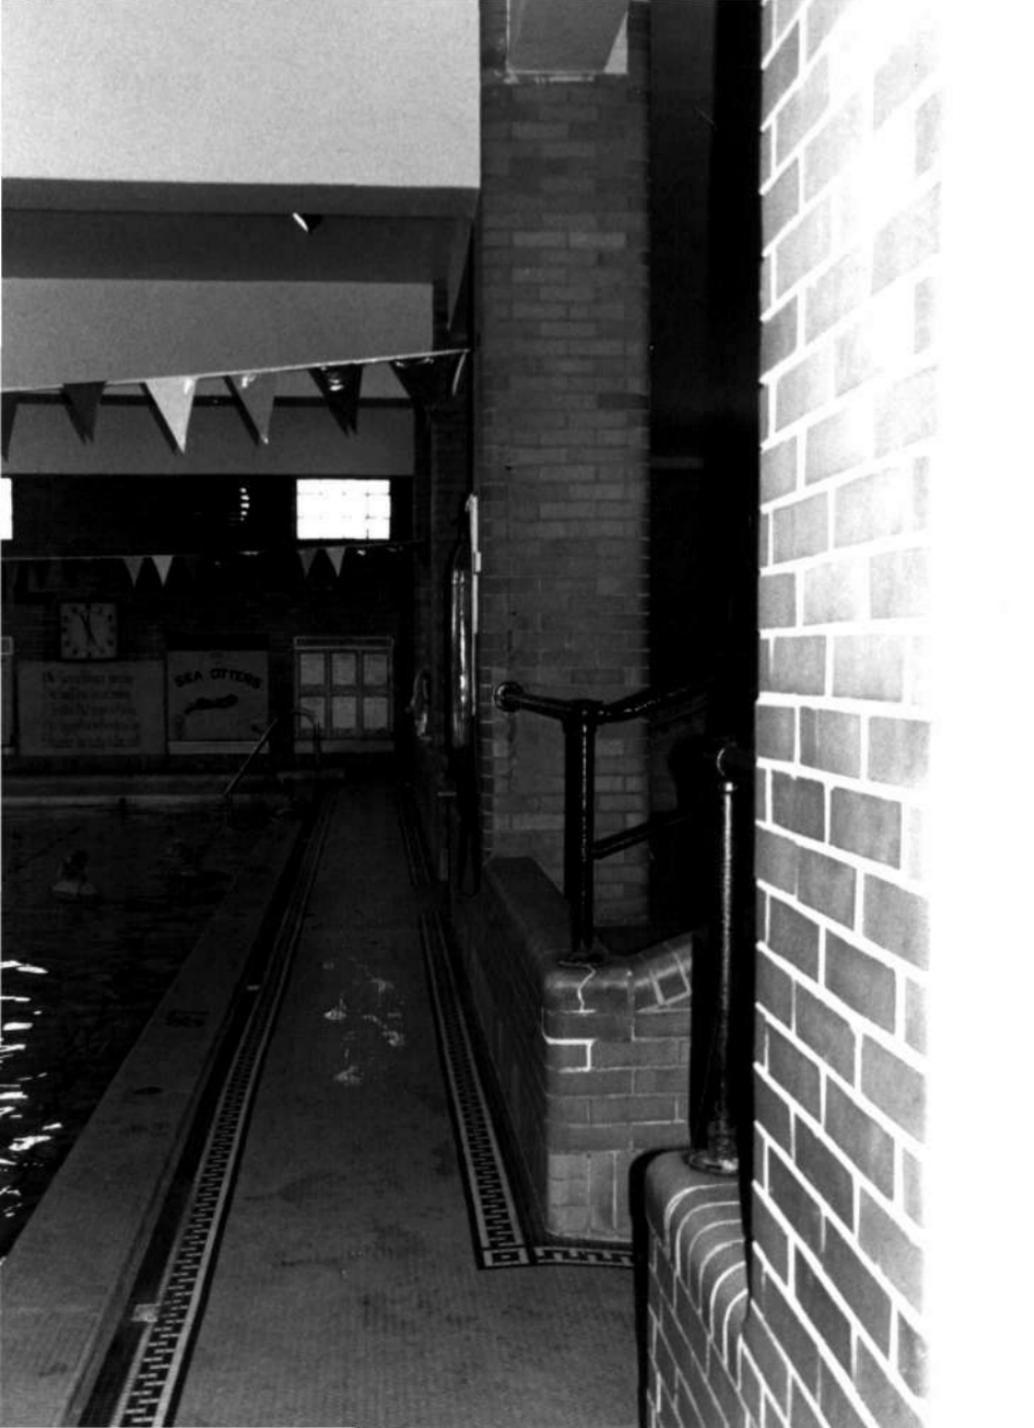
#16

pool

Also in the first floor of the north extension of the building is the swimming pool, in a large room lined with tile and yellow brick. Enclosed within brick walls, along the east side are bleachers. Above the pool and occupying the second and third story levels is the gym. It has a highly polished wooden floor, and an elevated jogging track around the perimeter.
