AL-V-A-025 Loar Log House
Hoffman Rd.
Clarysville vicinity, Allegany Co. MD
Not Eligible

INVENTORY FORM FOR STATE HISTORIC SITES SURVEY

Loar Log House

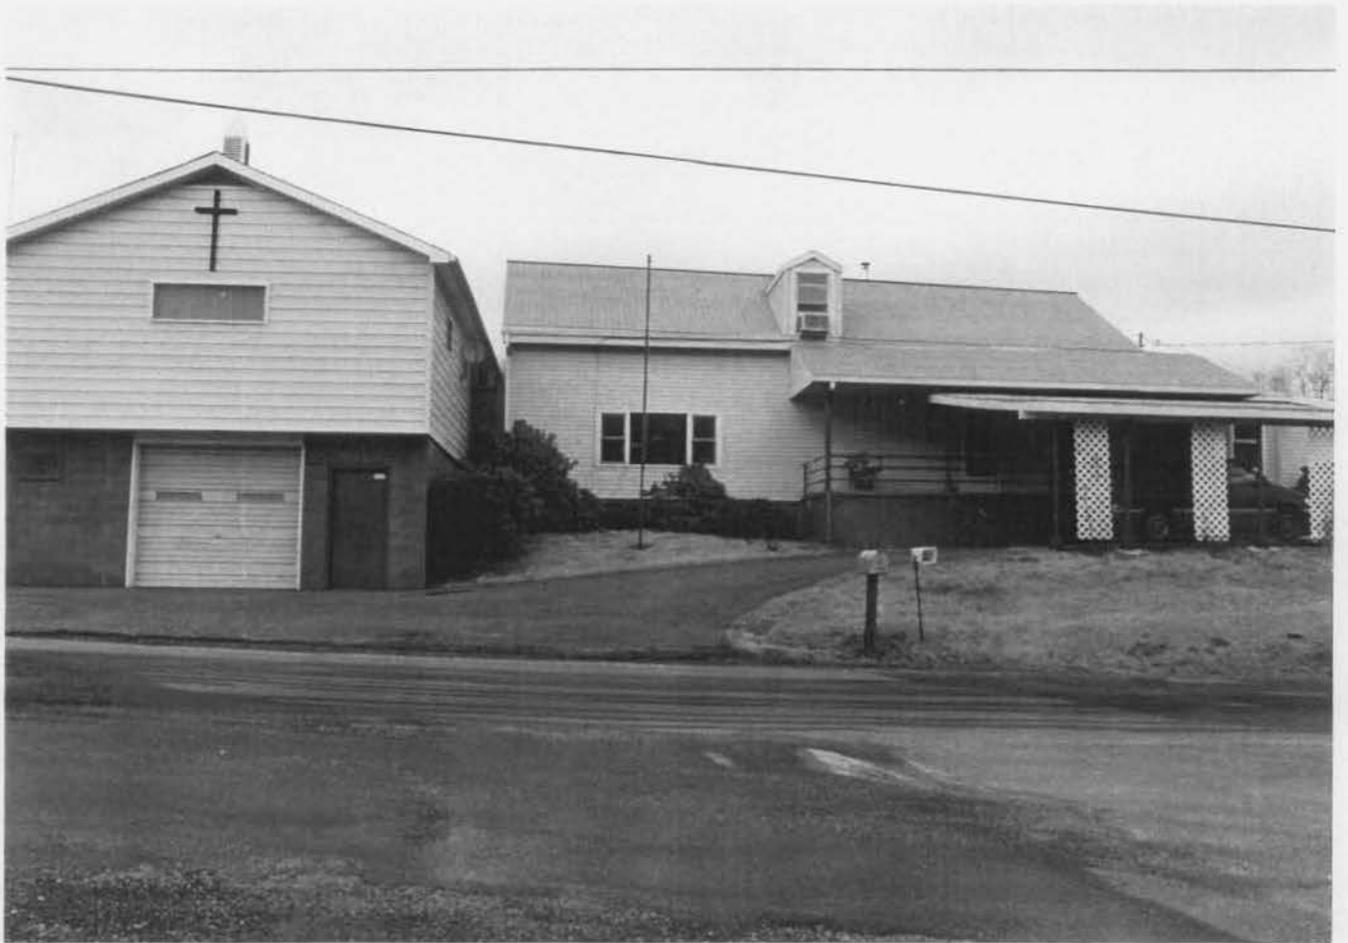
This 1 1/2-story log house has been so totally altered, modernized, and added onto as to be almost unrecognizable. Only the general shape and the central dormer remain from the original five-bay structure. This site is recommended as not eligible for the National Register of Historic Places due to lack of integrity of design, materials, workmanship, and feeling.

View of Loar Log House (Al-V-25).
