AL-V-B-090
Hemming Log Cabin
Cash Valley Road
Ca. 1840's

INVENTORY FORM FOR STATE HISTORIC SITES SURVEY

Log Cabin - Hemming

Cash Valley Road

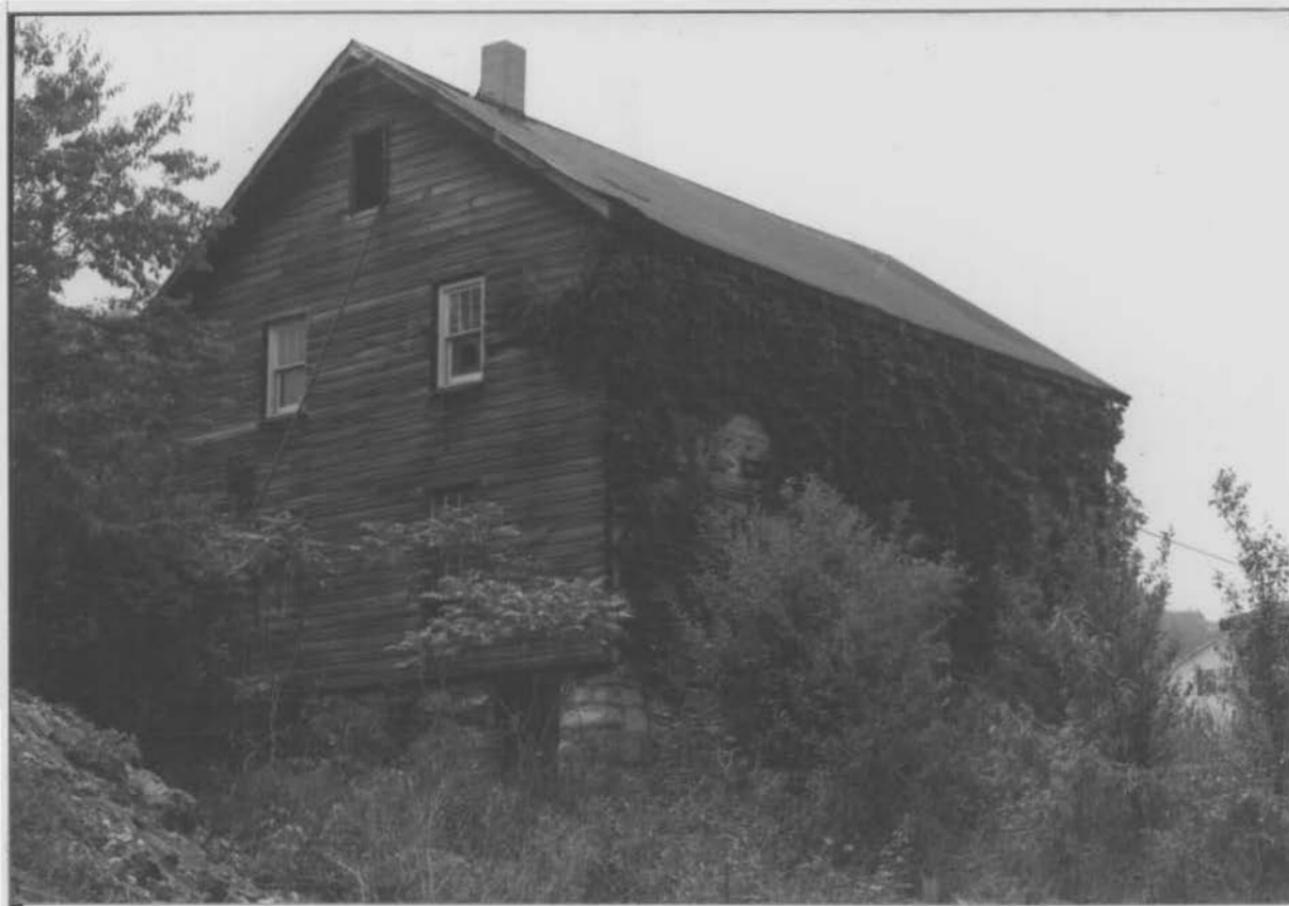
AI-V-B-090

This two and one-half story, three bay wide building of log construction featuring mud and wood chinking was in all probability once a farmer's house. Today it stands in deteriorating condition partly covered with clapboards.

The building is still structurally sound but in poor condition with only some of its original appearance to be seen.

Hemming Log House

South

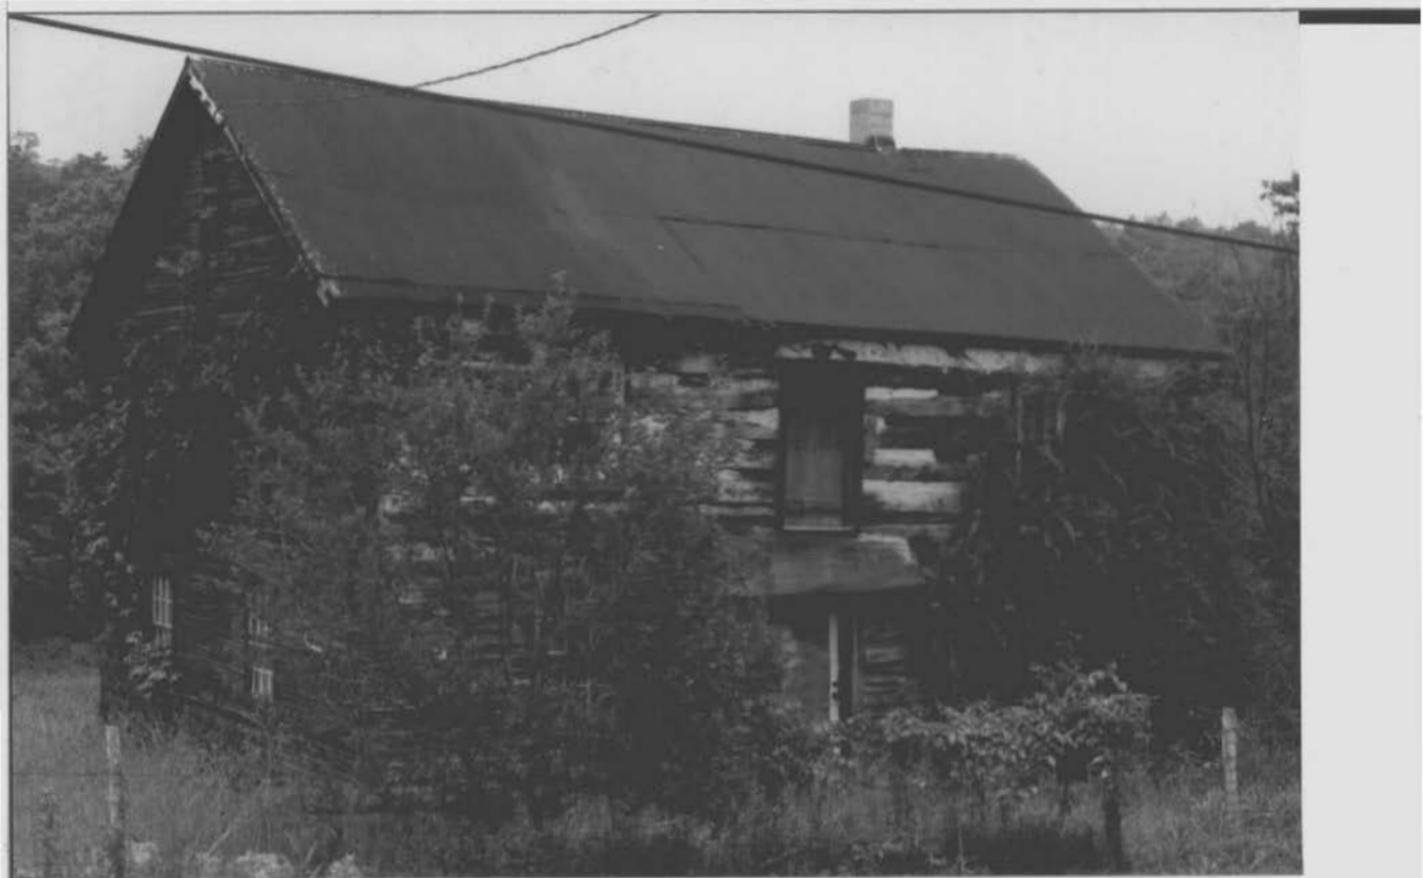
AI-V-B-090

Hemming Log House

North
