AL-V-B-093
Frost Log House
Off Cash Valley Road
Ca. 1850's

INVENTORY FORM FOR STATE HISTORIC SITES SURVEY

NAME OF PROPERTY: Frost Log House

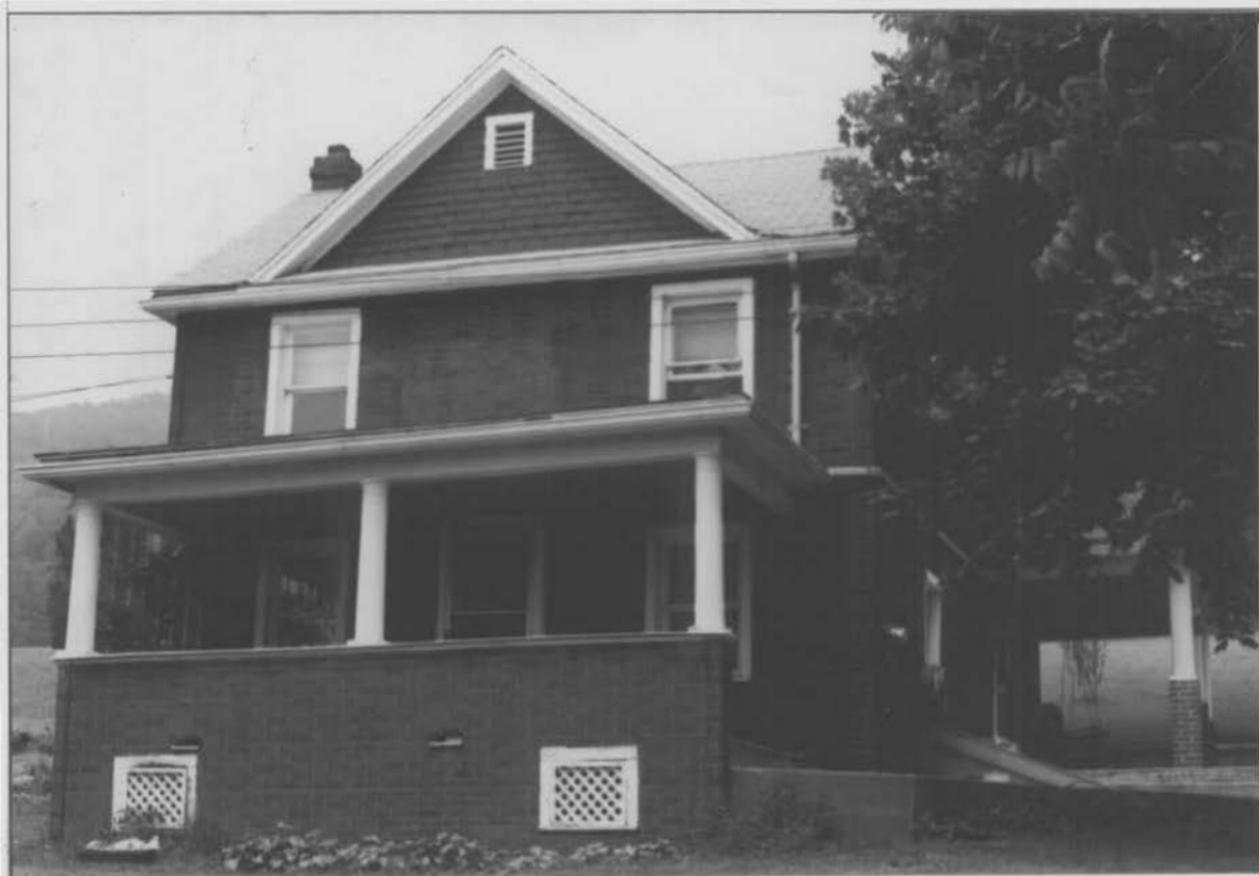
NORTHWEST

The building basically consists of a two story, three bay wide, "T" shaped structure. The building was originally a log structure but now is completely covered with insul brick. A rear two story wing abuts the building on the northwest facade. Wall features are plain. The building is supported by a low, replaced concrete foundation with a plain water table. The roof of the building is both gable front and gable flank and is covered with asphalt shingles; replaced. In the peak of each gable are louvered ventilators. Eaves of the roof exhibit original boxed cornices with return ends and wide soffit. A gabled dormer is located on the west facade with boxed cornice with return ends and soffit with a diamond shaped ventilator in the peak of its gable. Windows in the building are double hung, with wooden sash frames and one-over-one, six-over-one, and six-over-six lights. Window trim is plain. There is one corbeled brick chimney in the building. It is replaced and located outside end. The main entrance is located on the southeast facade with replaced hardware. The building has two porches. One is a two-bay, open porch on the southeast facade covered with a flat roof with soffit and supported by short wooden columns. A portico with hip roof is located on the northeast facade supported by columns resting on high, brick bases.

The building is structurally sound but has been drastically altered since original construction and retains practically none of its original appearance.
