Maryland Historical Trust

Maryland Inventory of Historic Properties number: AL-V-B-313

Name: #1068/MD35 OVER WILLS CREEK

SHA Bridge No. 1068 Bridge name MD 35 over Wills Creek

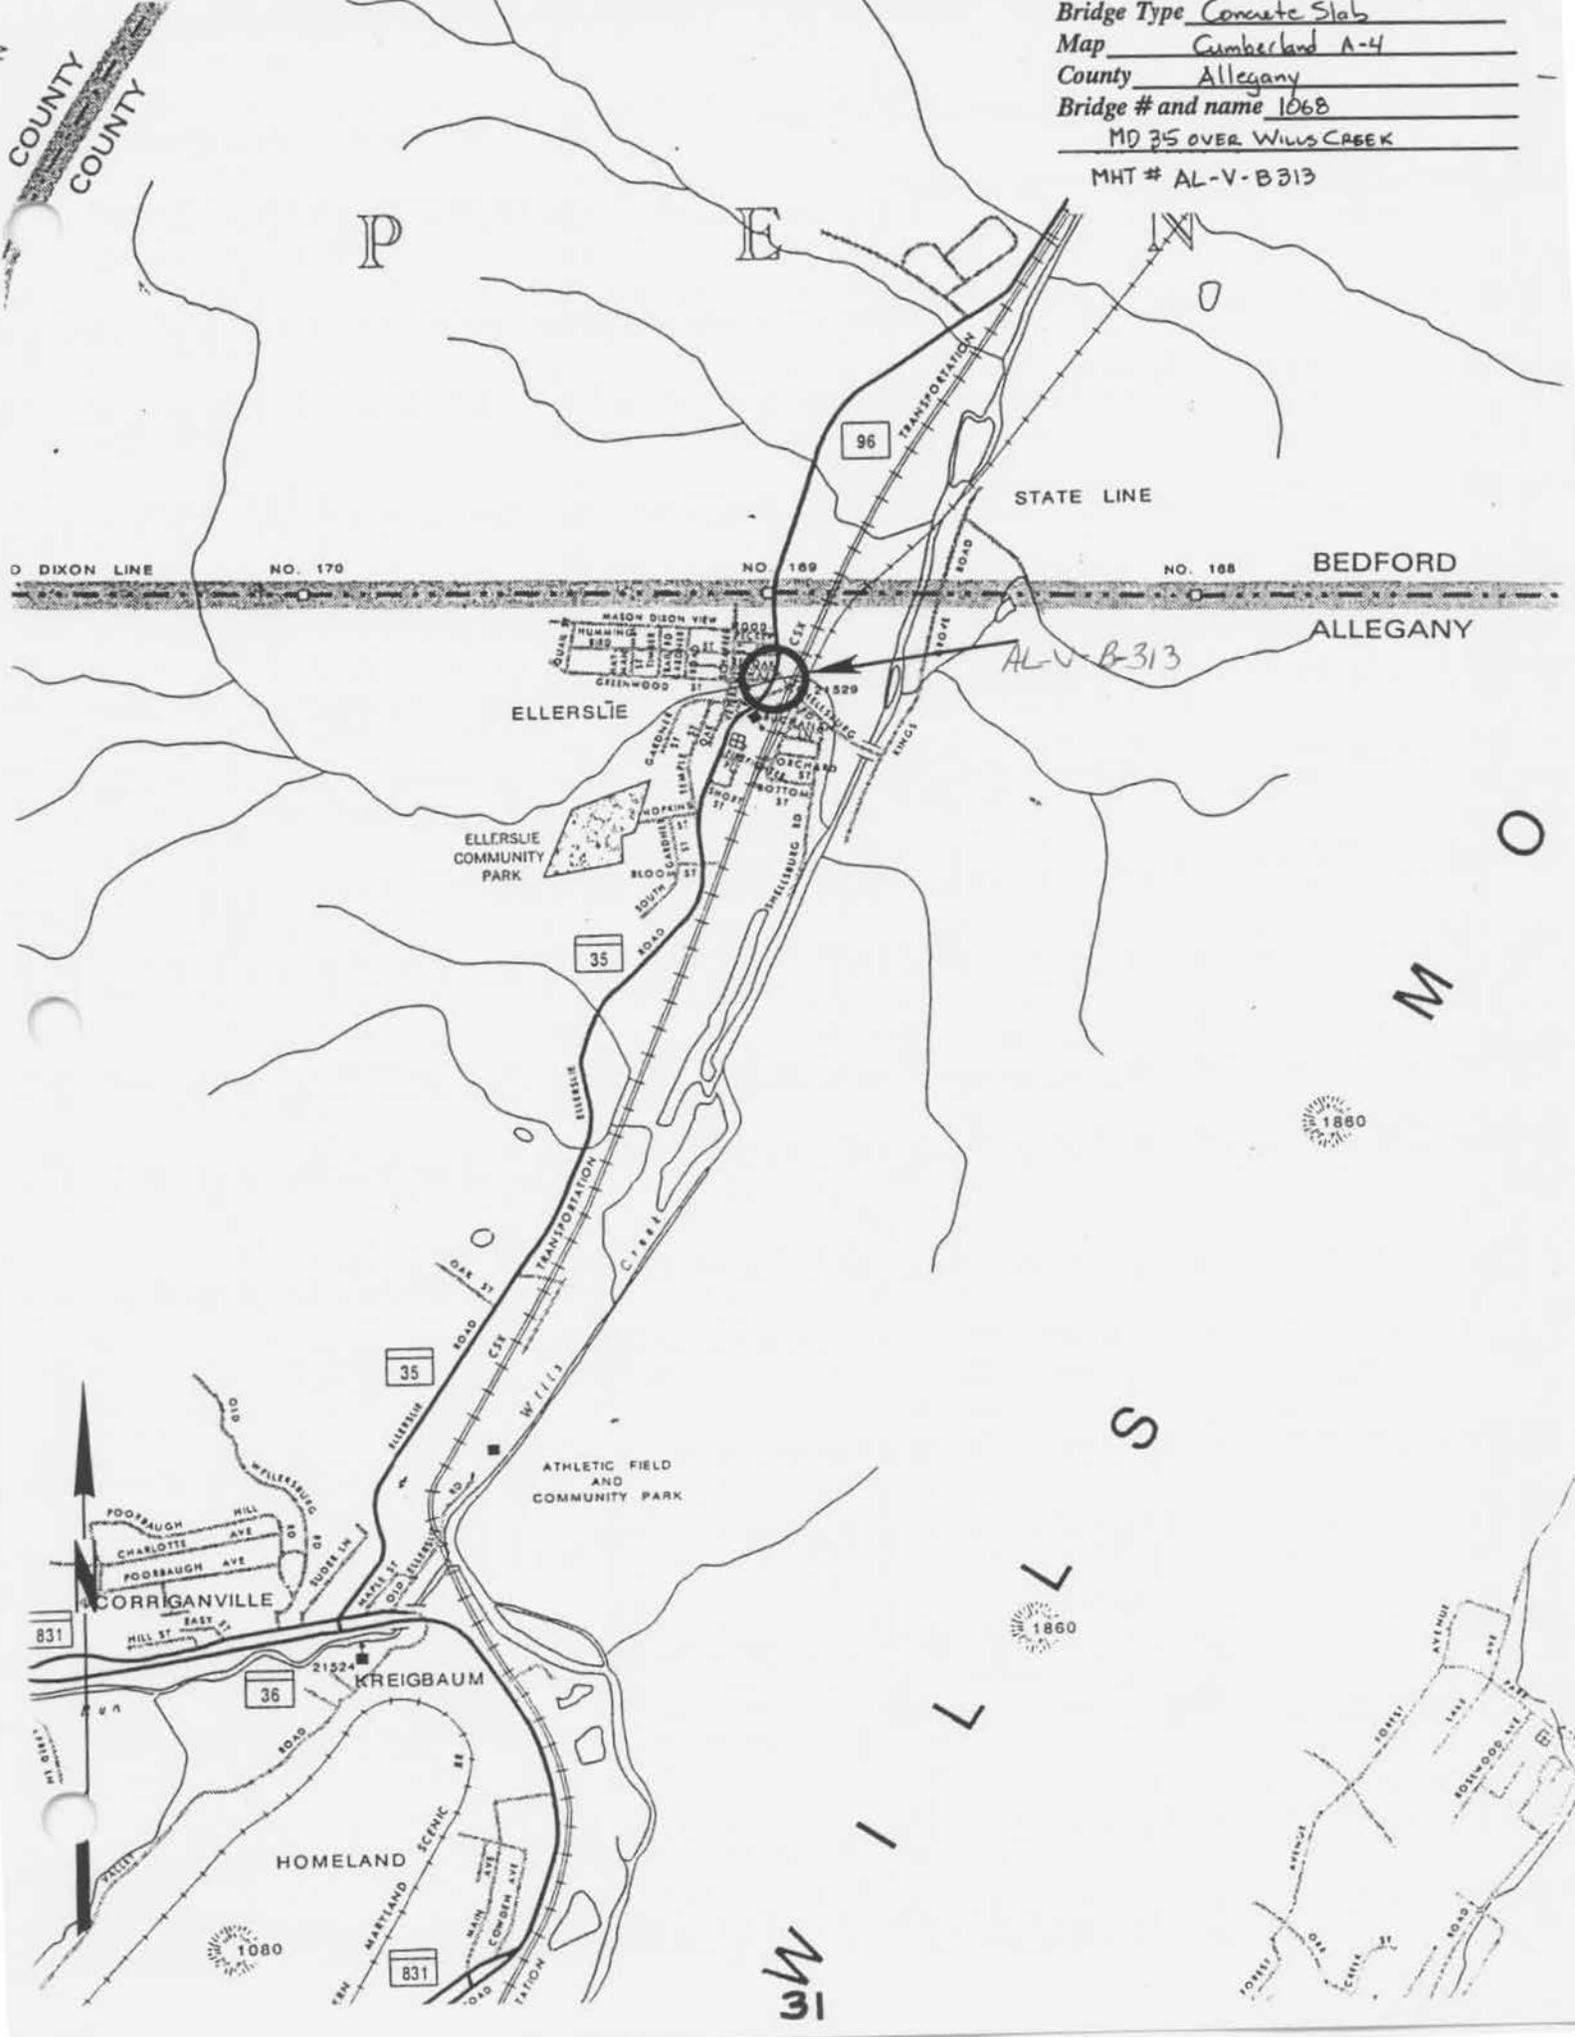
1. AL: V- B- 313
2. MD 35 over Willis Creek/1068
3. Allegany Co, MD
4. Ryan McKay
5. 3/97
6. MD SH PD
7. upstream elevation
8. 1 of 4

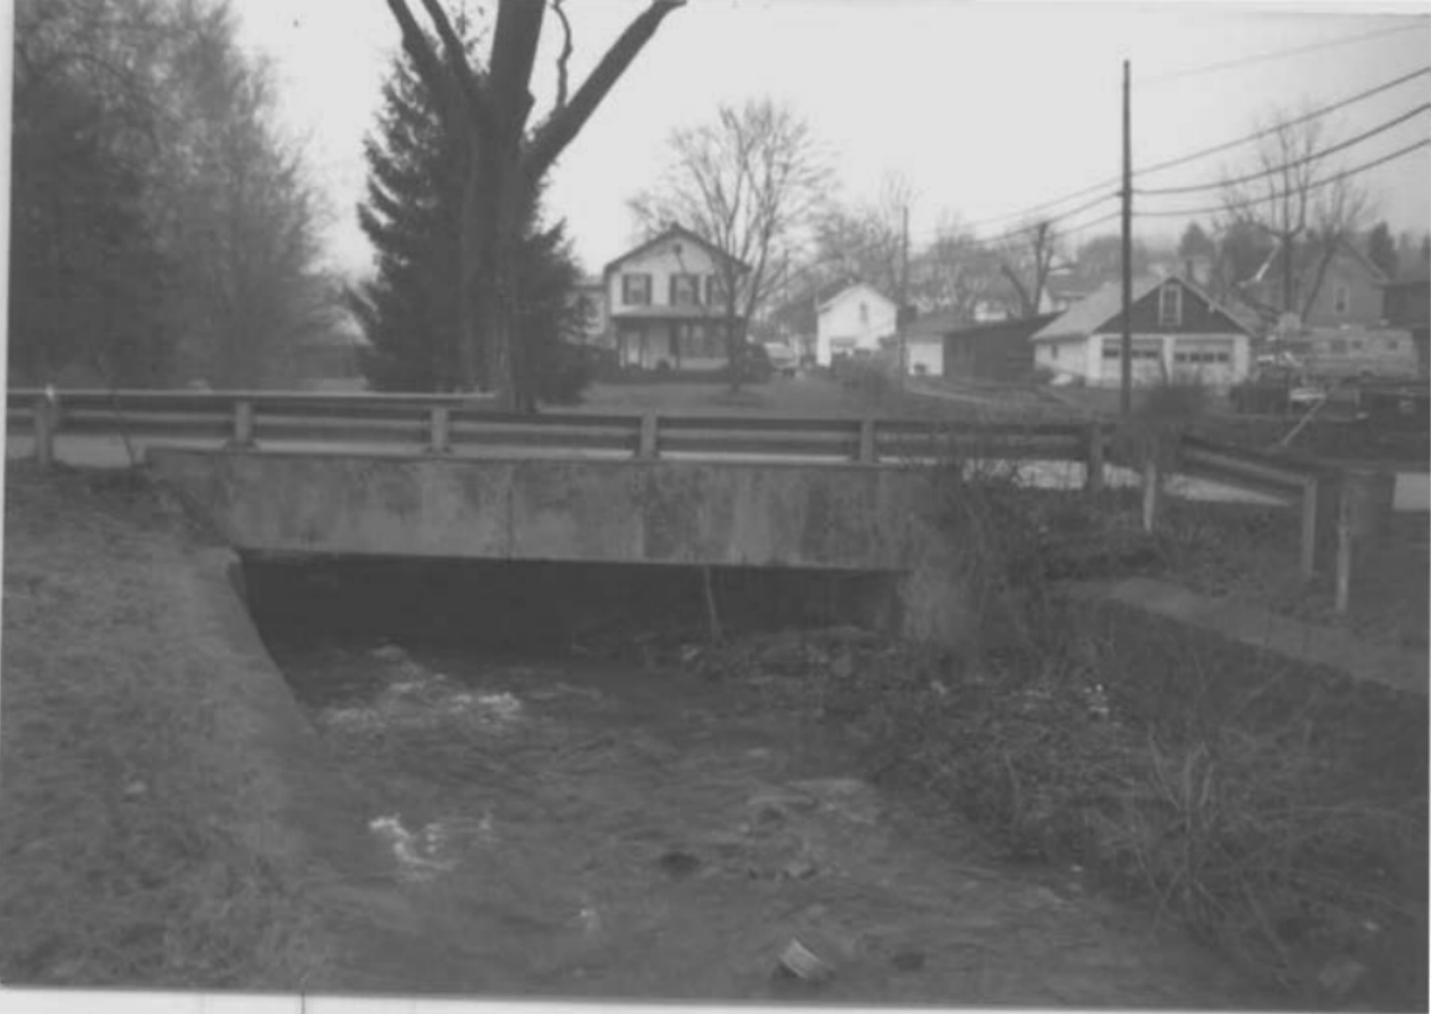
8 2 of 4

7 Downstream elevation

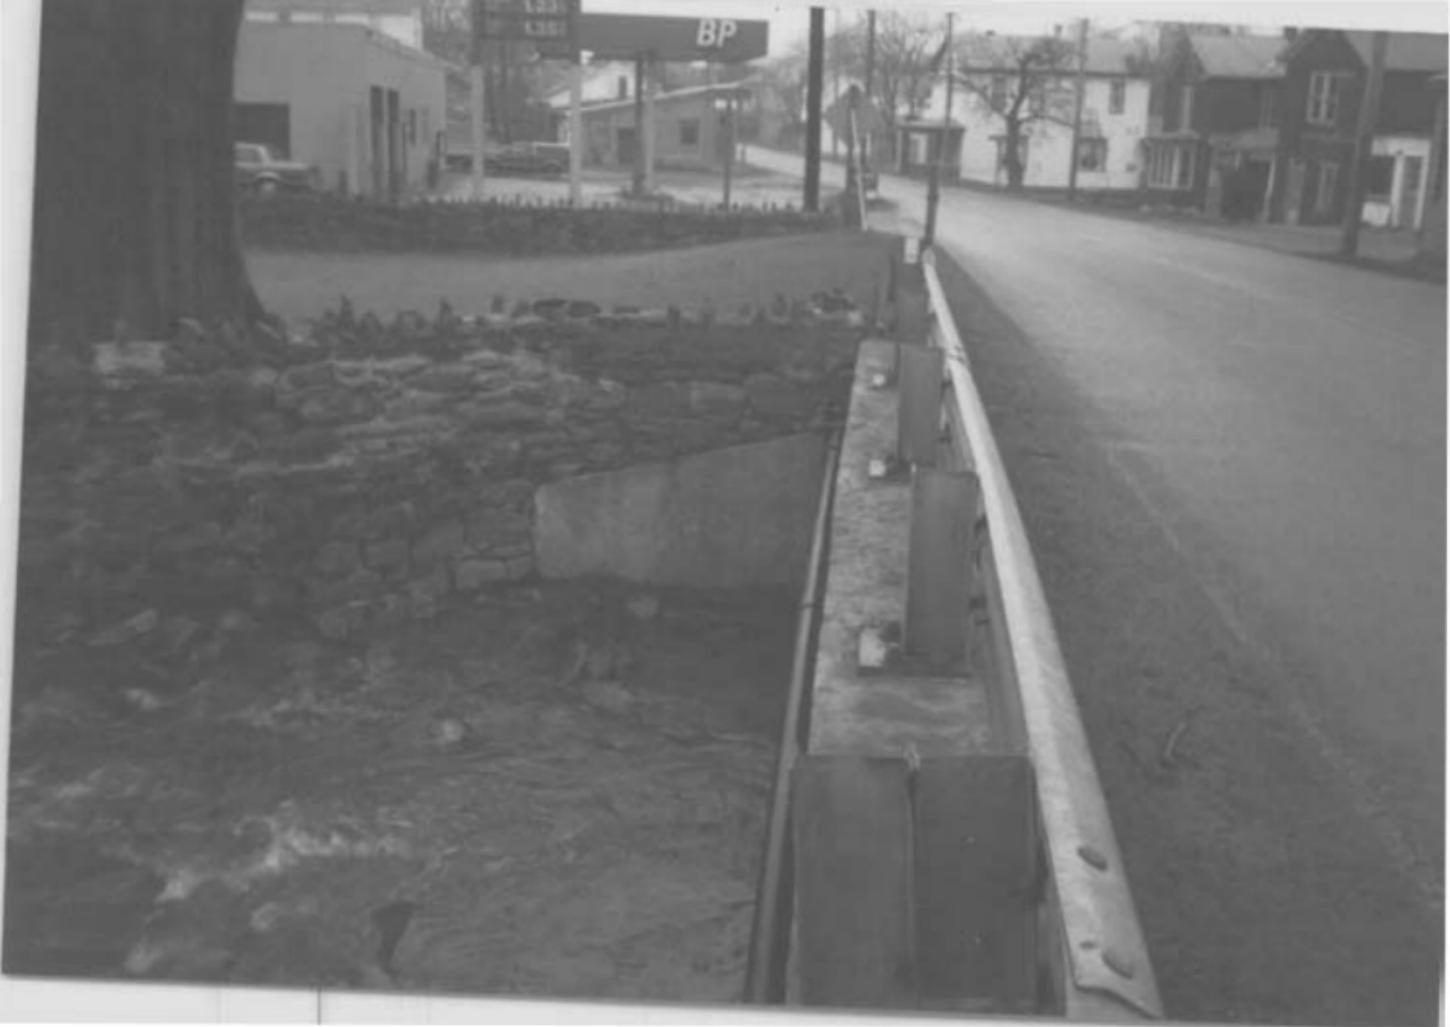
8. 4 of 4

Bridge No. 1068 is a 1-span, 2-lane, concrete slab bridge. The bridge was originally built in 1917 and the original concrete parapets were removed at an unknown date. The east curb of the superstructure was removed and replaced between 1987 and 1989. Wills Creek has an adjacent stone retaining wall, west of the bridge on the north bank, and east of the bridge on the south bank. The bridge is 24 feet, 11 inches long and has a clear roadway width of 29 feet; there are no sidewalks. The out-to-out width is 31 feet, 6 inches. The bridge was built on a 55° skew. The concrete slab is 2 feet, 6 inches thick, and it has a bituminous wearing surface. The structure has steel guard rails and the roadway approaches have narrow shoulders and steel guard rails on the east side. The substructure consists of two (2) concrete abutments and three (3) flared concrete wing walls; the northwest wing wall is a u-shaped concrete wing wall. The bridge is not posted, and has a sufficiency rating of 4.

7. Retail of NW wingwall
