CAIN FRAME SALTBOX

AL-VI-B-059
Vale Summit
ca. 1870

INVENTORY FORM FOR STATE HISTORIC SITES SURVEY

Cain Frame Saltbox

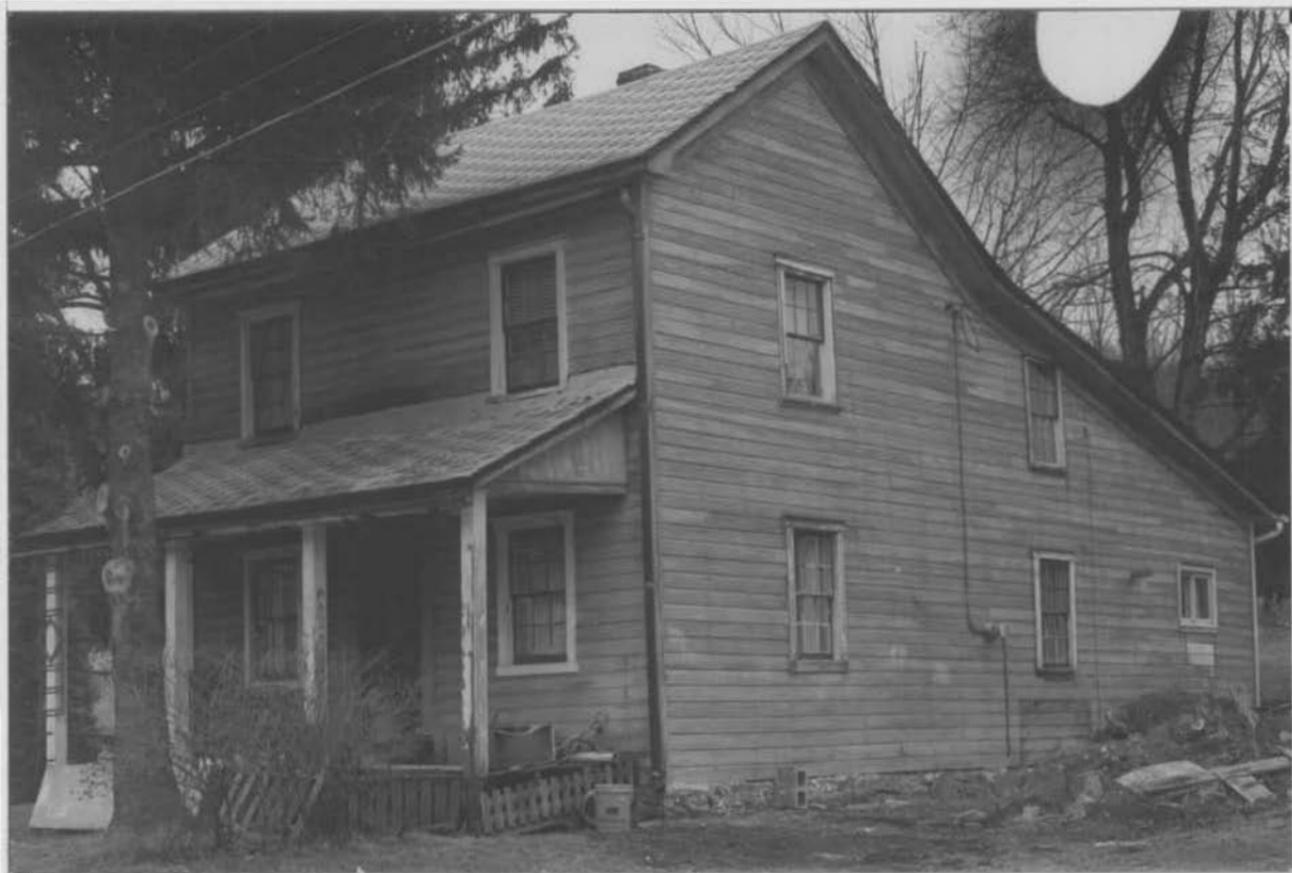
Southwest

The Cain house is a three bay wide, two story, frame saltbox. The entire structure rests on a low stone foundation. The roof is gabled with a soffit and covered with replaced asphalt shingles. Windows in the structure are pegged, double hung, wooden sash frames with six over six lights. Each window is topped with a cornice. The main entrance is located on the east facade and features a verticle paneled door with original hardware. The entrance is covered by a three bay shed roof end porch. A second entrance, located on the south side, is also covered by a one bay end porch and is surrounded on two sides by lattice work. A single original corbeled brick chimney is located in the interior of the building.
