AL-VI-B-243

Clise Farm

INVENTORY FORM FOR STATE HISTORIC SITES SURVEY

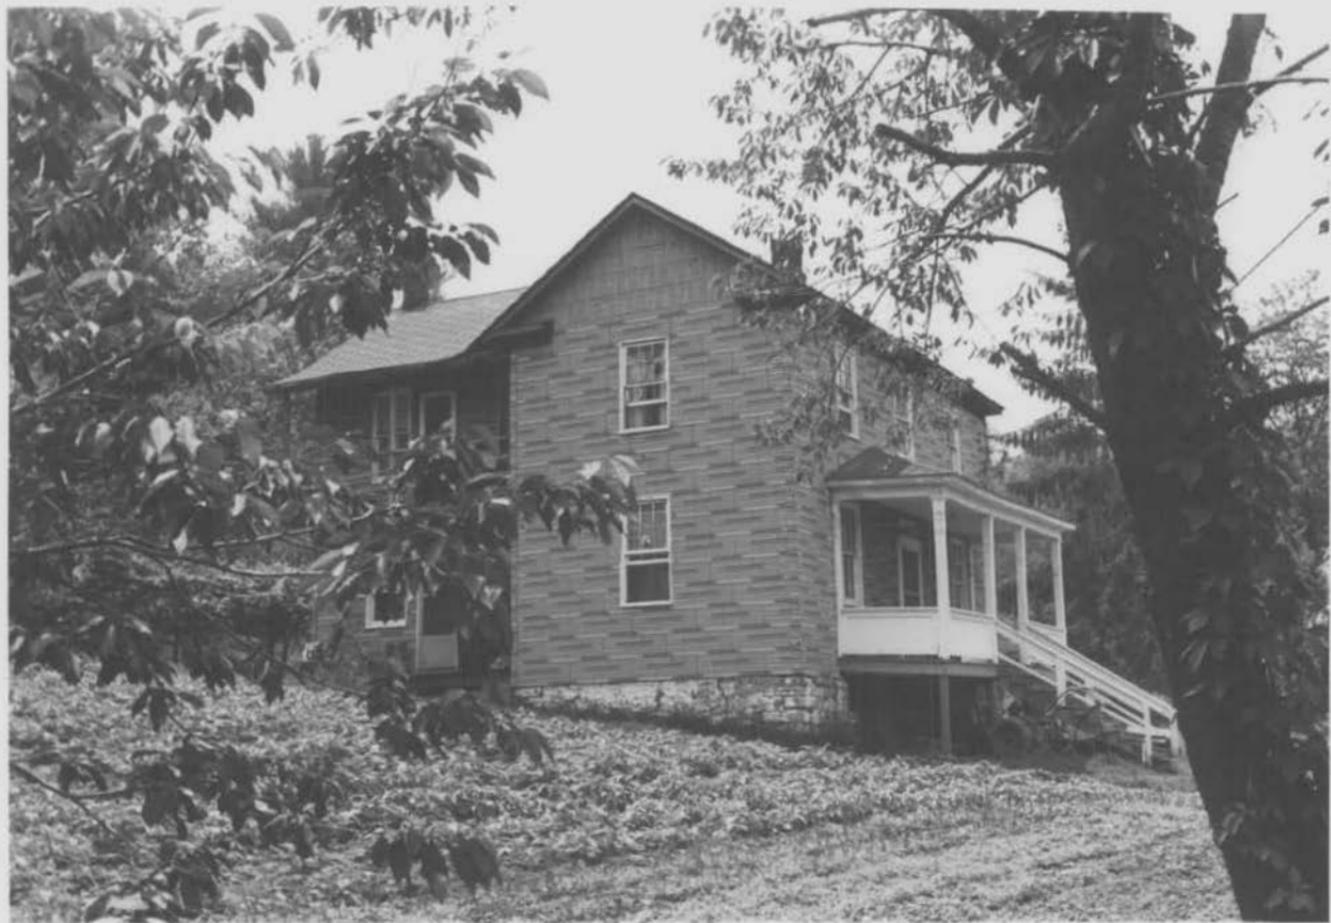
AL-VI-B-243
Clise Farm
Allegany Co., MD
David A. Dorsey 7/81
Farmhs. NW elevation

The Clise Farm is located south of Route 55 at Miller. The farm consists of a farmhouse and ten outbuildings. The farmhouse is two stories tall, three bays wide on the facade (NW elevation), and one bay deep. The house is "T" shaped due to the addition of a two story frame wing to the southeastern elevation which is two bays wide and one bay deep. The frame farmhouse has walls of tongue and groove flush boards covered with asbestos shingle siding. It rests on a high rubble stone foundation. The gabled roofs of both the main block and the addition are covered with asphalt shingles.

A porch on the facade has a hipped roof supported by capped square wooden posts. A two tiered porch on the northeastern elevation of the addition has a shed roof supported by square wooden posts. Windows are pegged 6/6 sash. An entrance in the center of the facade has a one light transom and an original door. The door has two horizontal panels and two square panels surmounted by one pane of frosted glass with an urn design. Engraved hardware of the door is original. A central chimney on the main block and an end chimney on the addition are of brick.

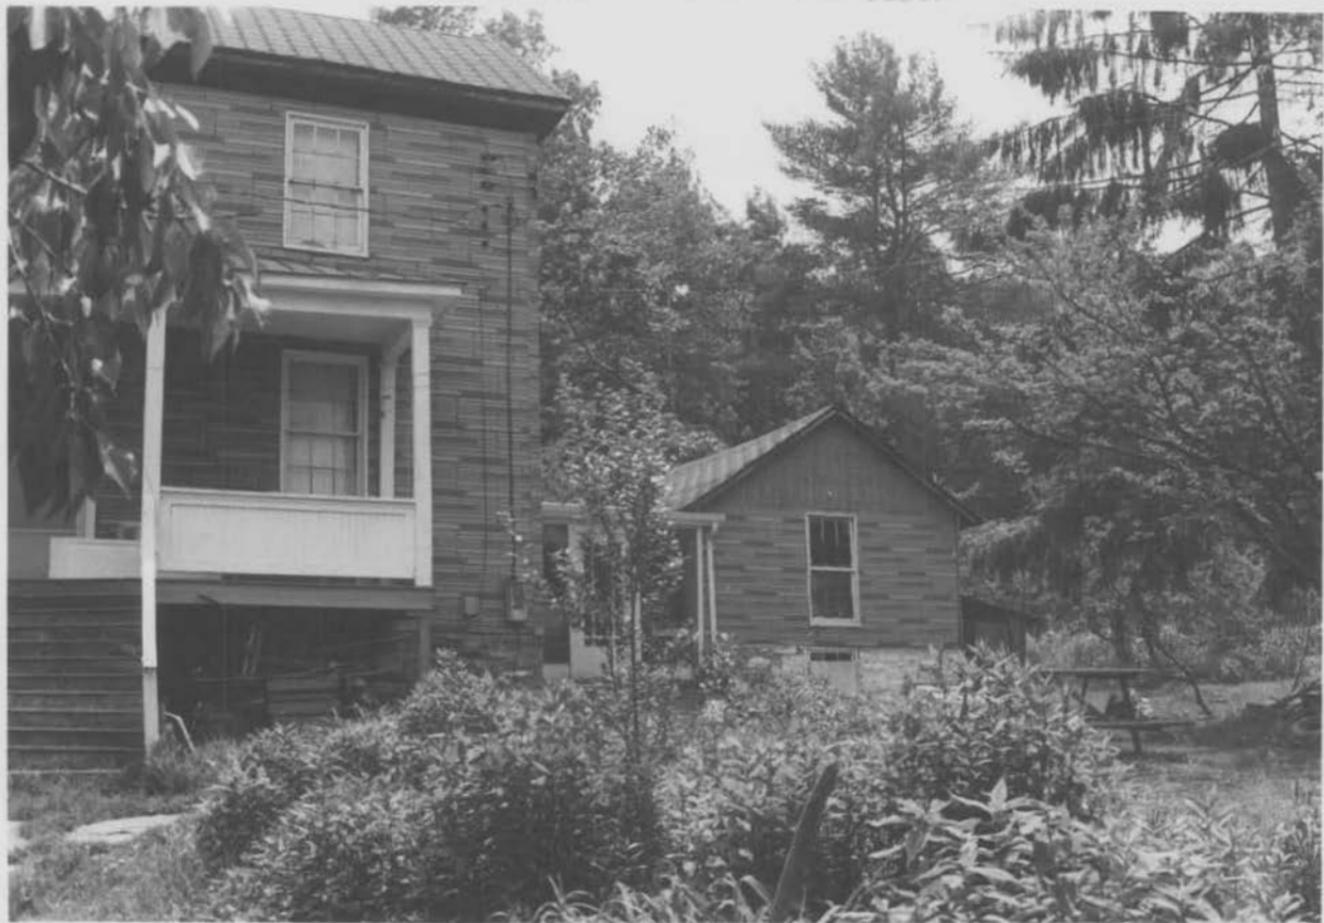
Springs. NW elev.

A springhouse is located immediately to the southwest of the farmhouse. The two buildings are connected by a small frame addition with a gabled roof. The frame springhouse is one story tall and is covered with german siding and insul brick siding. It rests on a high random ashlar stone foundation and has a gabled roof. A spring which emerges from beneath a stone retaining wall to the southeast of the springhouse flows through the foundation of the structure.

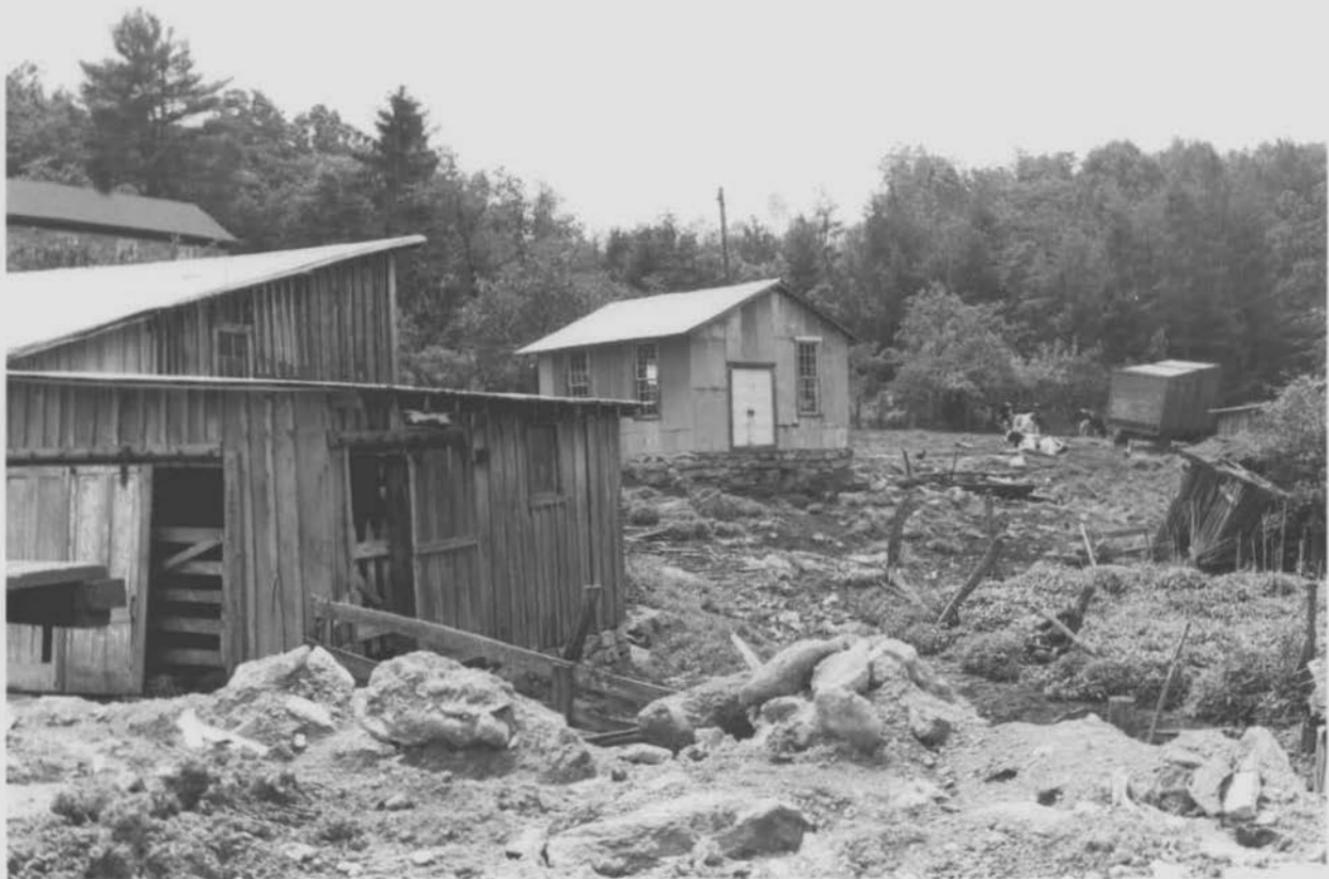
Outbldgs. View to the SW

A small frame milking house, a pavillion-like sawmill, and a recently rebuilt shop which rests on a highstone foundation are located to the northwest of the farmhouse. Two frame granaries, a drive-in, double bin corn crib, two shed roofed board and batten cow sheds, a rebuilt barn, and the foundation of a silo are located to the north of the farmhouse.

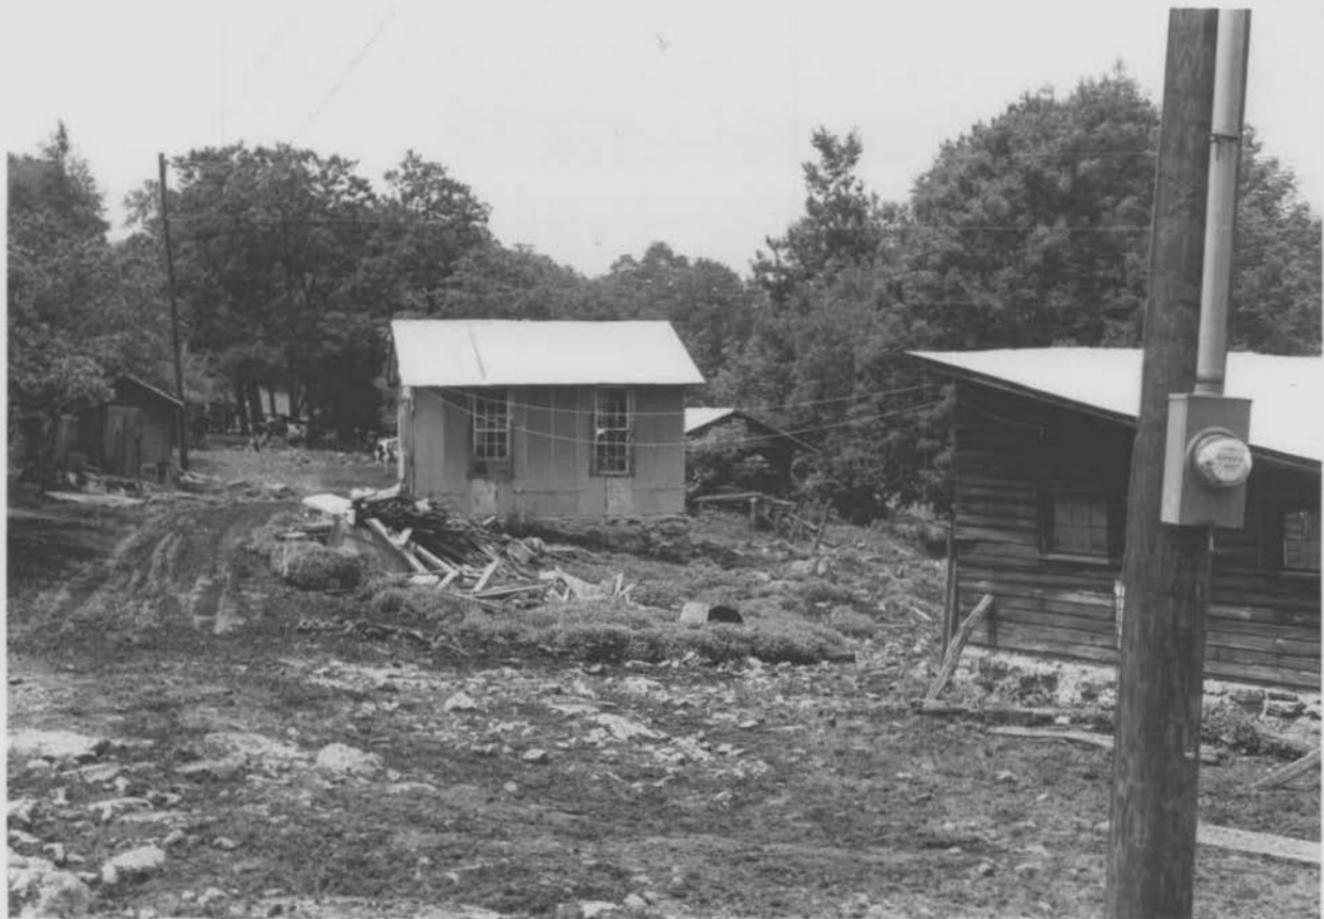
AL-VI-B-243
Clise Farm
Allegany Co., MD
David A. Dorsey 7/81
Outbldgs, View to the S

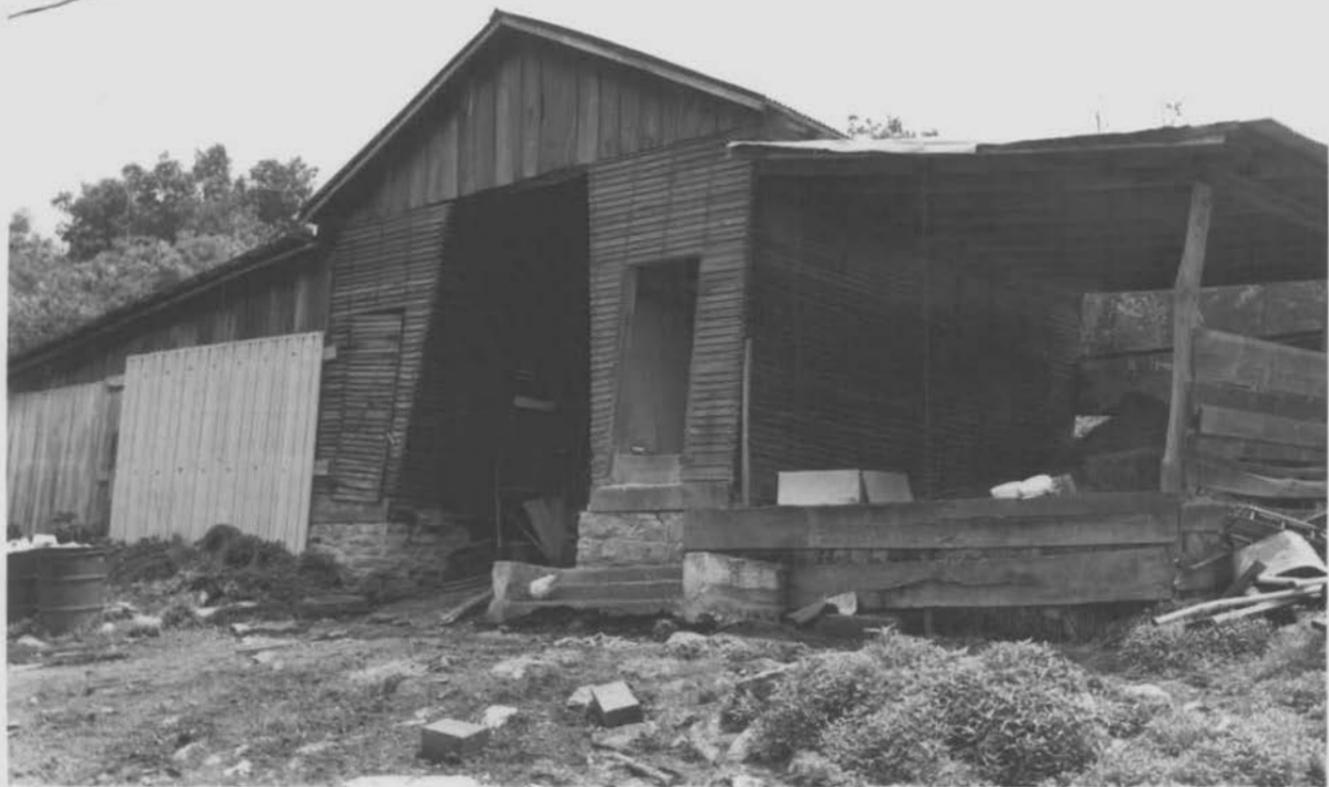
Corncrib, NW elev.
