Maryland Inventory of Historic Properties Number: AL-VI-13-336

Name: MD 36 over Georges Creek (1913)

MARYLAND INVENTORY OF HISTORIC BRIDGES
HISTORIC BRIDGE INVENTORY
MARYLAND STATE HIGHWAY ADMINISTRATION/
MARYLAND HISTORICAL TRUST

SHA Bridge No. 1013 Bridge name MD 36 over Georges Creek

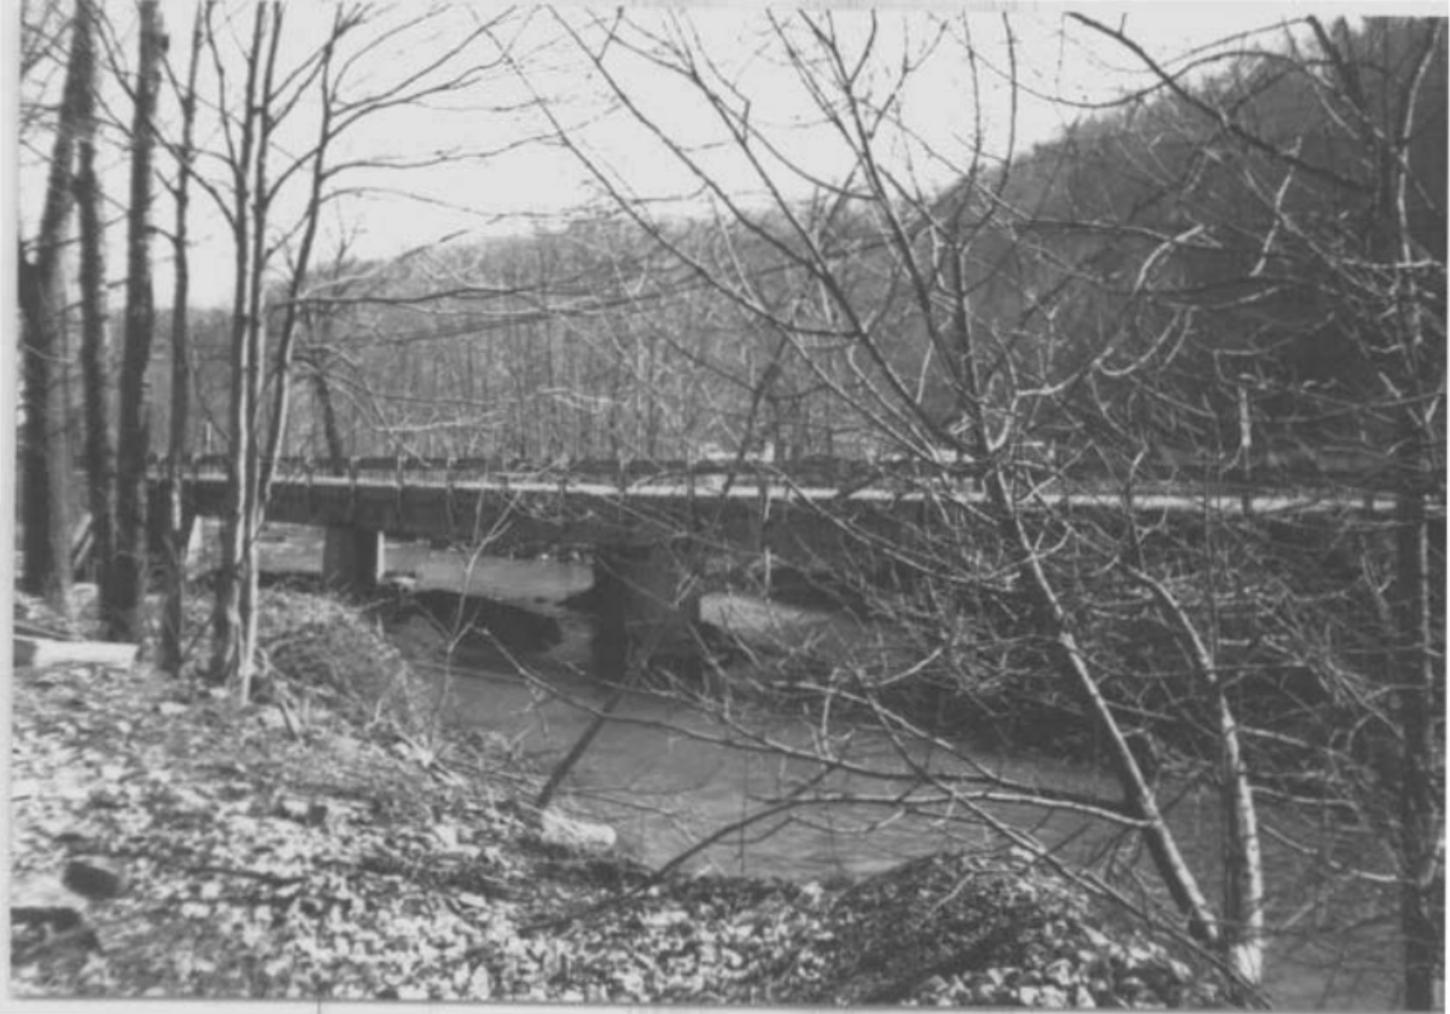
1. AL-VI-B-336
2. MD 36 over George's Creek
3. Allegany Co, MD
4. Ryan McKay
5. 3/97
6. MD SHPO
7. Downstream elevation
8. 1 of 6

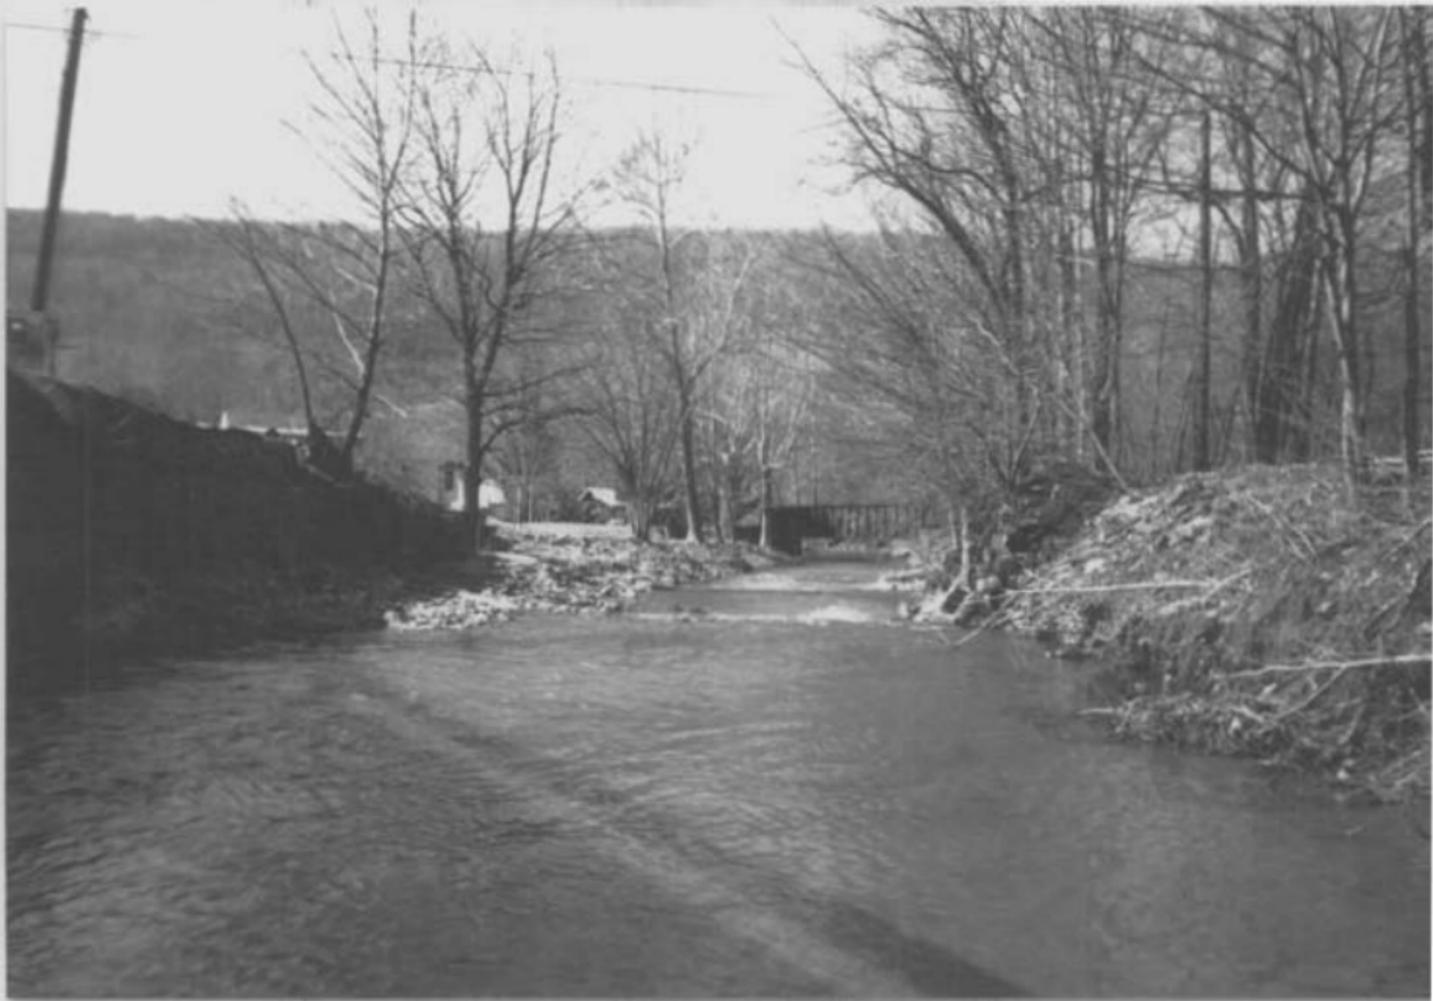
- 1 AL-VI-B-336
- 2 MD 36 over George's Creek
- 3 Allegany Co, MD
- 4 Ryan McKay
- 5 3/97
- 6 MD SHPO
- 7 Original abutment of org bridge
8. 2 of ~~6~~

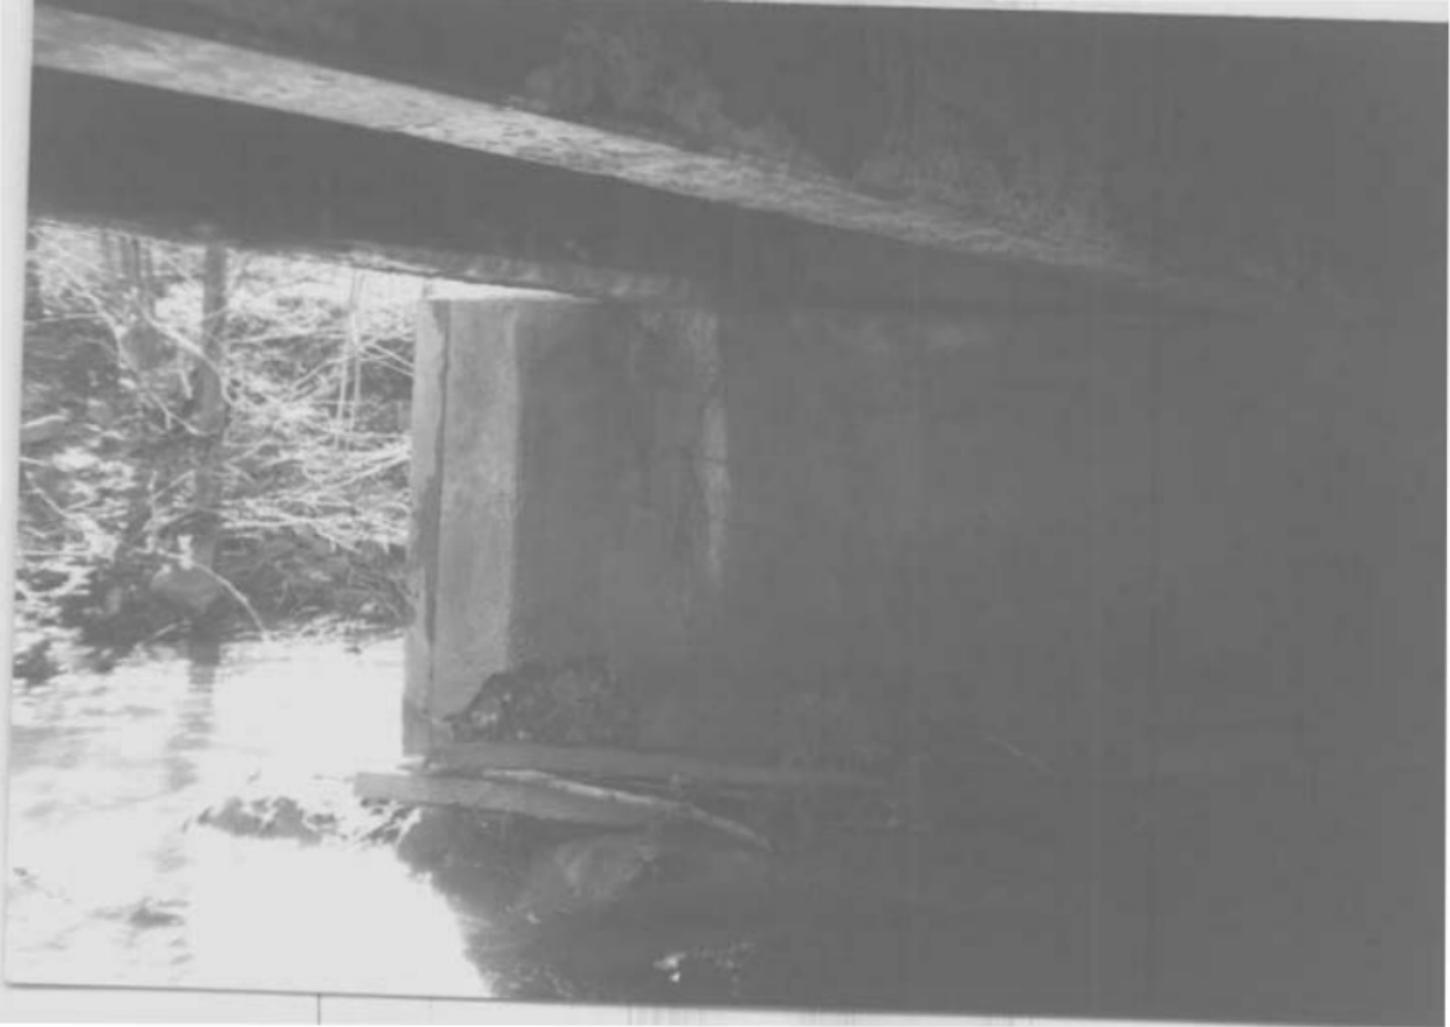
According to the 1996 inspection report, this structure was in fair condition with cracking, scaling, and spalling of concrete throughout the structure. The asphalt wearing surface has depressions in the traffic lanes. The concrete beams are badly spalled and have areas of rust and exposed reinforcing bars. The spans have shifted slightly, and the concrete piers have damage at the base. The abutments and wing walls have been patched with concrete in the past, and some of the repairs have failed.

- 1 AL-VI-B-336
- 2 MD 36 over George's Creek
- 3 Allegany Co, MD
- 4 Ryan McKay
- 5 3/97
- 6 MD SHPO
- 7 Detail of west pier & beam
- 8 3 of 6

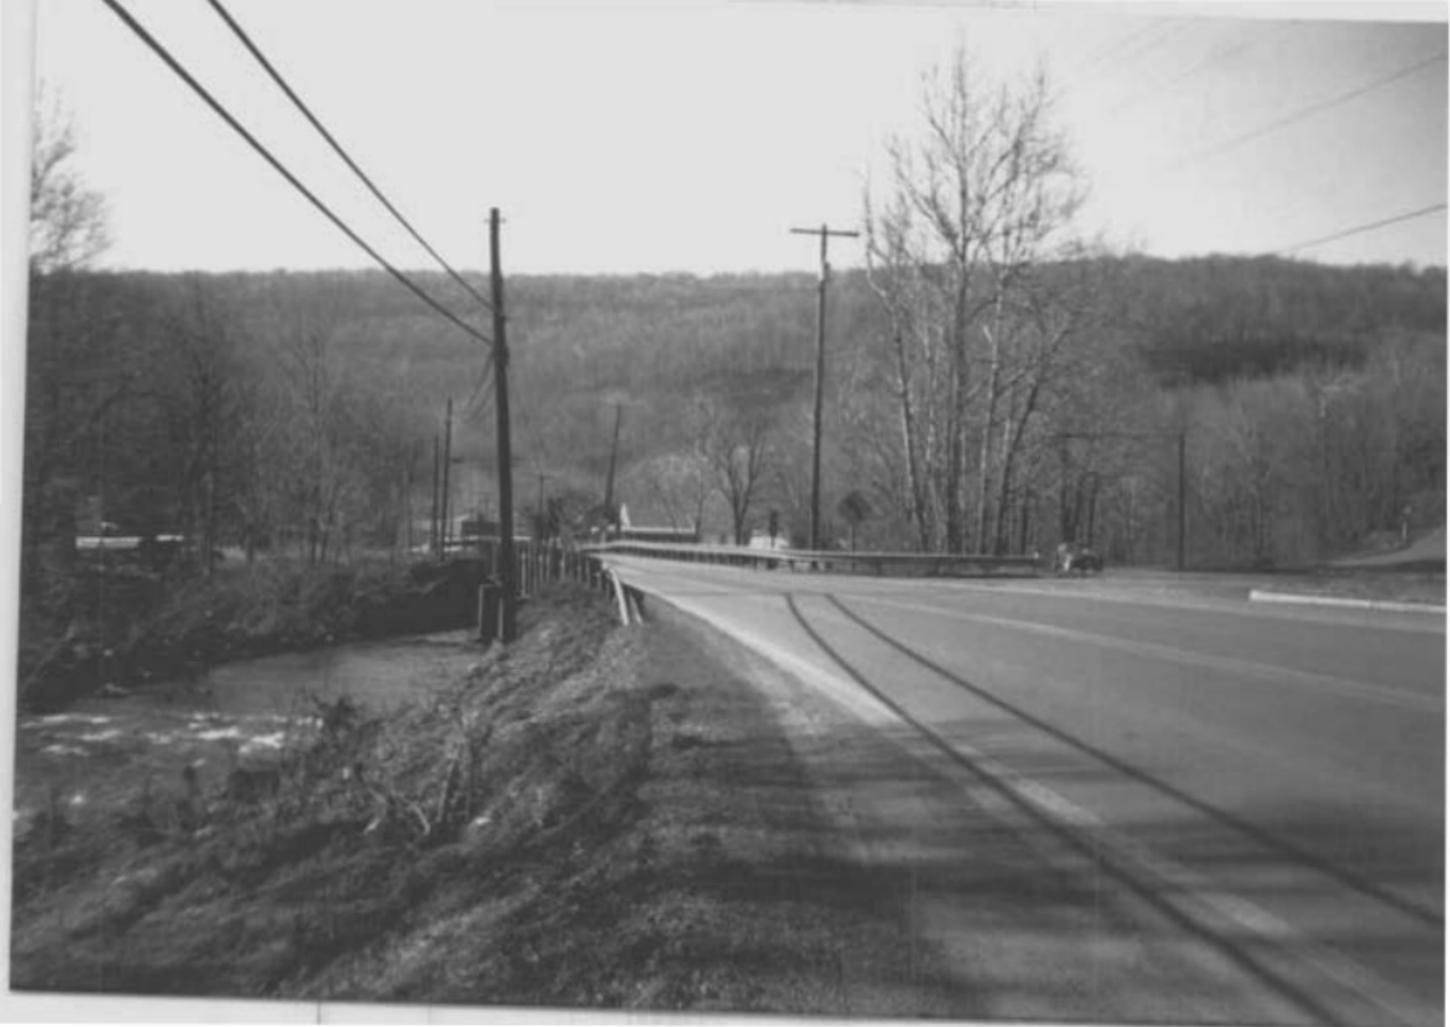
1. AL VI - B. 336
2. MD 36 over George's Creek
3. Allegany Co, MD
4. Ryan McKay
5. 3/97
6. MD SHPO
7. East approach
8. 4 of 6

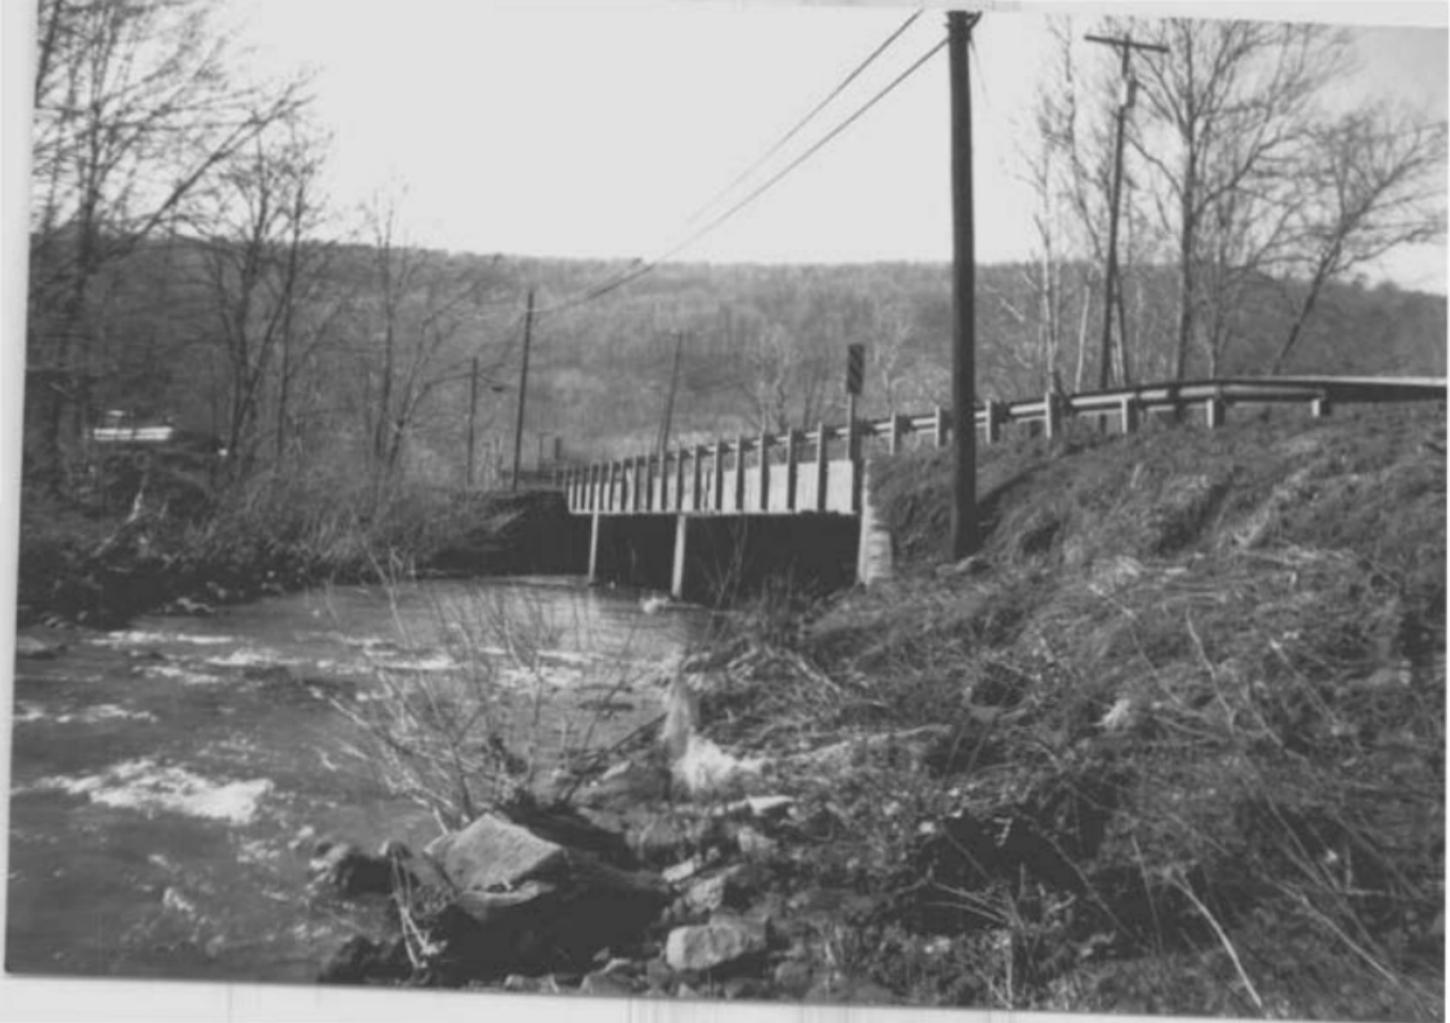
1. AL-VI-B-336
2. MD 36 over George's Creek
3. Allegany Co, MD
4. Ryan McKay
5. 3/97
6. MD SHPO
7. Upstream elevation
8. 5 of 6

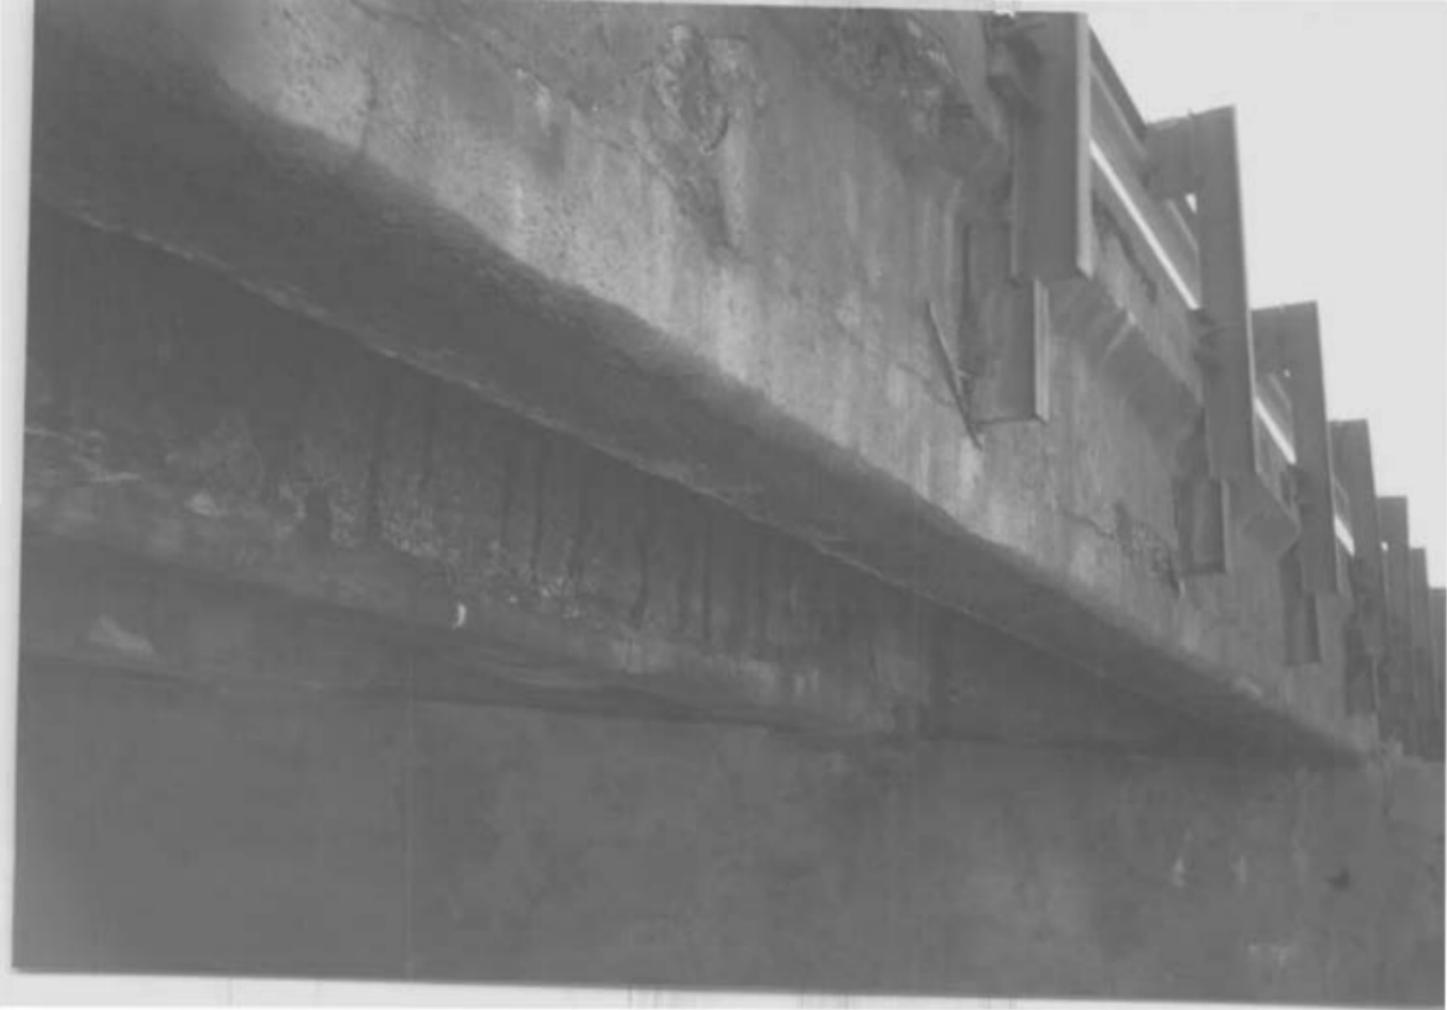
- 1 AL-VI-B-336
- 2 MD 36 over George's Creek
- 3 Allegany Co, MD
- 4 Ryan McKay
- 5 3/97
6. MD SHPD
- 7 Detail of downstream
super structure of beam
- 8- 6 of 6
