AA-1073

Fernglen Manor

Glen Burnie

AA-1073
Fenglen Manor

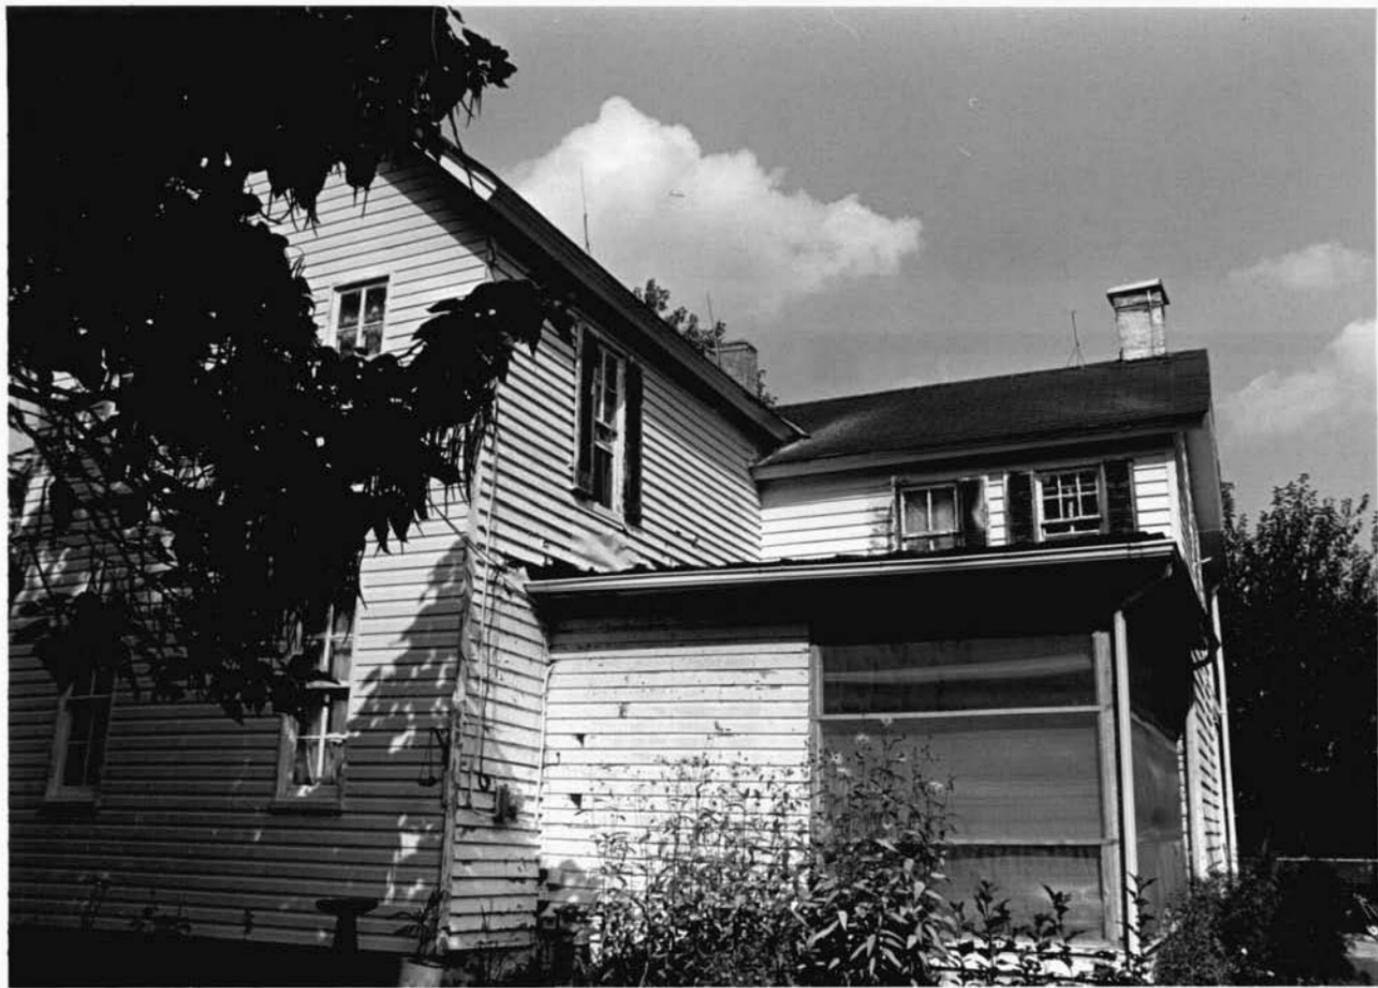
2 of 2

The front facade is dominated by an open, shed-roofed porch, which is supported by four, turned posts, embellished near the roofline with jig-sawn quatrefoil motives. A two-story porch projects from the west side of the ell, extending slightly beyond the longitudinal axis of the front block. Each level is supported by three square posts. The top level retains its flat jig-sawn balustrade.

NW Perspective
