HISTORIC SITES SURVEY FIELD SHEET  
 Individual Structure Survey Form

SURVEY NUMBER: <u>AA 1188</u>
NEGATIVE FILE NUMBER:
UTM REFERENCES: Zone/Easting/Northing
U.S.G.S. QUAD. MAP:
PRESENT FORMAL NAME:
ORIGINAL FORMAL NAME:
PRESENT USE: <u>Apartments</u>
ORIGINAL USE: <u>Apartments</u>
ARCHITECT/ENGINEER:
BUILDER/CONTRACTOR:
PHYSICAL CONDITION OF STRUCTURE: Excellent ( ) Good (X) Fair ( ) Poor: ( )
THEME:
STYLE: <u>Shingle</u>
DATE BUILT: <u>c.1880</u>

COUNTY: <u>Anne Arundel</u>
TOWN: <u>Annapolis</u>
LOCATION: <u>239 Prince George</u>
COMMON NAME:
FUNCTIONAL TYPE: <u>Res Map 32 Par 412</u>
OWNER: <u>Henry R. Buser</u> ADDRESS: <u>159 Main Street</u> <u>Annapolis, MD 21401</u>
ACCESSIBILITY TO PUBLIC: Yes (X) No ( ) Restricted ( )
LEVEL OF SIGNIFICANCE: Local (✓) State ( ) National ( ) <input checked="" type="radio"/>

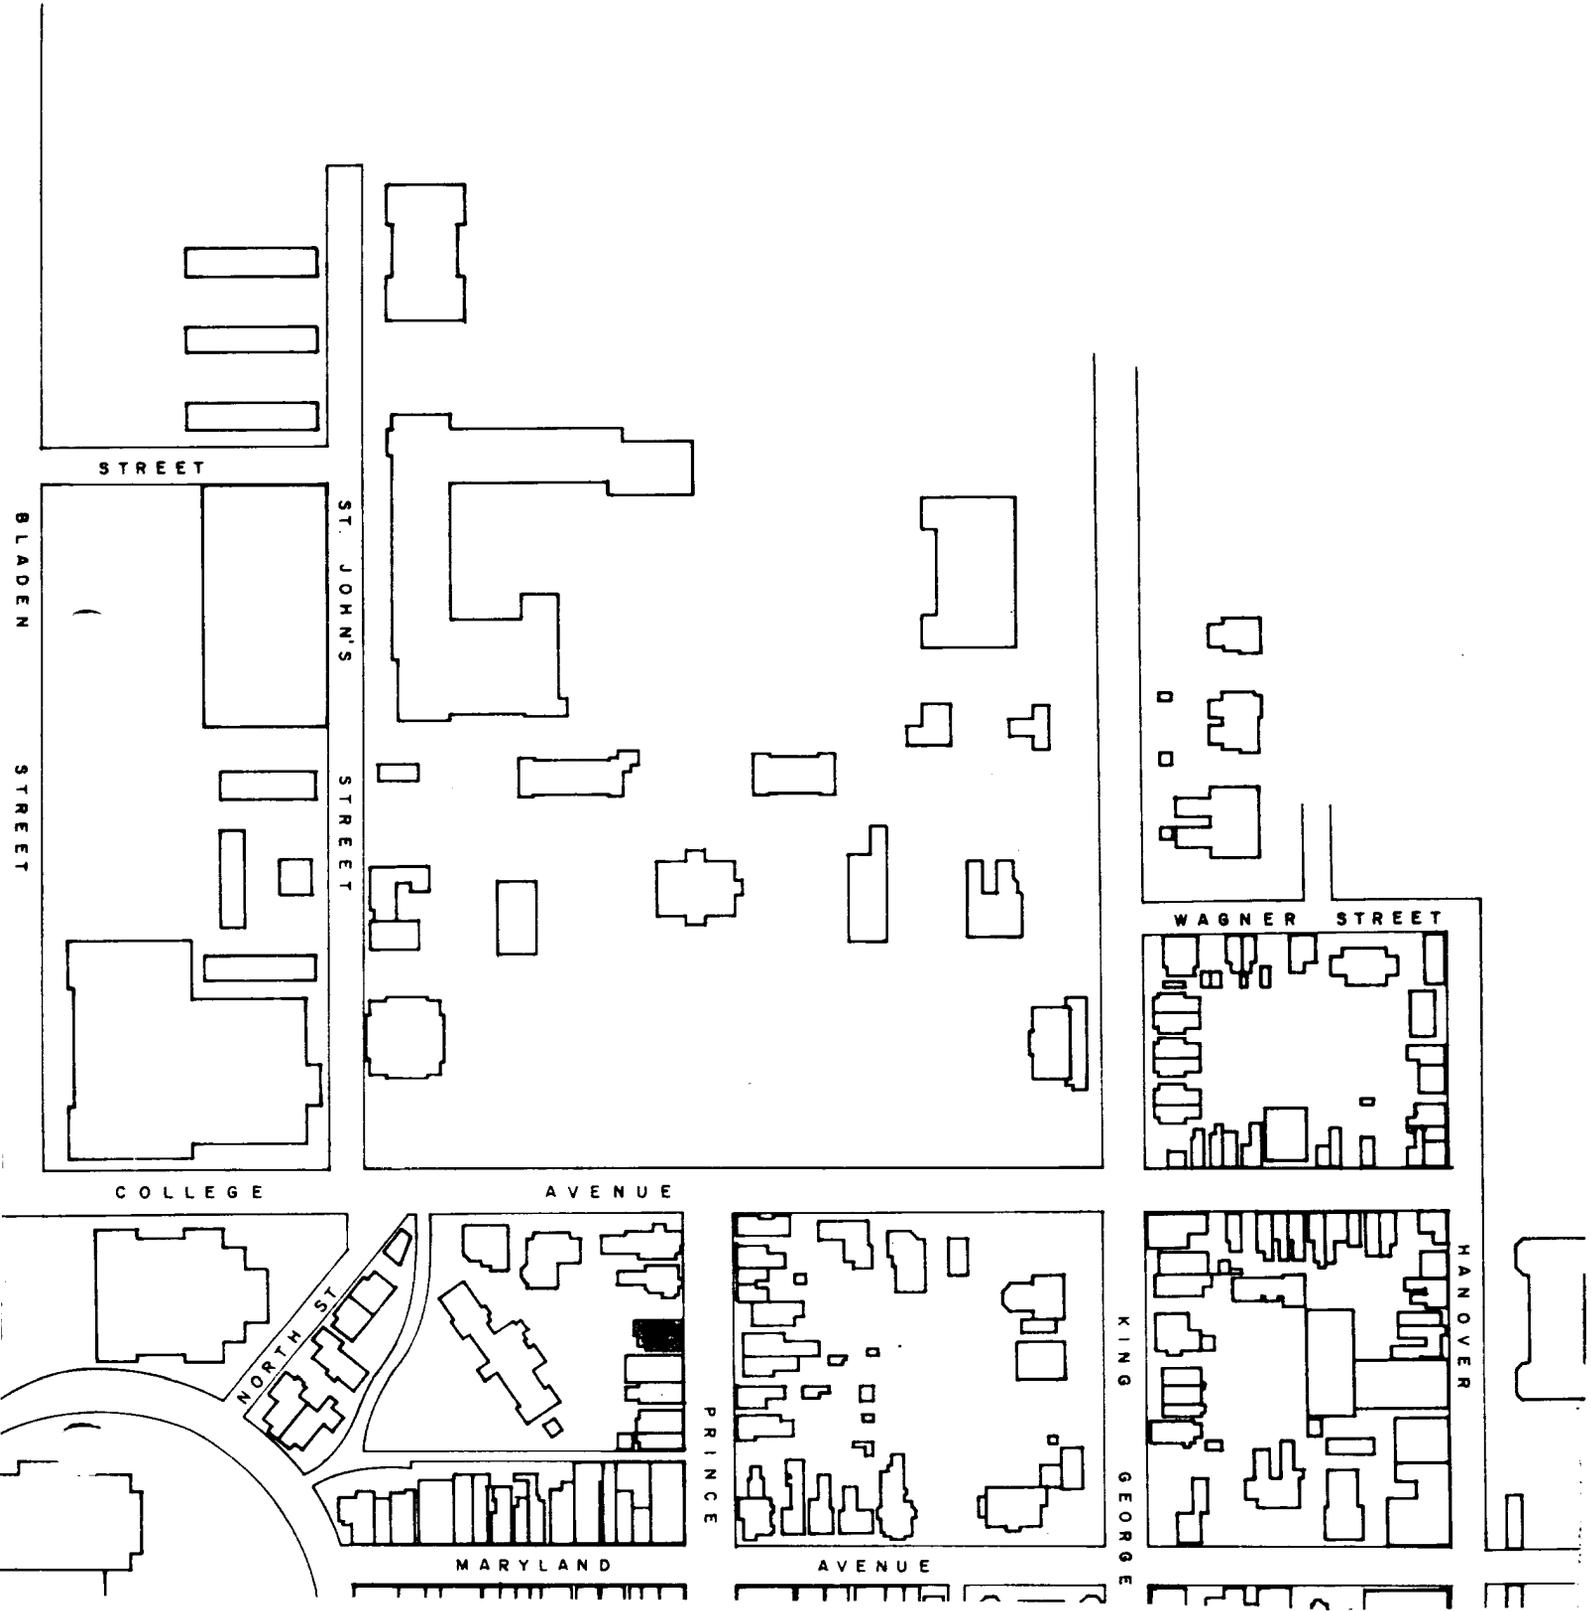
AA 118<sup>86</sup>  
ANNAPOLIS HIST. DIST.

239 Prince George                      AA 1188  
Annapolis, Anne Arundel County  
Russell Wright                      July, 1982  
Maryland Historical Trust,  
Annapolis, Maryland  
NWElevation/camera facing SE
