AA-1393

HISTORIC SITES SURVEY FIELD SHEET  
 Individual Structure Survey Form

1. STATE Annapolis, Maryland		HISTORIC AMERICAN BUILDINGS SURVEY INVENTORY	
COUNTY	TOWN	VICINITY	2. NAME
STREET NO. 35, 37, 39, 41 Cathedral St.			DATE OR PERIOD Late 19th C.
ORIGINAL OWNER	ORIGINAL USE residences	PRESENT OWNER	STYLE Victorian
PRESENT USE residences	WALL CONSTRUCTION wood 37, mod. shingl. / others	NO. OF STORIES two	ARCHITECT
			BUILDER

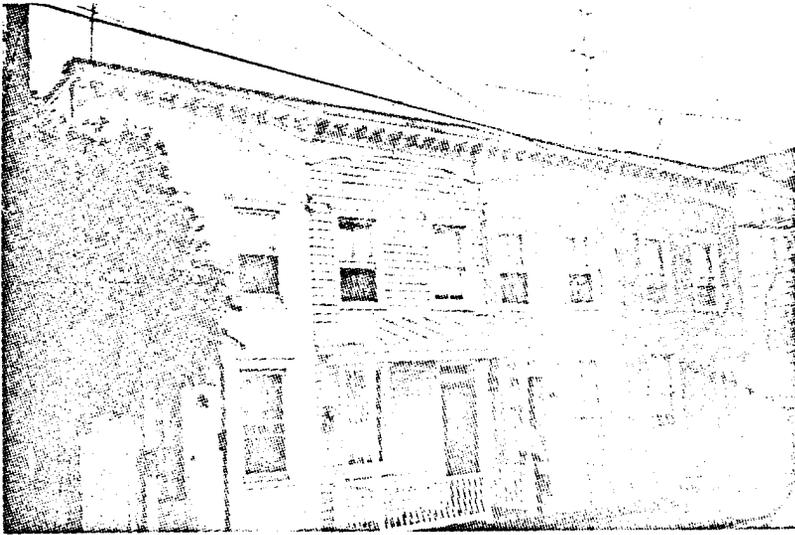
3. FOR LIBRARY OF CONGRESS USE
4. NOTABLE FEATURES, HISTORICAL SIGNIFICANCE AND DESCRIPTION		OPEN TO PUBLIC no	
<p>This quartet of small houses sharing party walls is an excellent example of four differently colored houses being unified with a single cornice - a fine Victorian cornice with large brackets and Victorian modillions and unified by four elliptical wood panels beneath (it is, I think, a rare motif) window sash is original as is clapboarding on No 37. Small but nice and relatively unadorned row houses - good of their type and good for street scale.</p>

5. PHYSICAL CONDITION OF STRUCTURE		Endangered	Interior
			Exterior fair
<p><i>Some of the original Naval Academy buildings had this motif of the cornice</i></p>
