AA-1400

HISTORIC SITES SURVEY FIELD SHEET
Individual Structure Survey Form

COUNTY: Anne Arundel
TOWN: Annapolis
LOCATION: 99 Cathedral Street
COMMON NAME:
FUNCTIONAL TYPE: Res Map 30 Par 564
OWNER: Ben D. & Virginia M. Conley ADDRESS: 1919 West Street Annapolis, MD 21401
ACCESSIBILITY TO PUBLIC: Yes (X) No () Restricted ()
LEVEL OF SIGNIFICANCE: Local (✓) State () National ()

<p>1. STATE Annapolis, Maryland COUNTY TOWN VICINITY STREET NO. 99, 97 Cathedral St. (2bld)</p> <p>ORIGINAL OWNER ORIGINAL USE residences PRESENT OWNER PRESENT USE residences WALL CONSTRUCTION shingle (97 moderns) NO. OF STORIES two plus mansard attic</p>	<p>HISTORIC AMERICAN BUILDINGS SURVEY INVENTORY</p> <p>2. NAME</p> <p>DATE OR PERIOD 1880, - 90s STYLE Victorian ARCHITECT BUILDER</p> <p>3. FOR LIBRARY OF CONGRESS USE</p>
---	---

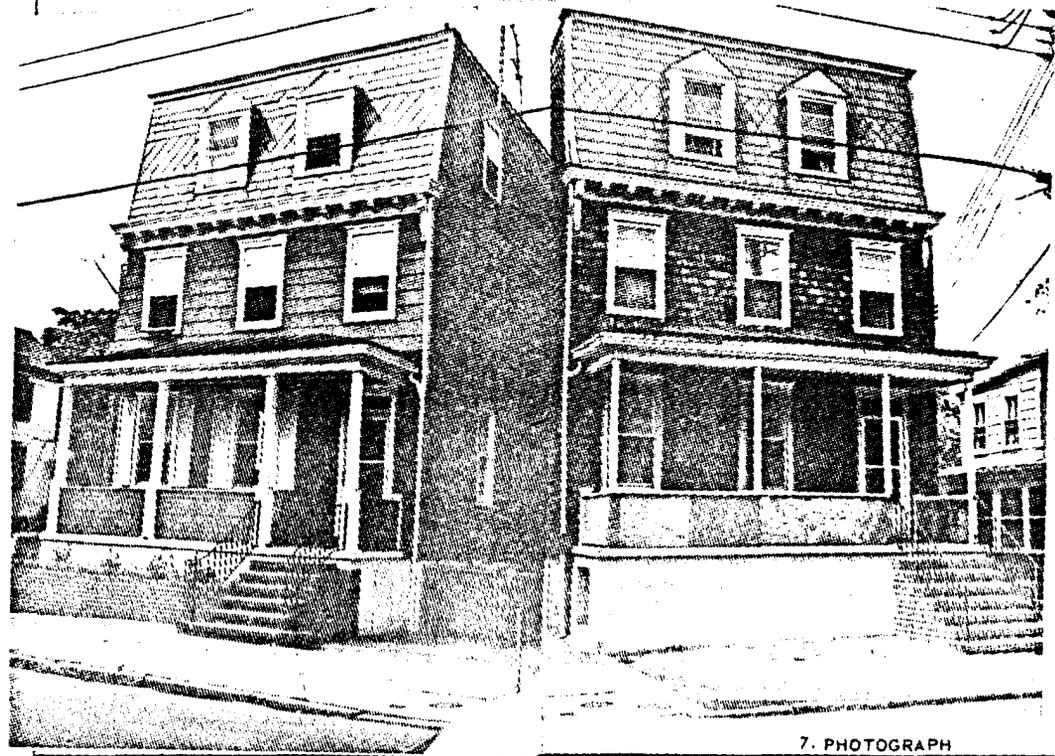
7. PHOTOGRAPH

This pair are a fine Victorian couple. Though identical both add to the street and are worth preserving as a unit. Good examples of Victorian residences which are large and usable while presenting imposing street facades. They sit up on c3' basements, have front porches held up by 4 slim pillars and decorated with scalloping, 3 second storey windows (2/2), with modillioned, bracketed, and scalloped cornices. The outstanding feature of these houses is their "applied" mansard roof making up the 3rd storey. The mansard is of slate with a decorative diamond pattern running through the middle. There are two slightly projecting dormers on both with abstracted sun bursts on the pediment. Topped by small plain cornice - flat roof. Both basically unaltered except for 97's new siding, 99's brown shingling is original and is superb. Very handsome.

*Ca. 1910
 Naval Academy
 Beauty Arts*

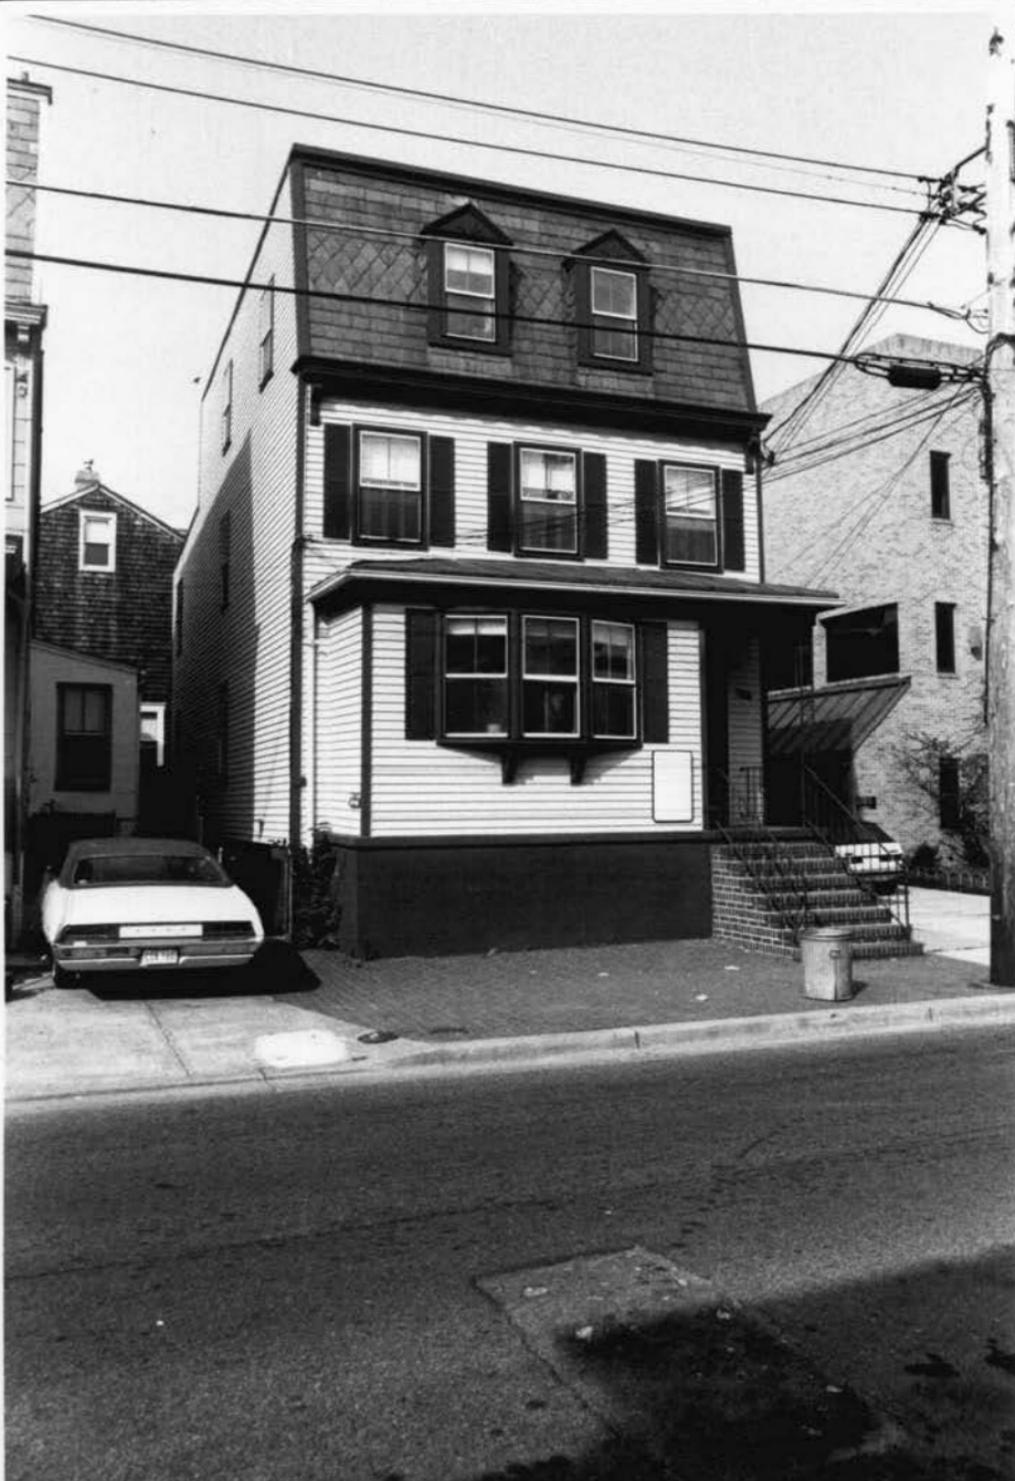
AA 1400

Excellent pedimented dormers with applied sunbursts in gables, on patterned shingle false Mansard roof; good bracketed cornice with end consoles; transom lit door; Porch has been infilled and entire structure covered with aluminum siding.

99 Cathedral

MWElevation/camera facing SE
